Hayling Island Defence Condition Assessment

Hayling Island Funding and Implementation Strategy

Havant Borough Council

May 2019

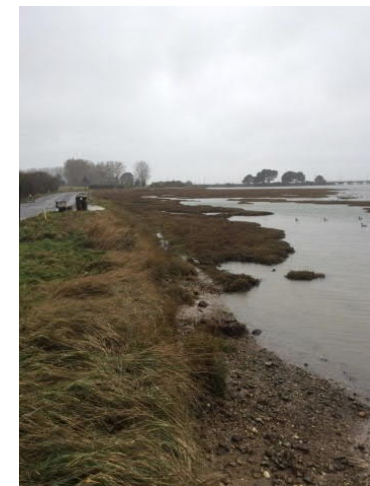
Defence Element:	5AHI01 (Length: 1100m)	Defence Section:	B

Foreshore Description:				
Mixture of fine and coarse gravel.				
Defence Condition and Grade:	Good	Residual Life (no maintenance):	15-20 years	
Generally good condition. Well vegetated structure with good crest width (5m). Minimal displacement of rock armour toe, good embedment.				
Owner (HBC/P/HA/HCC/EA/SWS/EH):	P	Maintainer (HBC/P/HA/HCC/EA/SWS/EH):	P	
Comments:

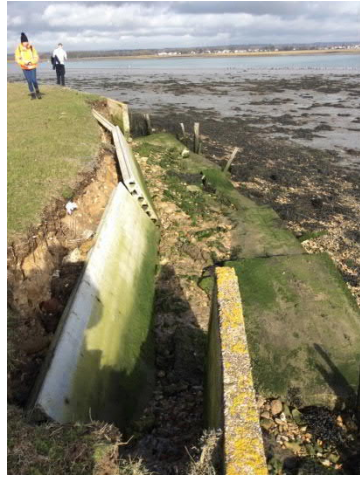
Construction Material:	Concrete			
Foreshore Description:				
Mud at the foreshore. Build-up of seaweed and material from tidal waters.				
Defence Condition and Grade:	Very poor	Residual Life (no maintenance):	Failed Otherwise < 5year	
Defence failed in places, exposing embankment behind to erosion. Crest level not uniform and areas with bad undermining.				
Owner (HBC/P/HA/HCC/EA/SWS/EH):	P	Maintainer (HBC/P/HA/HCC/EA/SWS/EH):	P	
Comments:

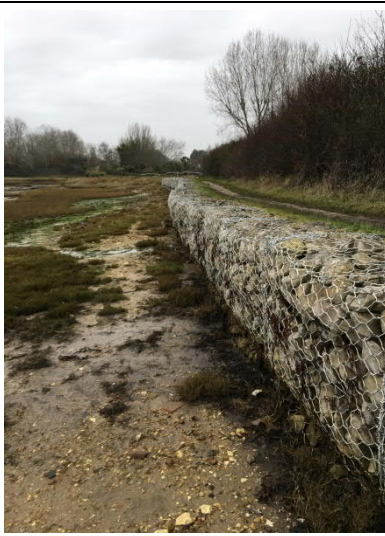
Defence Element:	5AHI04 (Length: 60m)	Defence Section:	F

Location:	Marine Walk	Year of Construction:	Unknown.	
Defence Description:				
Gabion basket structure (coarse rock filled). 1.5m high				
Construction Material:	Wire			
Foreshore Description:				
Mud flats & salt marsh to the toe of structure.				
Defence Condition and Grade:	Good	Residual Life (no maintenance):	15-20 years	
Good condition. Plastic coated protection to the mesh baskets. Evidence of buckling in some areas (non-critical).				
Owner (HBC/P/HA/HCC/EA/SWS/EH):	P	Maintainer (HBC/P/HA/HCC/EA/SWS/EH):	EA	
Comments:

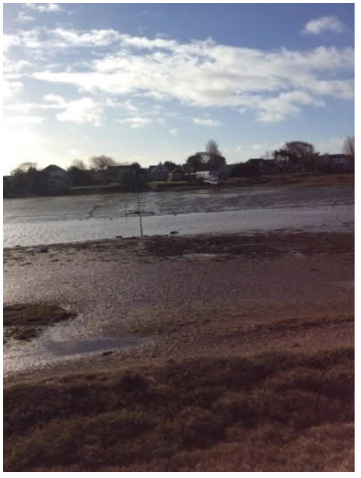
Location:	Eastoke Avenue	Year of Construction:	Unknown.	
Defence Description:				
Predominantly concrete retaining wall structures (1.5m high).				
Construction Material:	Concrete			
Foreshore Description:				
Mud flats.				
Defence Condition and Grade:	N/A	Residual Life (no maintenance):	N/A	
Unknown. Unable to assess.				
Owner (HBC/P/HA/HCC/EA/SWS/EH):	P	Maintainer (HBC/P/HA/HCC/EA/SWS/EH):	P	
Comments:				
Access was not granted and could only be photographed from the opposite bank.

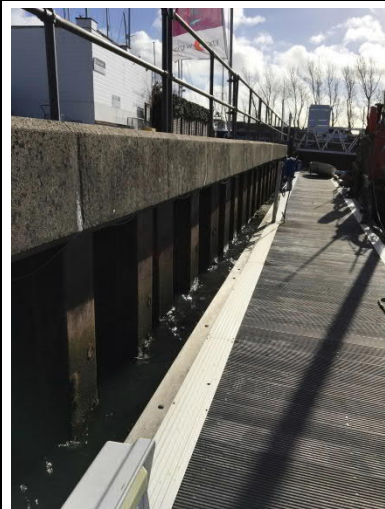
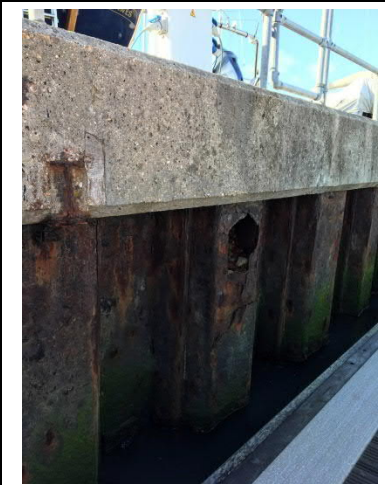
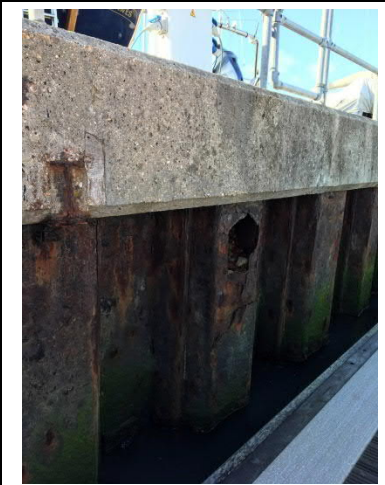
Location:	Sparkes Marina	Year of Construction:	Unknown	
Defence Description:				
Steel sheet piles with concrete capping beam.				
Construction Material:	Steel

Foreshore Description:				
Unable to assess due to high water level.				
Defence Condition and Grade:	Fair	Residual Life (no maintenance):	10-15 years

Fair condition. Signs of corrosion and damage to piles in some locations.				
Owner (HBC/P/HA/HCC/EA/SWS/EH):	P	Maintainer (HBC/P/HA/HCC/EA/SWS/EH):	P	
Comments:				
Unable to assess toe of structure due to high tide conditions.

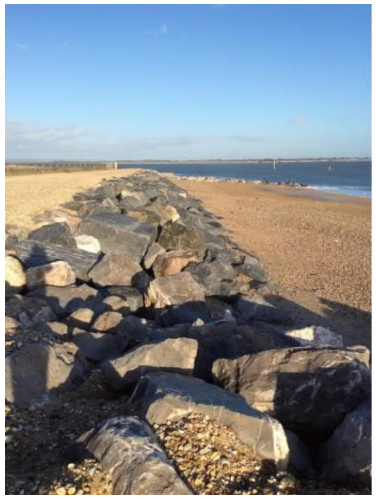
Location:	Hayling Beach	Year of Construction:	Unknown	
Defence Description:				
Rock armour revetment.				
Construction Material:	Rock			
Foreshore Description:				
Sand and shingle to the toe and crest of the structure.				
Defence Condition and Grade:	Good	Residual Life (no maintenance):	15-20 years	
Minor movement of structure. Rock density consistent. Crest height still in-tact. Minor movement in the toe alignment.				
Owner (HBC/P/HA/HCC/EA/SWS/EH):	HBC	Maintainer (HBC/P/HA/HCC/EA/SWS/EH):	HBC	
Comments:

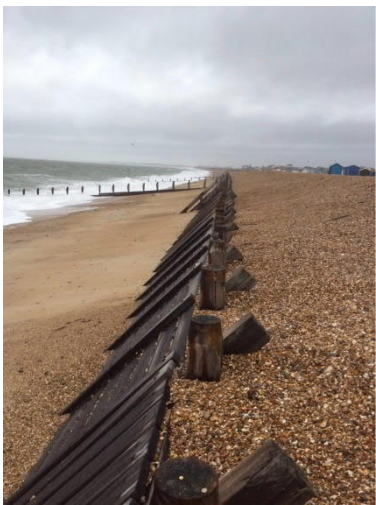
Location:	Pebble Beach	Year of Construction:	Unknown	
Defence Description:				
Timber revetment, 1m high.				
Construction Material:	Timber			
Foreshore Description:				
Sand and gravel to the toe and crest of the structure.				
Defence Condition and Grade:	Good	Residual Life (no maintenance):	15-20 years	
Good condition. Missing planks in some areas. Gaps within structure due to weathering. Splitting of some piles.				
Owner (HBC/P/HA/HCC/EA/SWS/EH):	HBC	Maintainer (HBC/P/HA/HCC/EA/SWS/EH):	HBC	
Comments:

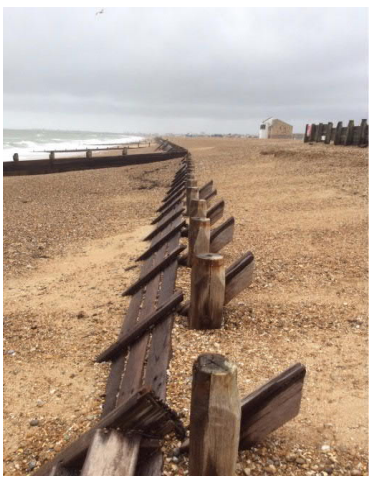
Location:	Pebble Beach	Year of Construction:	Unknown	
Defence Description:				
Timber revetment, approximately 1m high.				
Construction Material:	Timber			
Foreshore Description:				
Sandy beach material to the toe. Gravel/shingle material built up at the crest				
Defence Condition and Grade:	Very Good	Residual Life (no maintenance):	>20 years	
Very good. Good toe embedment. No planks missing with limited gaps between boards.				
Owner (HBC/P/HA/HCC/EA/SWS/EH):	HBC	Maintainer (HBC/P/HA/HCC/EA/SWS/EH):	HBC	
Comments:

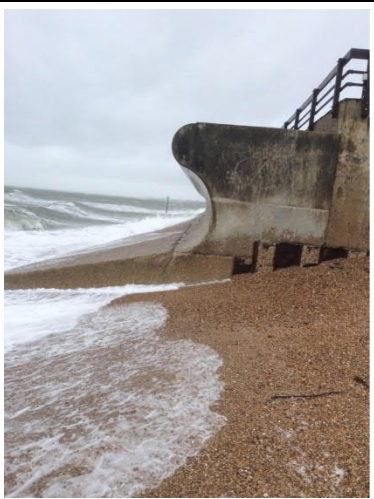
Location:	Inn on the Beach	Year of Construction:	Unknown	
Defence Description:				
Concrete recurve wave wall 3m high. Sheet piles to the east and west face.				
Construction Material:	Concrete			
Foreshore Description:				
Sand at the toe. High wave action during the survey date.				
Defence Condition and Grade:	Fair	Residual Life (no maintenance):	10-15 years	
Fair-good. Minor cracks and spawling of concrete in the face. Depression visible in the apron of the structure. Unknown if toe is undermined- unable to access due to stormy conditions. Sheet piling on east and west walls corroded, still intact.				
Owner (HBC/P/HA/HCC/EA/SWS/EH):	P	Maintainer (HBC/P/HA/HCC/EA/SWS/EH):	P	
Comments:

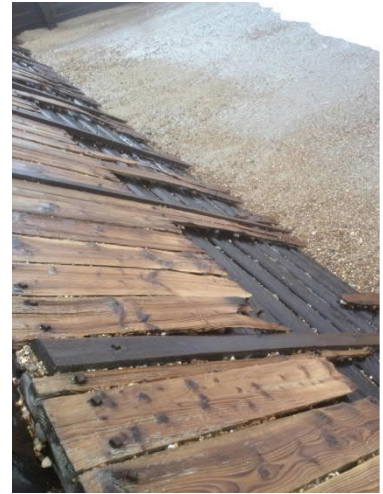
Construction Material:	Timber			
Foreshore Description:				
Shingle beach.				
Defence Condition and Grade:	Poor	Residual Life (no maintenance):	<10 years	
Poor condition. Numerous planks missing in areas, rotted material. End section appears to have been removed.				
Owner (HBC/P/HA/HCC/EA/SWS/EH):	HBC	Maintainer (HBC/P/HA/HCC/EA/SWS/EH):	HBC	
Comments:

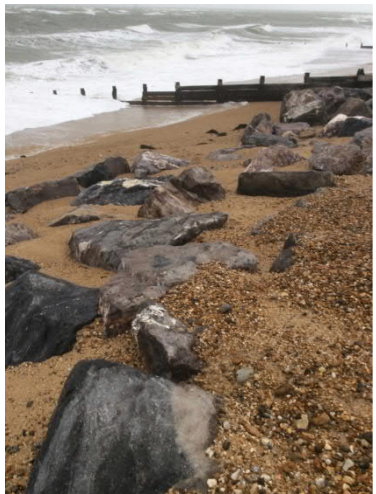
Location:	South of Hayling Golf Club	Year of Construction:	Unknown	
Defence Description:				
Rock armour revetment, approximately 1m high.				
Construction Material:	Rock			
Foreshore Description:				
Sand and gravel to the toe of the structure.				
Defence Condition and Grade:	Poor	Residual Life (no maintenance):	<10 years	
Loss of structure shape and alignment. Toe undermined. Sporadic coverage of stones.				
Owner (HBC/P/HA/HCC/EA/SWS/EH):	HBC	Maintainer (HBC/P/HA/HCC/EA/SWS/EH):	HBC	
Comments:

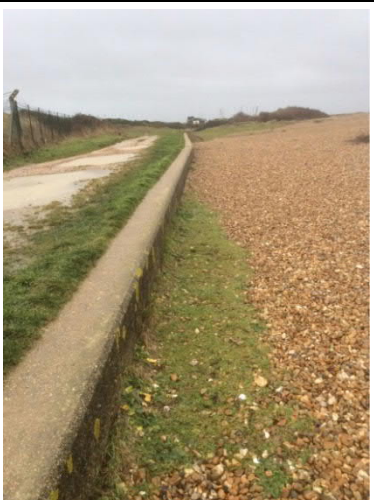
Location:	Hayling Ferry Sailing Club	Year of Construction:	Unknown	
Defence Description:				
0.5m high concrete wall.				
Construction Material:	Concrete			
Foreshore Description:				
Gravel to the toe and crest.				
Defence Condition and Grade:	Good	Residual Life (no maintenance):	15-20 years	
Good condition. Some loss of material at the joints. Minor damage to the surface face.				
Owner (HBC/P/HA/HCC/EA/SWS/EH):	P	Maintainer (HBC/P/HA/HCC/EA/SWS/EH):	P	
Comments:

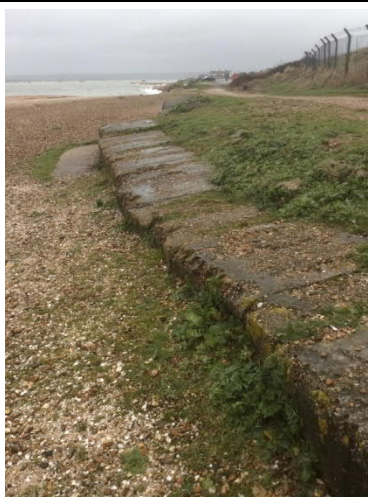
Location:	Hayling Ferry Sailing Club	Year of Construction:	Unknown	
Defence Description:				
Concrete blockwork. 1m wide x 0.5m high.				
Construction Material:	Blockwork			
Foreshore Description:				
Gravel.				
Defence Condition and Grade:	Fair	Residual Life (no maintenance):	10-15 years	
Fair condition. Surface damage to the concrete. Lateral cracks within the structure. Some localised holes in the structure.				
Owner (HBC/P/HA/HCC/EA/SWS/EH):	P	Maintainer (HBC/P/HA/HCC/EA/SWS/EH):	P	
Comments:

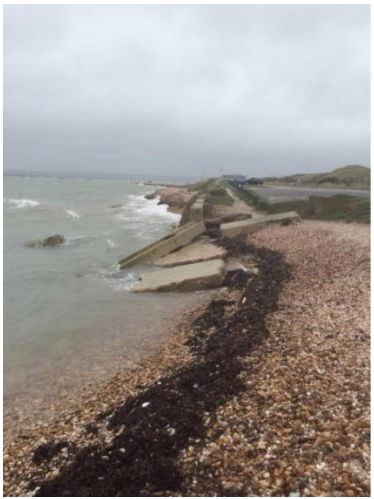
Location:	Hayling Ferry Sailing Club	Year of Construction:	Unknown	
Defence Description:				
Pre-cast concrete blocks.				
Construction Material:	Blockwork			
Foreshore Description:				
Gravel and shingle material to the toe.				
Defence Condition and Grade:	Very Poor	Residual Life (no maintenance):	Failed	
Failed. Structure has breached in multiple locations with a loss of form. Blockwork now appears to be randomly positioned.				
Owner (HBC/P/HA/HCC/EA/SWS/EH):	P	Maintainer (HBC/P/HA/HCC/EA/SWS/EH):	P	
Comments:

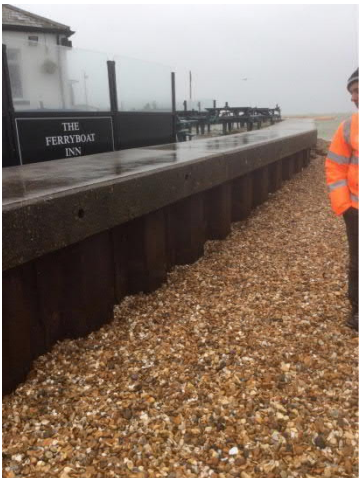
Location:	Ferryboat Inn	Year of Construction:	Unknown	
Defence Description:				
Sheet piles with concrete cap.				
Construction Material:	Steel			
Foreshore Description:				
Gravel and beach shingle material.				
Defence Condition and Grade:	Good	Residual Life (no maintenance):	15-20 years	
Good condition. Concrete capping beam in very good condition. Minimal rust to the piles, no loss of thickness.				
Owner (HBC/P/HA/HCC/EA/SWS/EH):	P	Maintainer (HBC/P/HA/HCC/EA/SWS/EH):	P	
Comments:

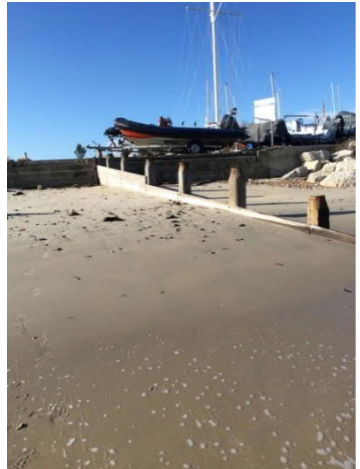
Defence Condition and Grade:	3- Good 2- Fair 4- N/A (Buried)	Residual Life (no maintenance) Yrs:	15-20 years 10-15 years N/A	
Good – Fair Condition throughout. No Missing planks or gaps between panels. Minor defects to the timber, but no severe rot. Timber panels buckling in some areas.				
Owner (HBC/P/HA/HCC/EA/SWS/EH):	P	Maintainer (HBC/P/HA/HCC/EA/SWS/EH):	P	
Comments:				
4 timber groynes were unable to be surveyed due to high beach level.

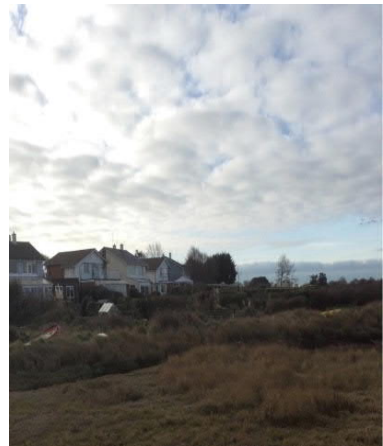
Location:	Northshore Road (South)	Year of Construction:	Unknown	
Defence Description:				
Vegetated embankment. 1m above top of creek level. Appears to be protecting private properties behind.				
Construction Material:	Earth			
Foreshore Description:				
Mud flats/ Creek to the upper. Shingle beach to the middle.				
Defence Condition and Grade:	Good	Residual Life (no maintenance):	15-20 years	
Good condition. Well vegetated structure, protected by the creek.				
Owner (HBC/P/HA/HCC/EA/SWS/EH):	P	Maintainer (HBC/P/HA/HCC/EA/SWS/EH):	P	
Comments:

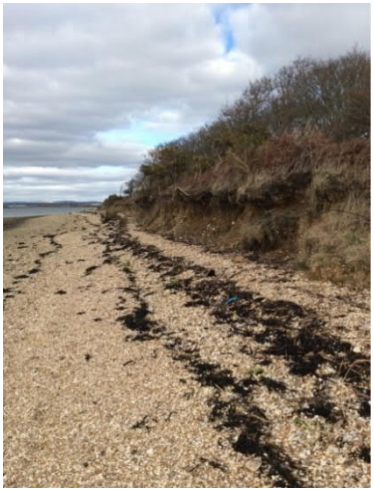
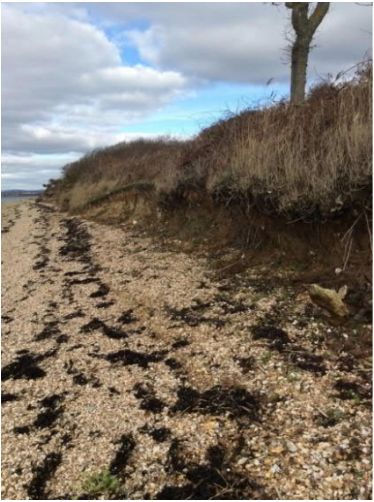
Location:	Billy Trail	Year of Construction:	Unknown	
Defence Description:				
Earth embankment 2-3m high. Vegetated.

Construction Material:	Earth			
Foreshore Description:				
Shingle to the toe. Seaweed line 1m away from the toe.				
Defence Condition and Grade:	Poor	Residual Life (no maintenance):	<10 years	
Poor. Undermining of the toe. Well vegetated. Local slips of the embankment occurring. Clifing of the crest in many areas.				
Owner (HBC/P/HA/HCC/EA/SWS/EH):	HCC	Maintainer (HBC/P/HA/HCC/EA/SWS/EH):	HCC	
Comments:

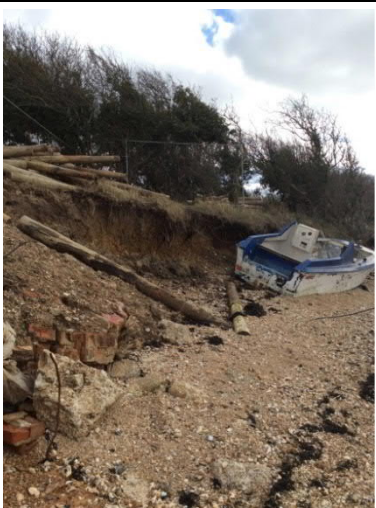
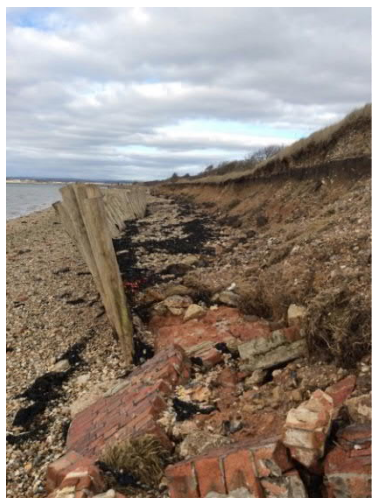
Location:	Billy Trail	Year of Construction:	Unknown	
Defence Description:				
Timber pile revetment.				
Construction Material:	Timber

Foreshore Description:				
Shingle to the toe.				
Defence Condition and Grade:	Very Poor	Residual Life (no maintenance):	Failed	
Failed. Slope behind the revetment has collapsed. Timber piles have been displaced and removed from their alignment vertically and horizontally. 0.5m of land left between the foreshore and billy line trail in some locations.				
Owner (HBC/P/HA/HCC/EA/SWS/EH):	HCC	Maintainer (HBC/P/HA/HCC/EA/SWS/EH):	HCC	
Comments:

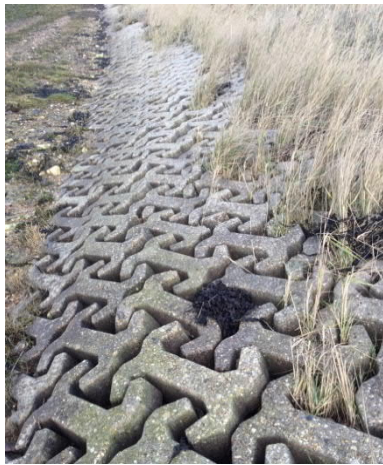
Foreshore Description:				
Grasslands and coarse material at the toe.				
Defence Condition and Grade:	Fair	Residual Life (no maintenance):	10-15 years	
Non uniform. Minor movement and root growth. Toe exposed.				
Owner (HBC/P/HA/HCC/EA/SWS/EH):	HCC	Maintainer (HBC/P/HA/HCC/EA/SWS/EH):	EA	
Comments:

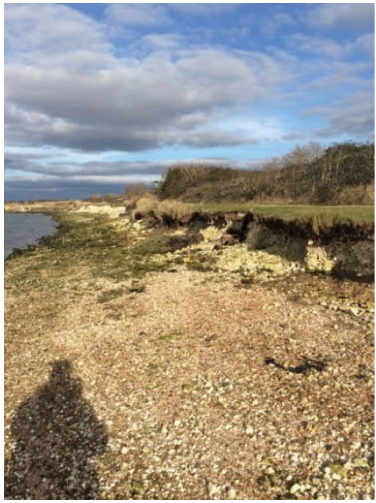
Location:	Oyster Beds	Year of Construction:	Unknown	
Defence Description:				
Vegetated earth embankment.				
Construction Material:	Earth			
Foreshore Description:				
Shingle.				
Defence Condition and Grade:	Fair	Residual Life (no maintenance):	10-15 years	
Unevenly vegetated, locally poor. Clifing of the embankment in many areas. Contaminated land located behind defence.				
Owner (HBC/P/HA/HCC/EA/SWS/EH):	HBC	Maintainer (HBC/P/HA/HCC/EA/SWS/EH):	HBC	
Comments:

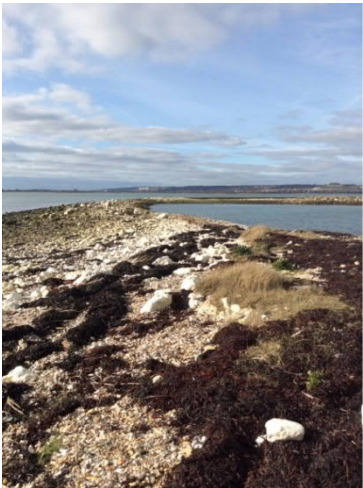
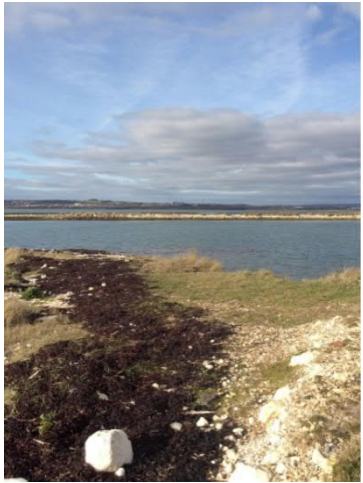
Location:	Oyster Beds	Year of Construction:	Unknown	
Defence Description:				
Rock armour breakwater / embankment.				
Construction Material:	Rock

Foreshore Description:				
Grasslands and coarse gravel material.				
Defence Condition and Grade:	Fair	Residual Life (no maintenance):	10-15 years	
Lack of coherent structure. Missing boulders and voids.				
Owner (HBC/P/HA/HCC/EA/SWS/EH):	HBC	Maintainer (HBC/P/HA/HCC/EA/SWS/EH):	HBC	
Comments:

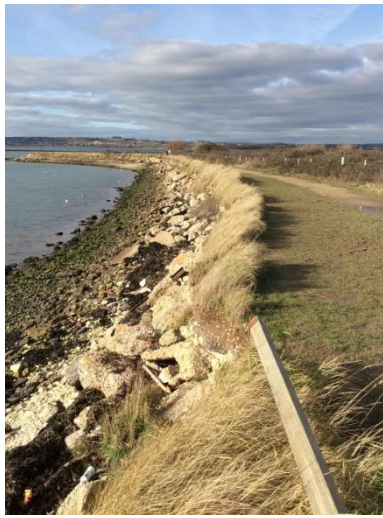
Location:	Oyster Beds	Year of Construction:	Unknown	
Defence Description:				
Rubble revetment.				
Construction Material:	Rubble			
Foreshore Description:				
Coarse shingle material at the toe.				
Defence Condition and Grade:	Poor	Residual Life (no maintenance):	<5 years	
Eroded, overhang. Toe exposed. Contaminated land located behind defence.				
Owner (HBC/P/HA/HCC/EA/SWS/EH):	HBC	Maintainer (HBC/P/HA/HCC/EA/SWS/EH):	HBC	
Comments:

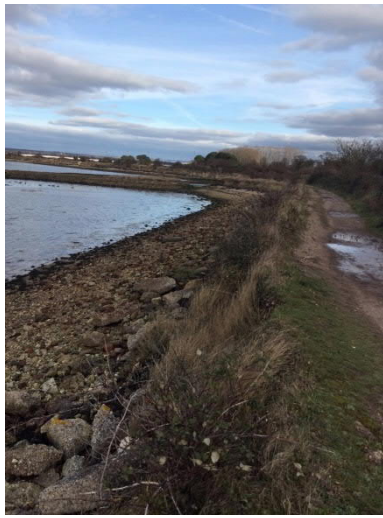
Location:	North-West Hayling/Oyster Beds	Year of Construction:	Unknown	
Defence Description:				
Earth Embankment – 2m high.				
Construction Material:	Rubble			
Foreshore Description:				
Oyster beds, silty mud flats / marsh.				
Defence Condition and Grade:	Fair	Residual Life (no maintenance):	10-15 years	
Vegetated, Locally poor, footpath eroding.				
Owner (HBC/P/HA/HCC/EA/SWS/EH):	HBC	Maintainer (HBC/P/HA/HCC/EA/SWS/EH):	HBC	
Comments:

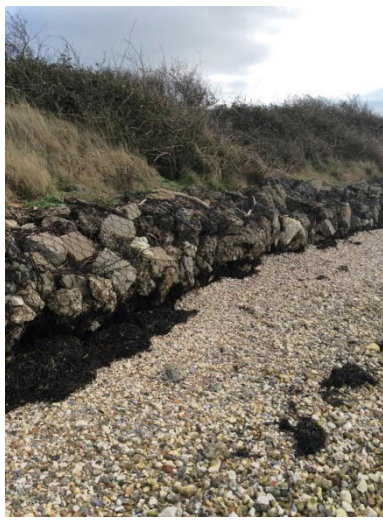
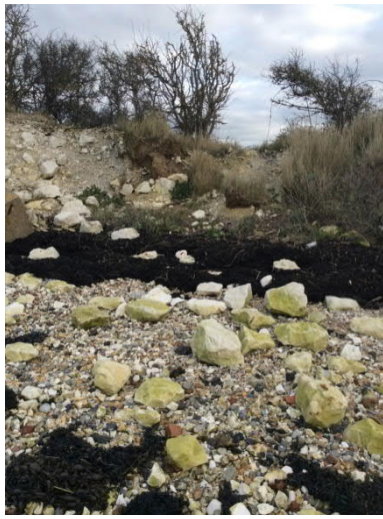
Location:	North West Hayling	Year of Construction:	Unknown	
Defence Description:				
Rock filled gabion mesh.				
Construction Material:	Wire/rock

Foreshore Description:				
Shingle material at the toe of structure				
Defence Condition and Grade:	Poor	Residual Life (no maintenance):	<5 years	
Wire split in places, loss of form and shape. Failed in some locations.				
Owner (HBC/P/HA/HCC/EA/SWS/EH):	HCC	Maintainer (HBC/P/HA/HCC/EA/SWS/EH):	HCC	
Comments:

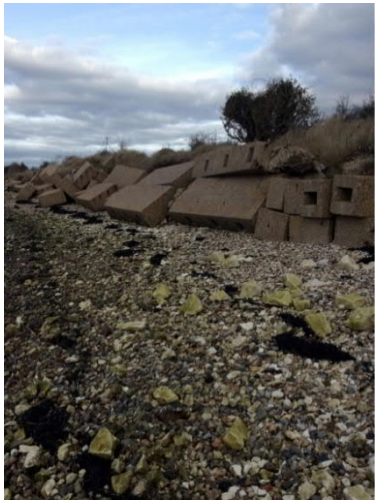
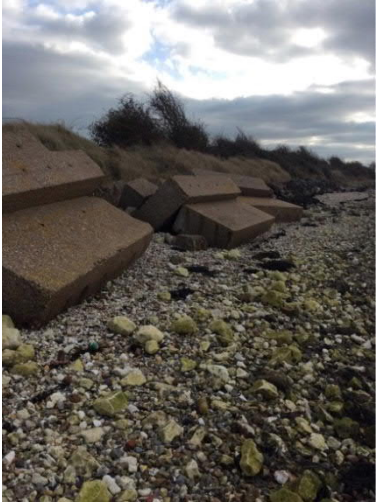
Location:	North West Hayling	Year of Construction:	Unknown	
Defence Description:				
Rubble revetment, 2m high.				
Construction Material:	Rubble

Foreshore Description:				
Shingle material at the toe.				
Defence Condition and Grade:	Poor	Residual Life (no maintenance):	5-10 years	
Missing sections of rubble blockwork. Evidence of erosion in these locations.				
Owner (HBC/P/HA/HCC/EA/SWS/EH):	HCC	Maintainer (HBC/P/HA/HCC/EA/SWS/EH):	HCC	
Comments:

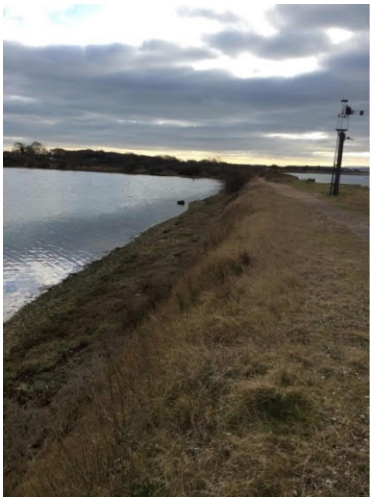
Location:	North Hayling	Year of Construction:	Unknown	
Defence Description:				
Vegetated earthwork embankment.				
Construction Material:	Earth			
Foreshore Description:				
Unable to assess due to water level.				
Defence Condition and Grade:	Fair	Residual Life (no maintenance):	10-15 years	
Fair condition. Non-uniform structure and shape, well vegetated.				
Owner (HBC/P/HA/HCC/EA/SWS/EH):	HCC	Maintainer (HBC/P/HA/HCC/EA/SWS/EH):	HCC	
Comments:

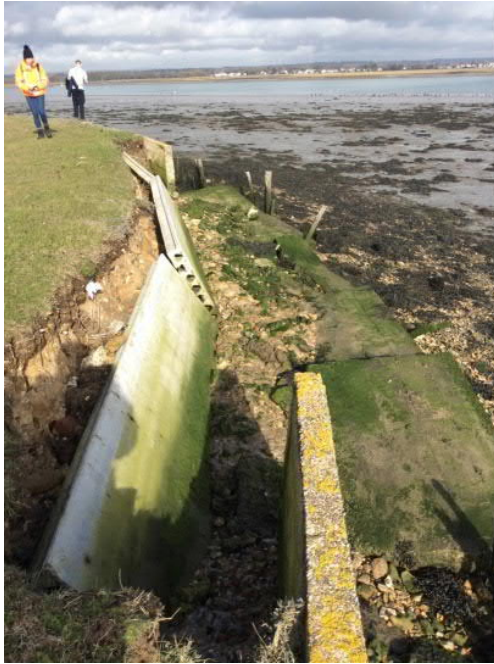
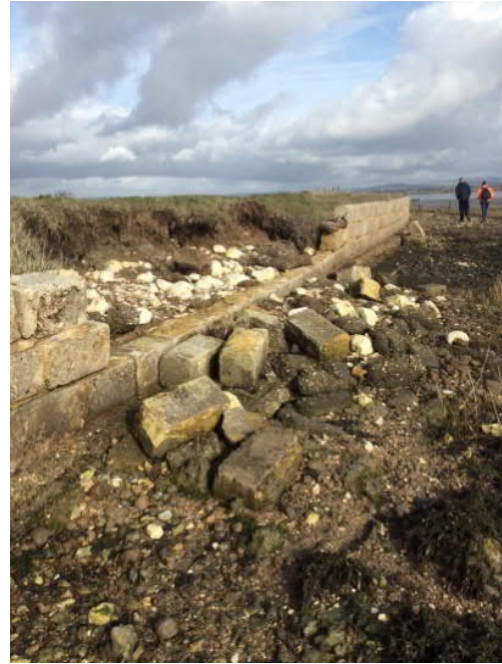
Figure 7-2. Photographs of failed defences between 5AH102 A-E

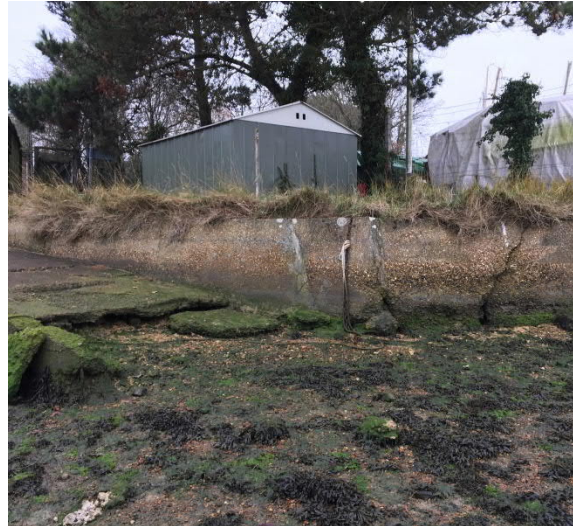
Figure 7-3. Photograph of 5AH104 section A showing lateral crack
