Assessment of the sea wall between Langstone Mill and Wade Lane

Technical Study

Client: Chichester Harbour Conservancy

Reference: PC5050-RHD-XX-XX-RP-X-0001

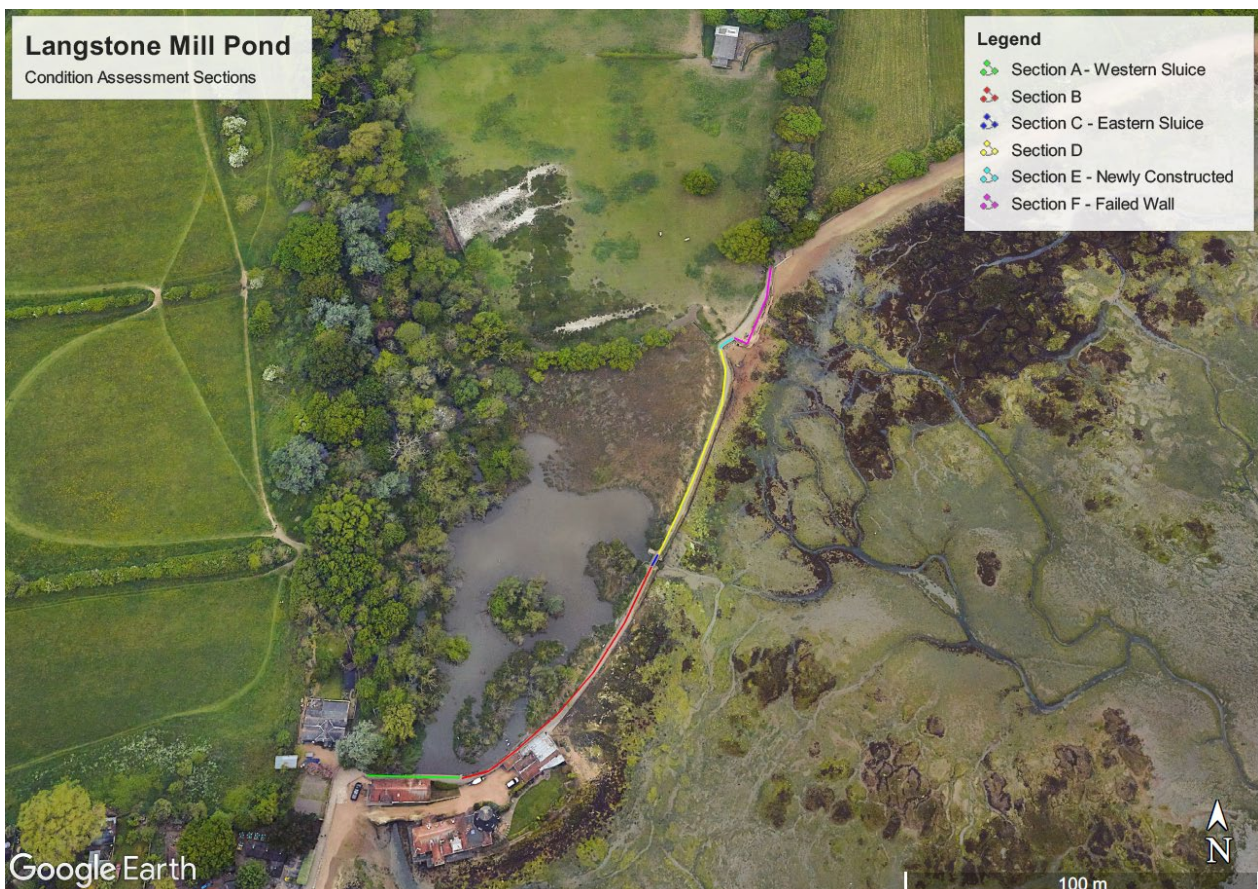
Figure 2: Overview of the coastal defences around Langstone Mill, including condition assessment sections.

The coastal defences between Langstone Mill Pond and Wade Lane consist of an earth embankment with masonry covering its seaward face. Along the southern-most section of the mill pond, Langstone Mill is adjacent to Langstone Mill Pond, and the coastal path runs between the mill pond and the mill (**Figure 2**). The path continues over the top of the seawall towards Wade Lane, from where it continues onto the beach. As such, the coastal defences fulfil three functions: retention of fresh water in the mill pond, flood protection to the hinterland and preserving the coastal path.

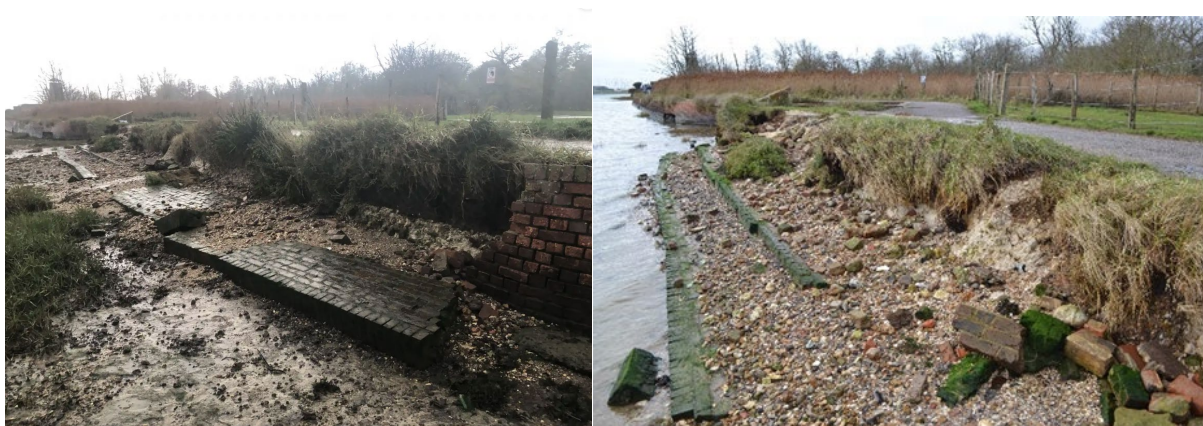
Figure 3 (Left) collapsed sea wall in spring 2022 (photograph coastal partners); (right) collapsed sea wall in January 2023 (photograph D. Brew, RHDHV 2023)

In March 2022, an approximately 30m section of brick sea wall collapsed near Wade Lane following winter storms (**Figure 3**) and a condition assessment was undertaken in which the sea wall was assigned a poor rating by AECOM (2019).

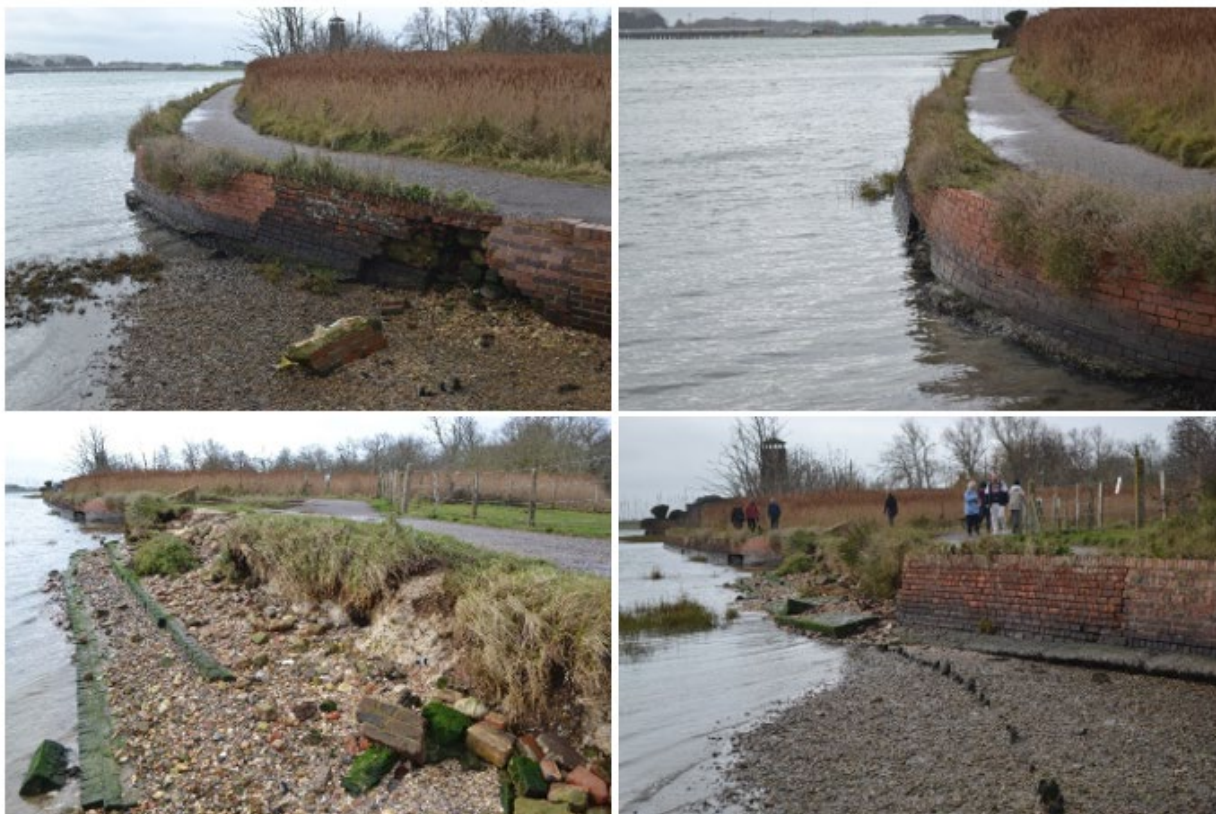
Figure 4 Damaged seawall at Langstone Mill. Photographs taken 4th January 2023 (RHDHV 2023).

A high-level assessment of the Chichester Harbour seawalls was carried out in January 2023 by Royal HaskoningDHV (RHDHV 2023) and the same damage to the wall was highlighted. Attempts were made by locals from the community to repair/maintain the damaged areas with sandbags. However, these sandbags are a temporary solution and are already failing (see [Langstone Coastal Path Local Initiatives — Coastal Partners](#)). In the largest area of failure, Section F in **Figure 2**, there was a considerable amount of rubble in the initial photos (**Figure 3**). Some displacement of that material has taken place; it cannot be confirmed whether this was manually moved or reworked by the tides.

Following these signs of wear and deterioration, Coastal Partners have been monitoring this sea wall closely and further information is available on their website ([Langstone, Mill Pond to Wade Lane, Havant — Coastal Partners](#)). Between December 2022 and July 2023 their monitoring indicated that some sections of the footpath are not eroding but are instead becoming wider by up to 0.3 m and other areas are eroding by up to 0.8 m. The areas of accretion may reflect sections where the embankment is slumping giving the impression that the footpath is stable here but with time it is expected these areas will erode. At the maximum observed rate of erosion (0.13 m per month), the full footpath width (average 3.5 m) would be removed within 2-2.5 years (from July 2023).

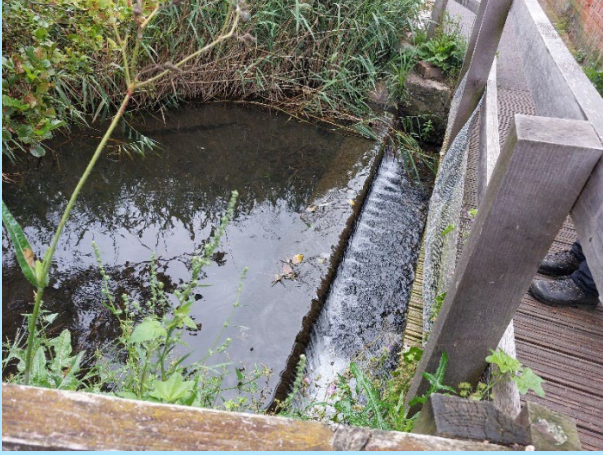
<p>The weir at Langstone Mill Pond; this weir is in good condition, with an even flow over the crest.</p>	A
B

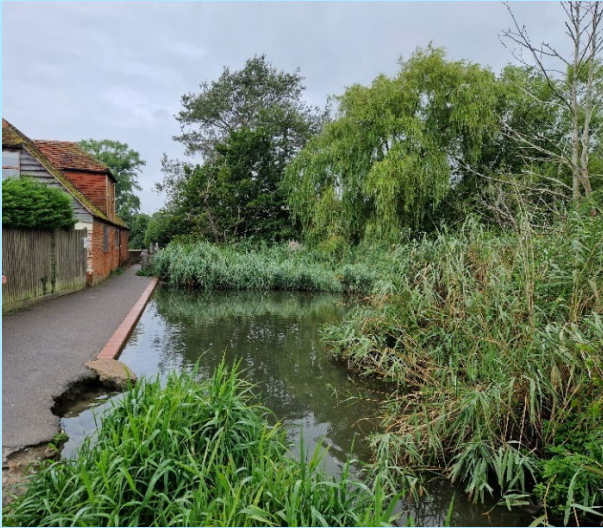
<p>The mill pond, showing the brick retaining wall in good condition, with the broken failing path in the foreground.</p>	A
C

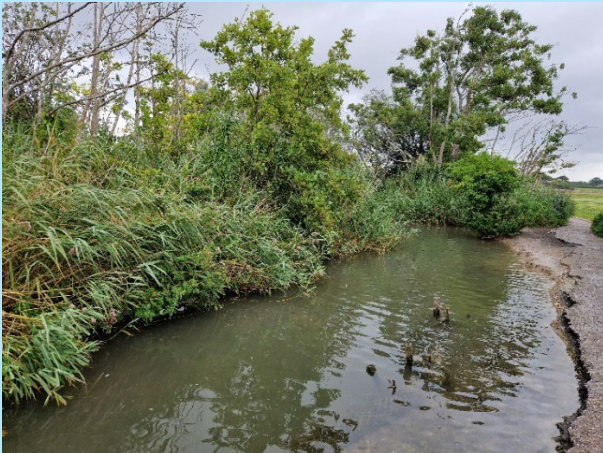
<p>The Mill Pond and the failed path.</p>	B

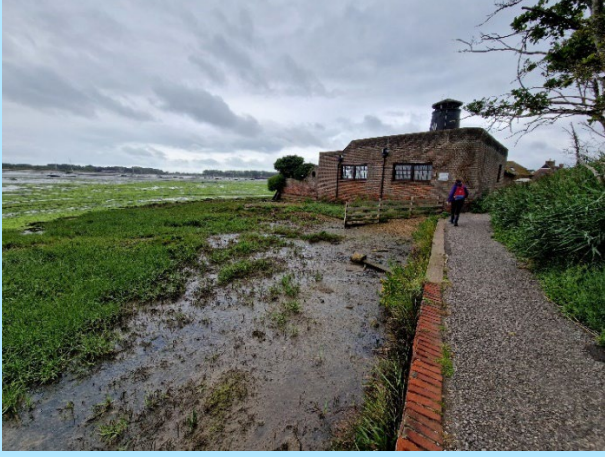
<p>This photo looks back at Langstone Mill along the seawall. The mixture of capping styles can clearly be seen.</p>	B
E

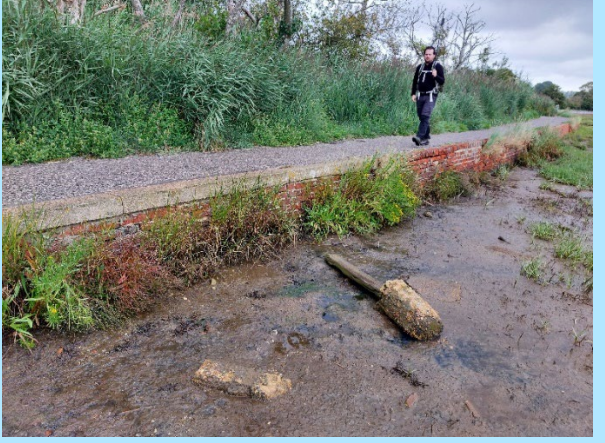
<p>The seawall, with 2 different capping styles.</p> <p>There is significant movement of the masonry capping.</p> <p>Vegetation can be seen coming through the masonry sections.</p>	B
F

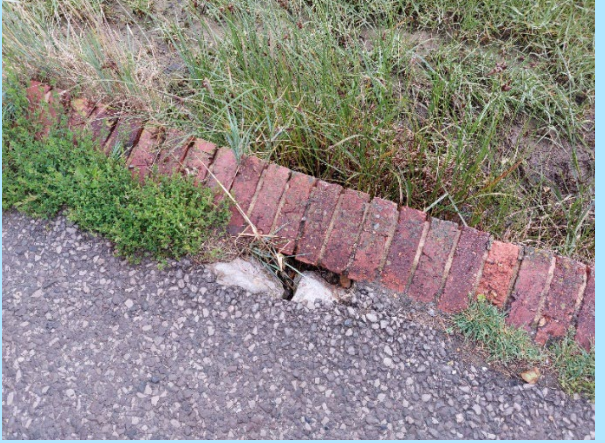
<p>Development of a void behind the masonry seawall.</p>	B

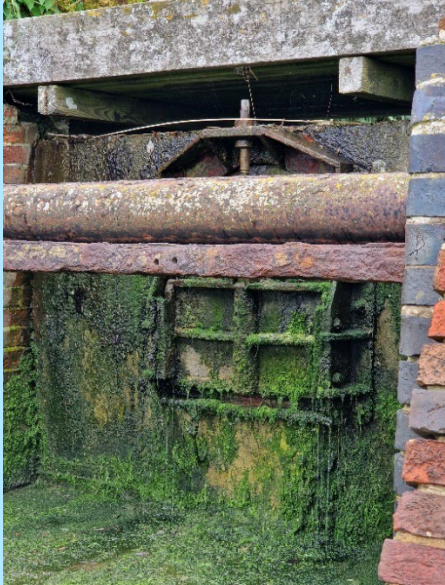
<p>Sluice gate with heavy vegetation growth.</p> <p>Gap at the top allowing for overflow.</p>	C
H

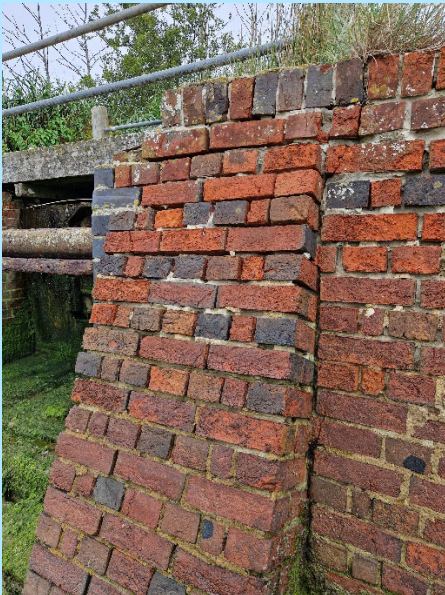
<p>Masonry strut in the sluice outfall structure showing mortar missing.</p>	C

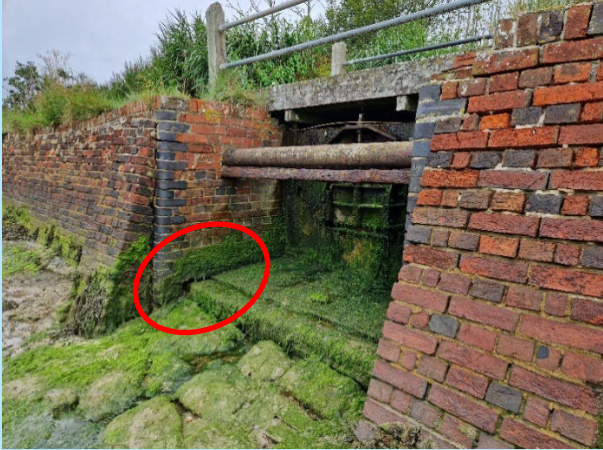
<p>Sluice outfall structure. The far strut is showing some undermining at the internal toe.</p>	C
J

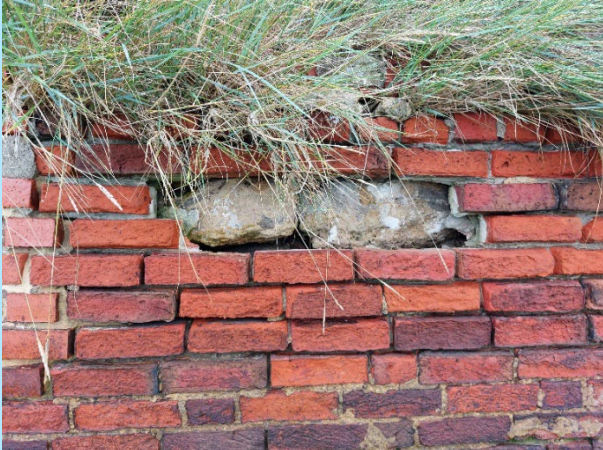
<p>Masonry bricks missing, showing rock infill behind.</p>	D
K

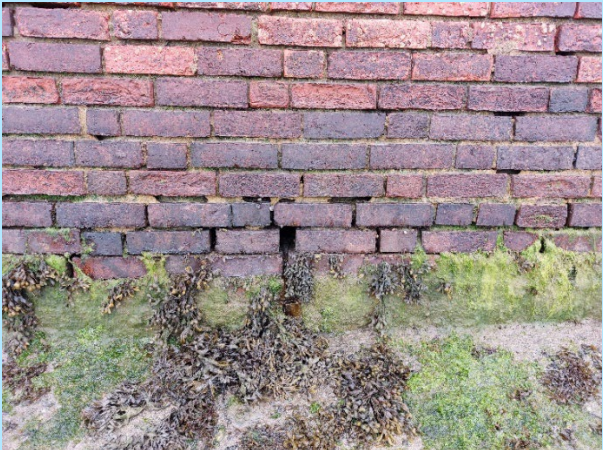
<p>Masonry grouting missing at the bottom of the seawall</p>	D

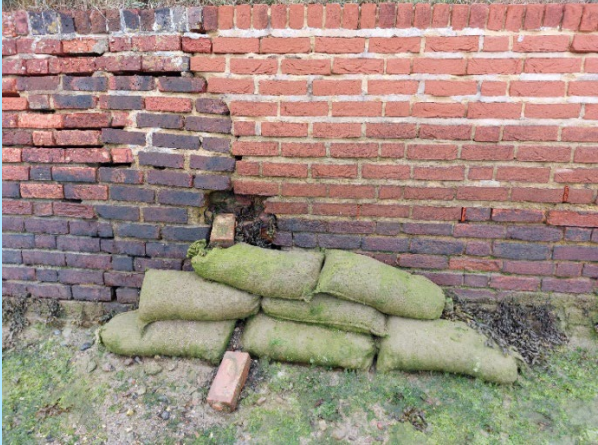
<p>Failed seawall, which was attempted to be repaired with sandbags. More bricks have been displaced since.</p>	D
M

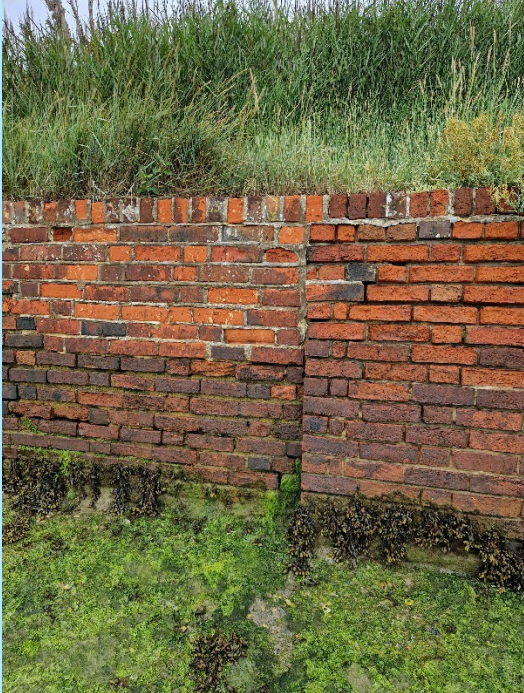
<p>Loss of mortar. There also seems to be a difference in the batter angle between two sections of the masonry seawall.</p>	D
N

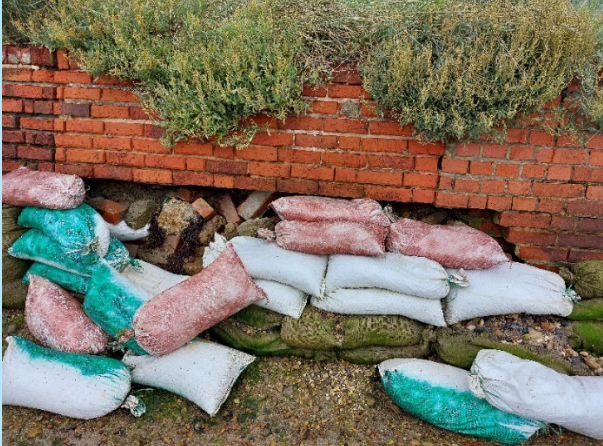
<p>A major failure of the masonry seawall which was attempted to be repaired with sandbags at least twice.</p>	D

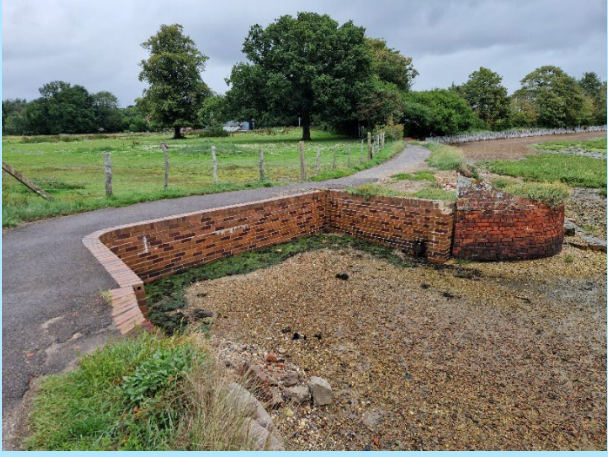
<p>A recently constructed section of seawall.</p>	E
P

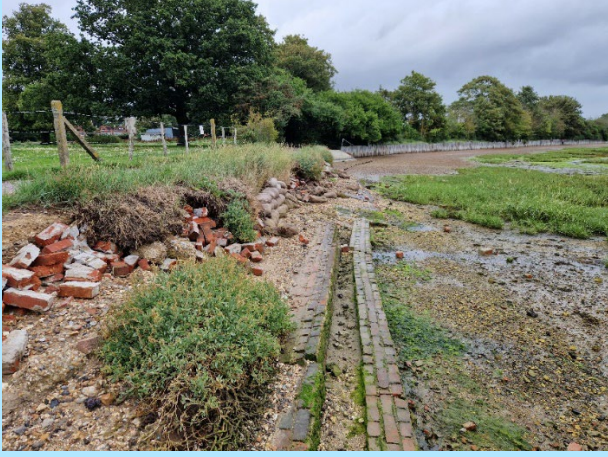
<p>Approximately 30m of failed wall section. Along some areas, repairs have been attempted.</p>	F
Q

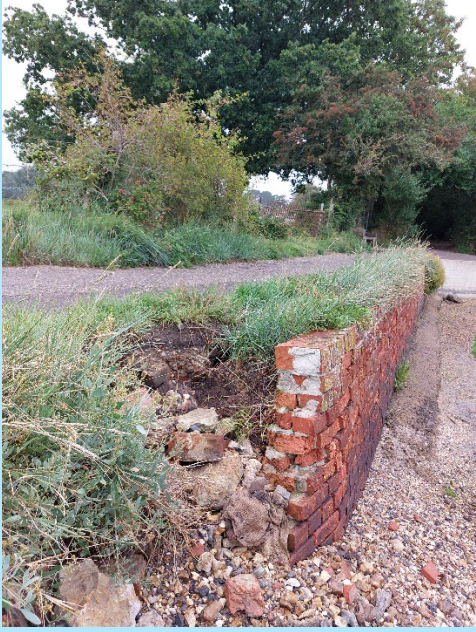
<p>Remaining standing section of the failed wall.</p>	F

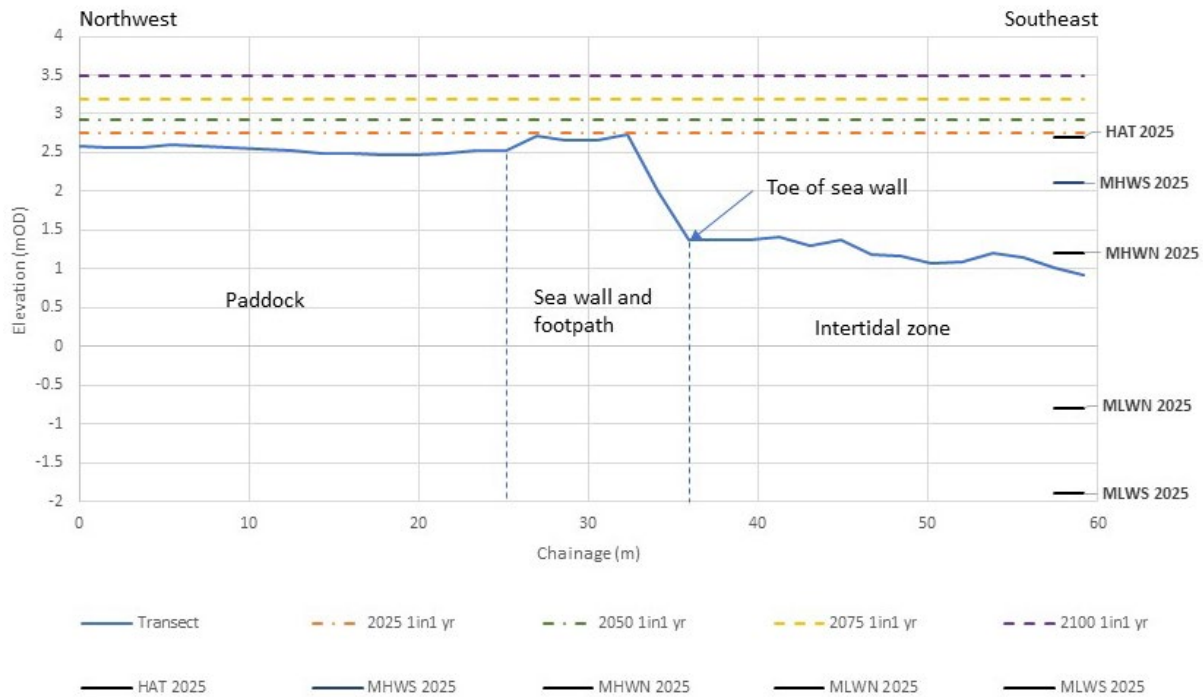
Figure 9: Transect showing elevations of the site relative to predicted tide levels in 2025 and extreme water levels until 2100. The location of this transect is shown on Figure 8.

Figure 9 displays a cross section of the coastal defence alongside the projected tide levels for 2025 and estimates of future extreme sea levels (refer to Figure 8 for location of cross section). At present, the sea wall is prone to Still Water Level overtopping in the event of a 1-in-1-year storm and also during the Highest Astronomical Tide (HAT). It is important to note that HAT is the expected maximum astronomical tidal level under average meteorological conditions and does not account for extreme variations caused by

specific weather conditions, which can result in both higher and lower water levels. Given that in 2025, Mean High Water Spring (MHWS; the average of the two high waters with the highest tidal range in each tidal cycle) is only 62cm under the crest, the sea wall is also considered to have a high chance of overtopping during spring tides. Note, these levels do not account for additional water level induced by waves, which would raise the levels further.

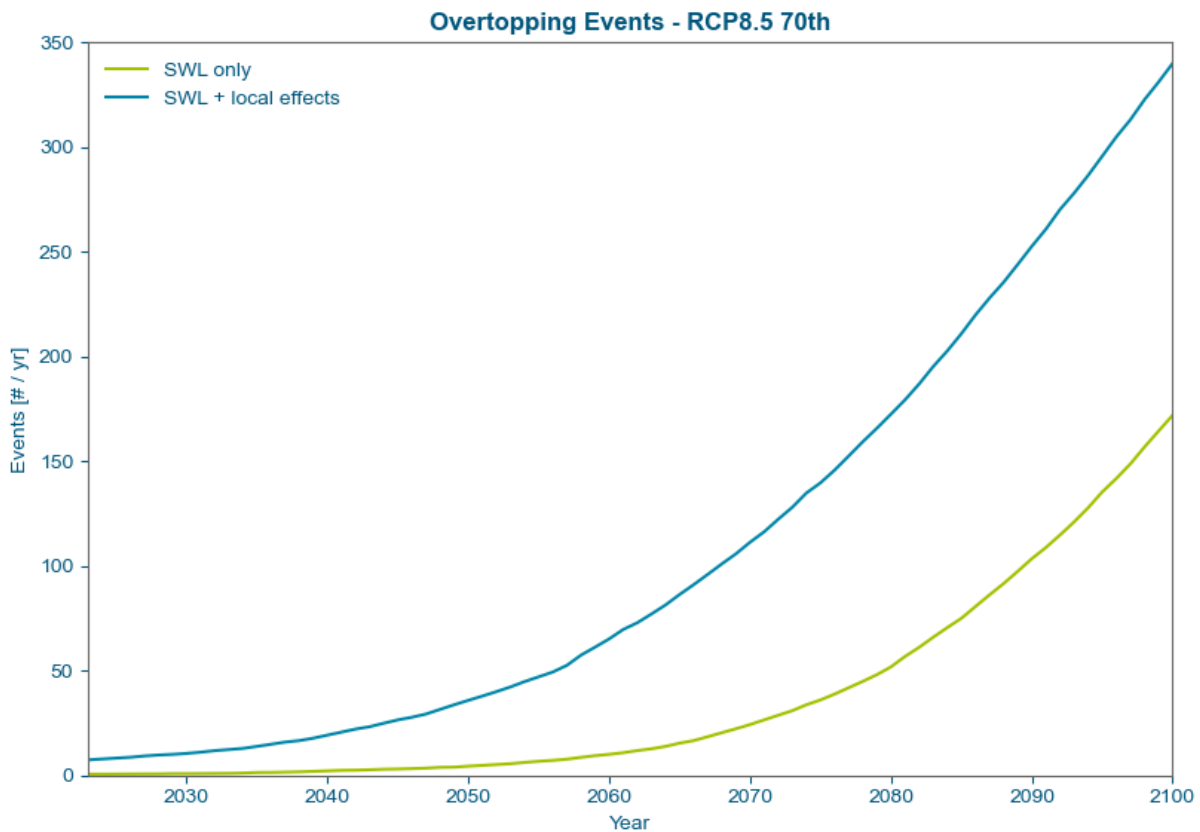
Figure 13: Estimated expected overtopping events under climate change scenario RCP8.5 70th percentile.

To pragmatically account for local set-up and potential wave overtopping, it was assumed that a freeboard of at least 25cm would be required to mitigate any overtopping caused by these additional effects (acknowledging that for extreme storm events this is unlikely to be sufficient). These numbers should thus be interpreted with care. Performing the same analysis but comparing the water levels with a 2.45 mOD threshold (2.7mOD minus 0.25m freeboard), generates the blue line in **Figure 13**. Clearly, the added effect of local wave influences is likely to be significant. In 2023, on average, ten overtopping events are expected to occur (approximately one per month on average, but more likely a higher number of events will occur in winter when compared to summer), with this count increasing to nearly one event a day by 2100.

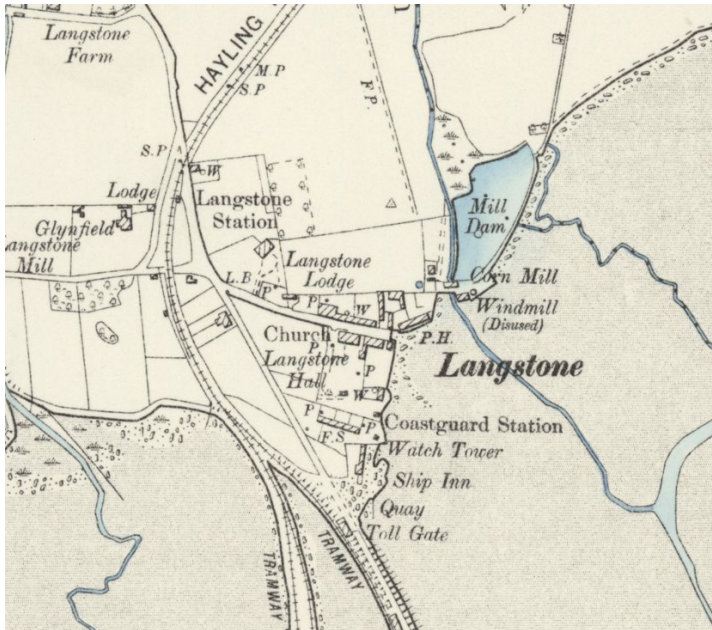
Figure 15 Ordnance Survey map 1888-1913 (source: National Library of Scotland)

Langstone Mill Pond is documented on historical maps from as early as 1888 (Figure 15). Langstone Mill was constructed in phases between 1720 and 1832 and it is likely the early sea wall or dam was constructed at the same time, cutting Lymbourne stream off from the harbour and allowing water to pond creating what is now Langstone Mill Pond.

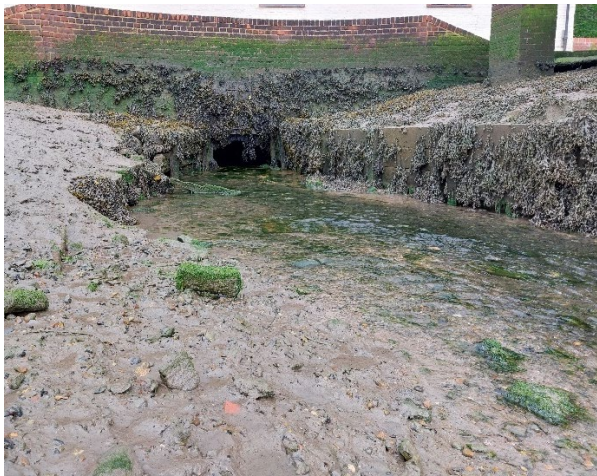
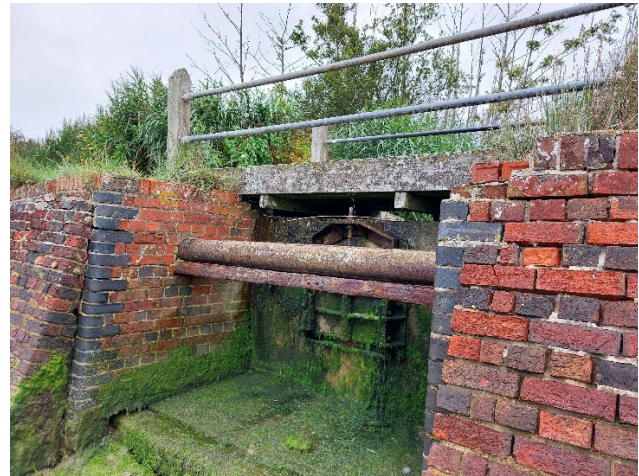
Figure 16 (Left) outfall/weir from the mill pond; (Right) sluice controlling fresh and brackish water outlet/inlet (Photographs taken during site visit 9th August 2023)

The mill pond covers an area of approximately 0.9ha and is separated from the adjacent intertidal area by the sea wall, an outfall and sluice gates that limit the ingress of tidal waters (Figure 16). The sluice gate is manually controlled, and its purpose is to allow freshwater to drain from the mill pond although there is a gap between the top of the sluice and the overlying bridge which would create a path for tidal ingress during high tides or storm surges. Anecdotal evidence suggests the pond is inundated by brackish water up to four times a winter during high tides or storm surges when brackish water overtops the seawall (Chichester Harbour Conservancy 2022). This may be the reason why some of the trees along the south-east edge of Langstone Mill Pond have died (Figure 17).

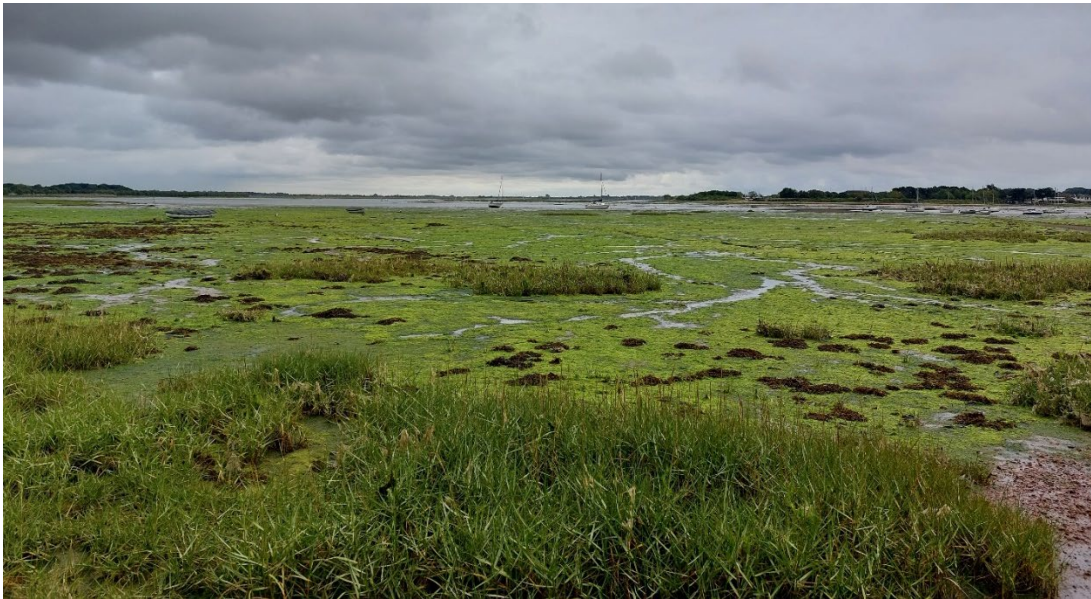
Figure 18 Photograph showing sparse saltmarsh fronting the sea wall at Langstone (taken during the site visit on 8th August 2023)

The intertidal area fronting the study area is classified as mudflat and saltmarsh (**Figure 18**) which are BAP priority habitats. The saltmarsh habitat across Chichester Harbour is declining and over the period 1946 to 2018, the extent of saltmarsh habitat has reduced by 60.6% (Lockwood and Drakeford 2021). The Environment Agency has mapped the extent of saltmarsh between 2008 and 2016 and the data suggests the area of saltmarsh directly adjacent to the study area has increased over this period (Environment Agency 2023b) (**Table 7; Figure 19**). During the site visit, the intertidal area was characterised as a mudflat with sporadic patches of saltmarsh and the aerial imagery shows a general pattern of an increase in the area of mudflat and decrease in the area of saltmarsh from 1995 to 2022 (**Figure 20**). Historic photographs of Langstone show the saltmarsh thrived in the area in the past (**Figure 21**). It is likely the overall trend is one of saltmarsh decline but that localised fluctuations in saltmarsh extent occur over shorter timescales.

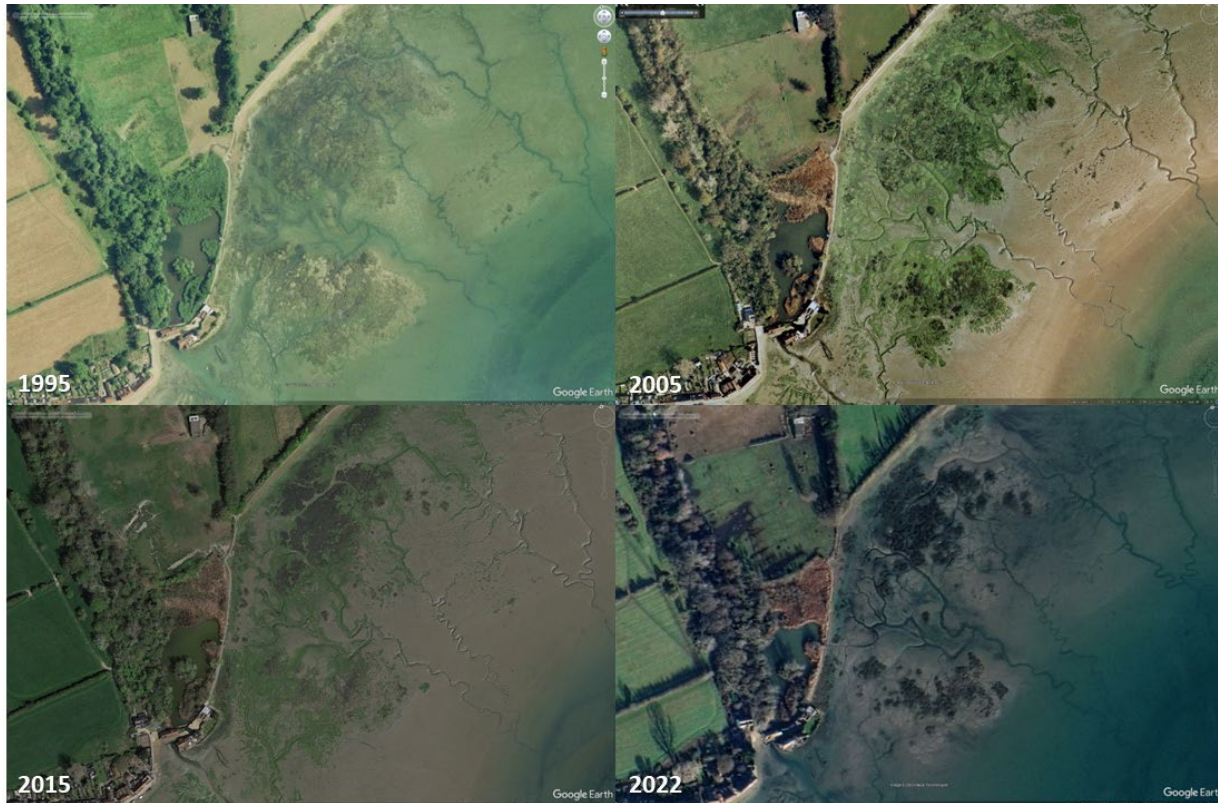
Figure 20 Changes in saltmarsh extent from 1995 to 2022 (source: Google Earth historical imagery)

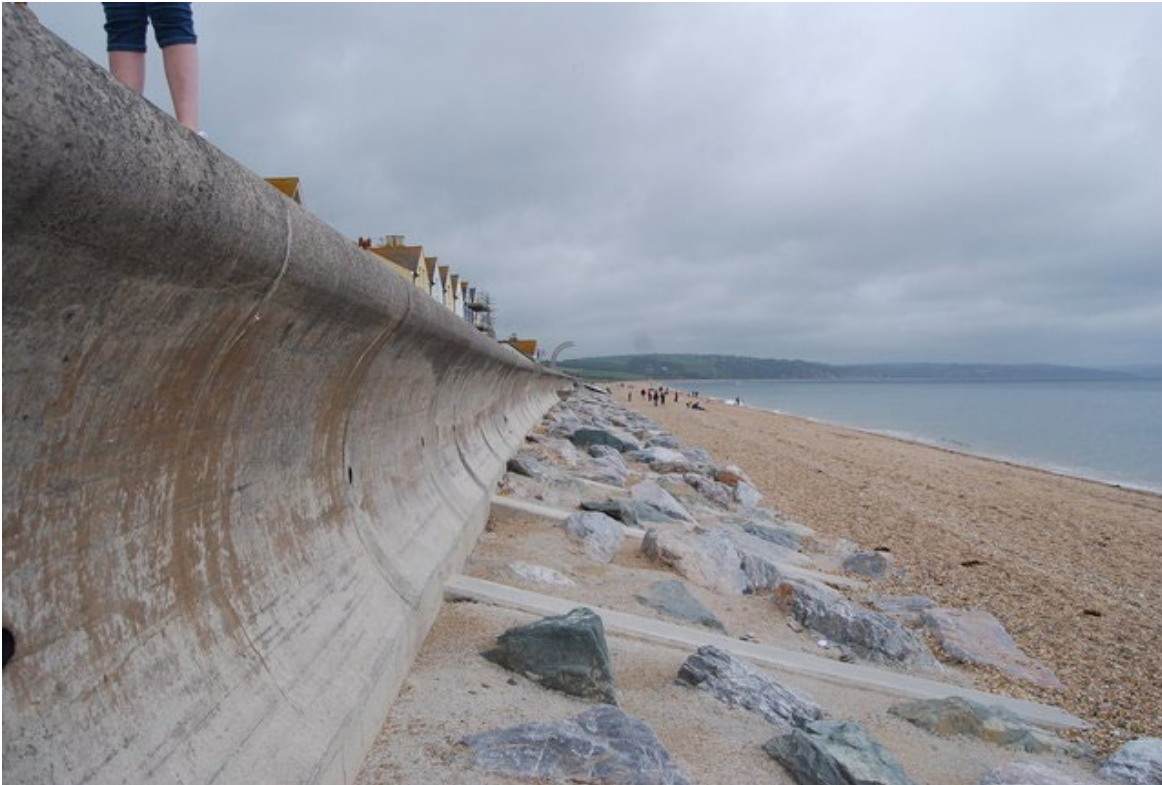
Figure 28: Example of a concrete seawall at Torcross, Devon, where the path is on top of the seawall crest.

This option would fully replace the existing masonry wall and earth embankment with a concrete seawall. This wall could be constructed to the required height to protect the mill pond against frequent overtopping. The option is a hard engineering technique which has been used widely (**Figure 28**). The structure would be effective and last up to 50 years with maintenance. Vegetation management will be required to maintain the structure over its lifetime. However, there are opportunities for enhancement of biodiversity through the inclusion of elements that promote growth of intertidal flora and through the use of eco-concrete. The sluice gate that is currently in place would have to be replaced to fit with the new seawall.

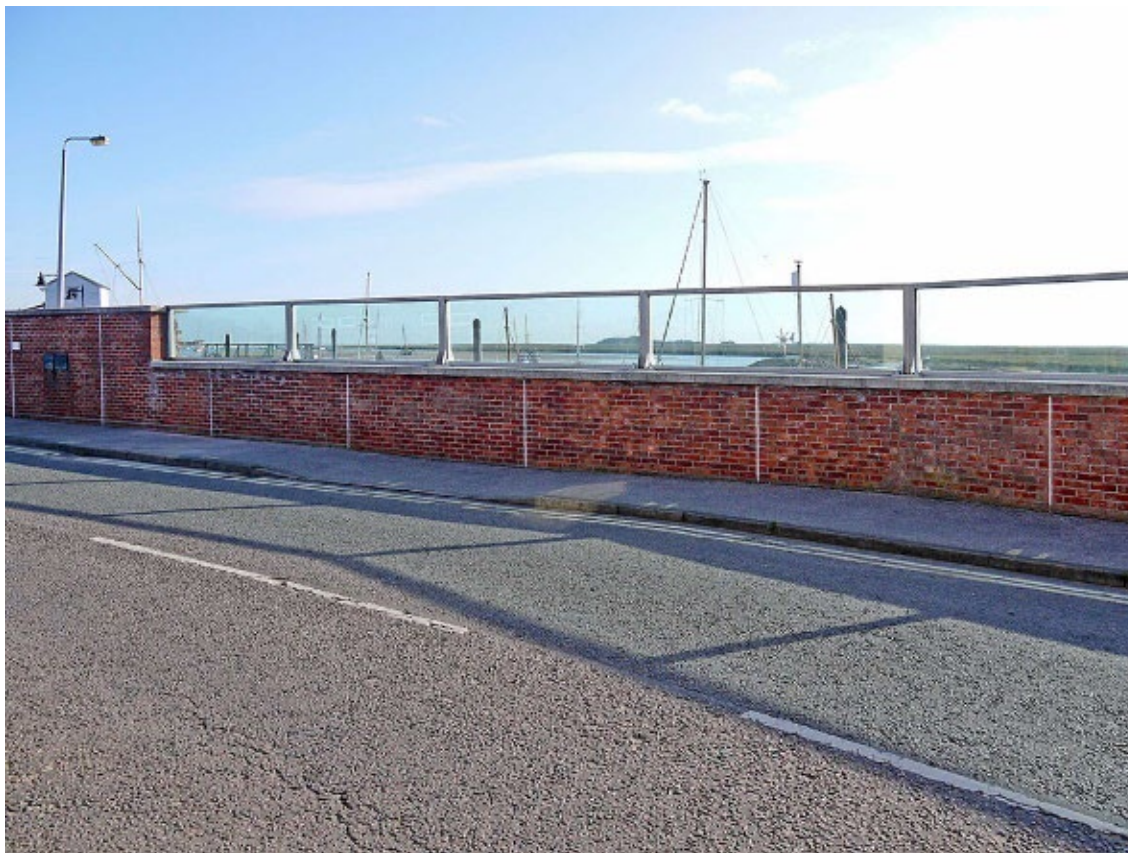
Figure 29: Example of glass and masonry seawall in Wells on the sea, Norfolk.

This option seeks to retain and repair the current masonry wall (similar to **Section 7.2** above) with an upstand glass wall on the seaward edge of the crest (**Figure 29**). This option would maintain the existing footpath and would be in keeping with the area, preserving the look and feel of the mill pond. Implementation would not have to be immediate but could be phased: repairs to the seawall within the next five years with addition of the upstand wall when overtopping becomes unacceptable.

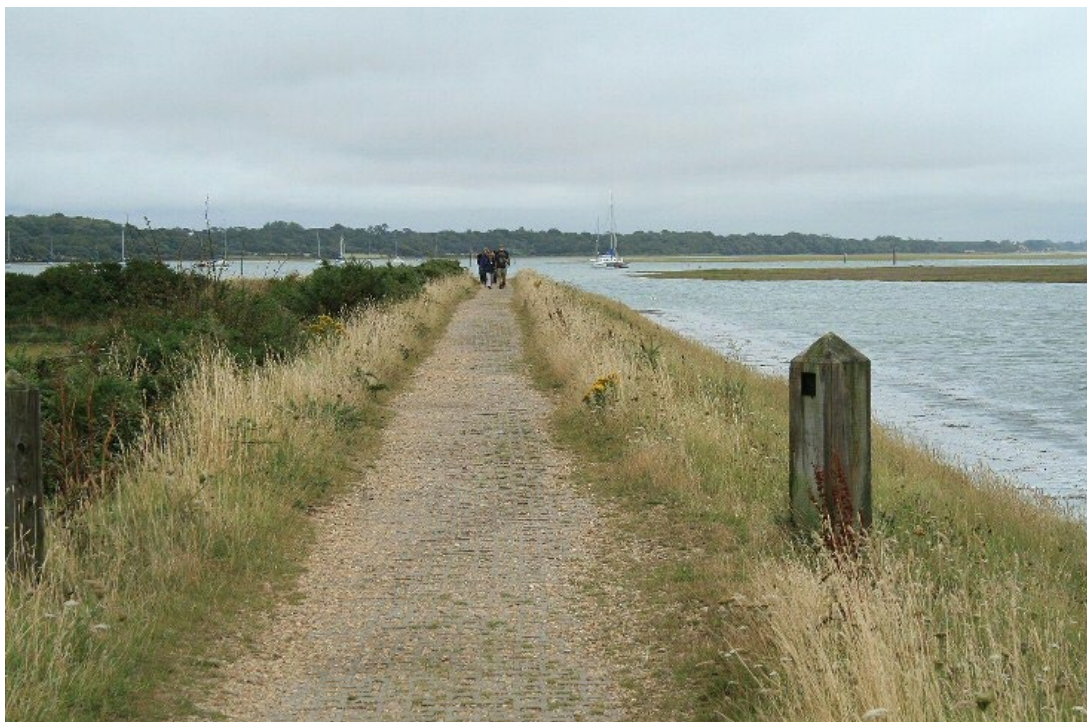
Figure 30: Embankment at Lymington, Hampshire.

This option considers replacing the existing wall with an enlarged embankment. This embankment would protect the hinterland against a suitable Standard of Protection, considering future sea-level rise. Typically, these embankments are trapezoidal in shape: two sloping sides and a crest wide enough to accommodate the footpath (Figure 30). It would allow vegetation to grow naturally on the slopes and add stability to those slopes against erosion.

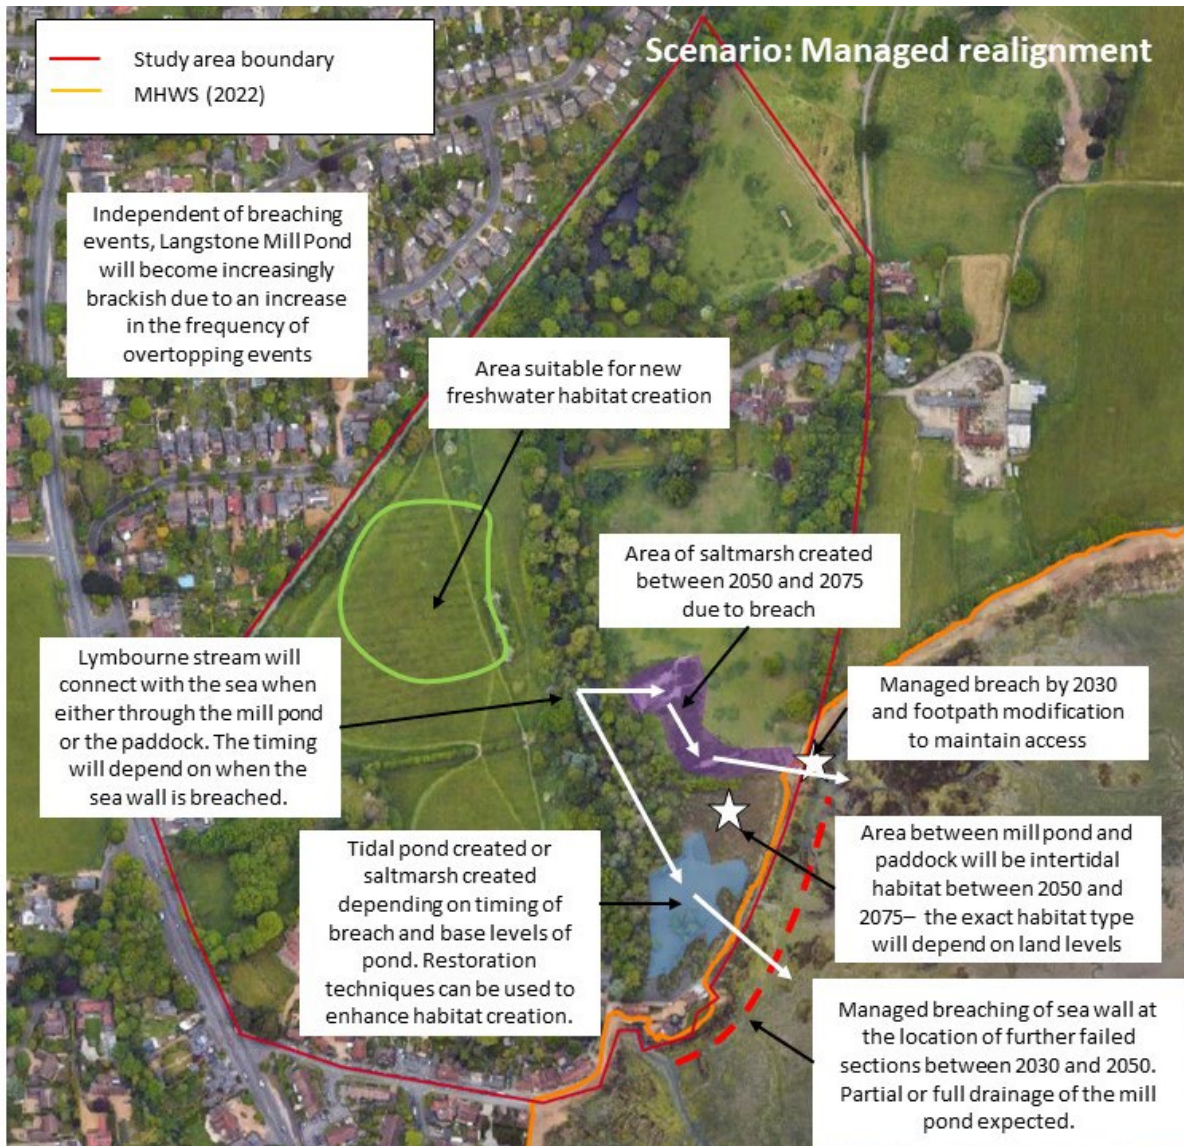
Figure 31: Proposed section of the sea wall to be breached – dashed red line.

The managed realignment option for Langstone outlined here considers both the removal of a section of a sea wall (the damaged section of the wall – see **Figure 31**) and the re-routing of Footpath 108/56/2. It also considers the life expectancy of the sea wall and Langstone Mill Pond and outlines a phased approach with different options to manage or compensate for the inevitable loss of freshwater habitat.

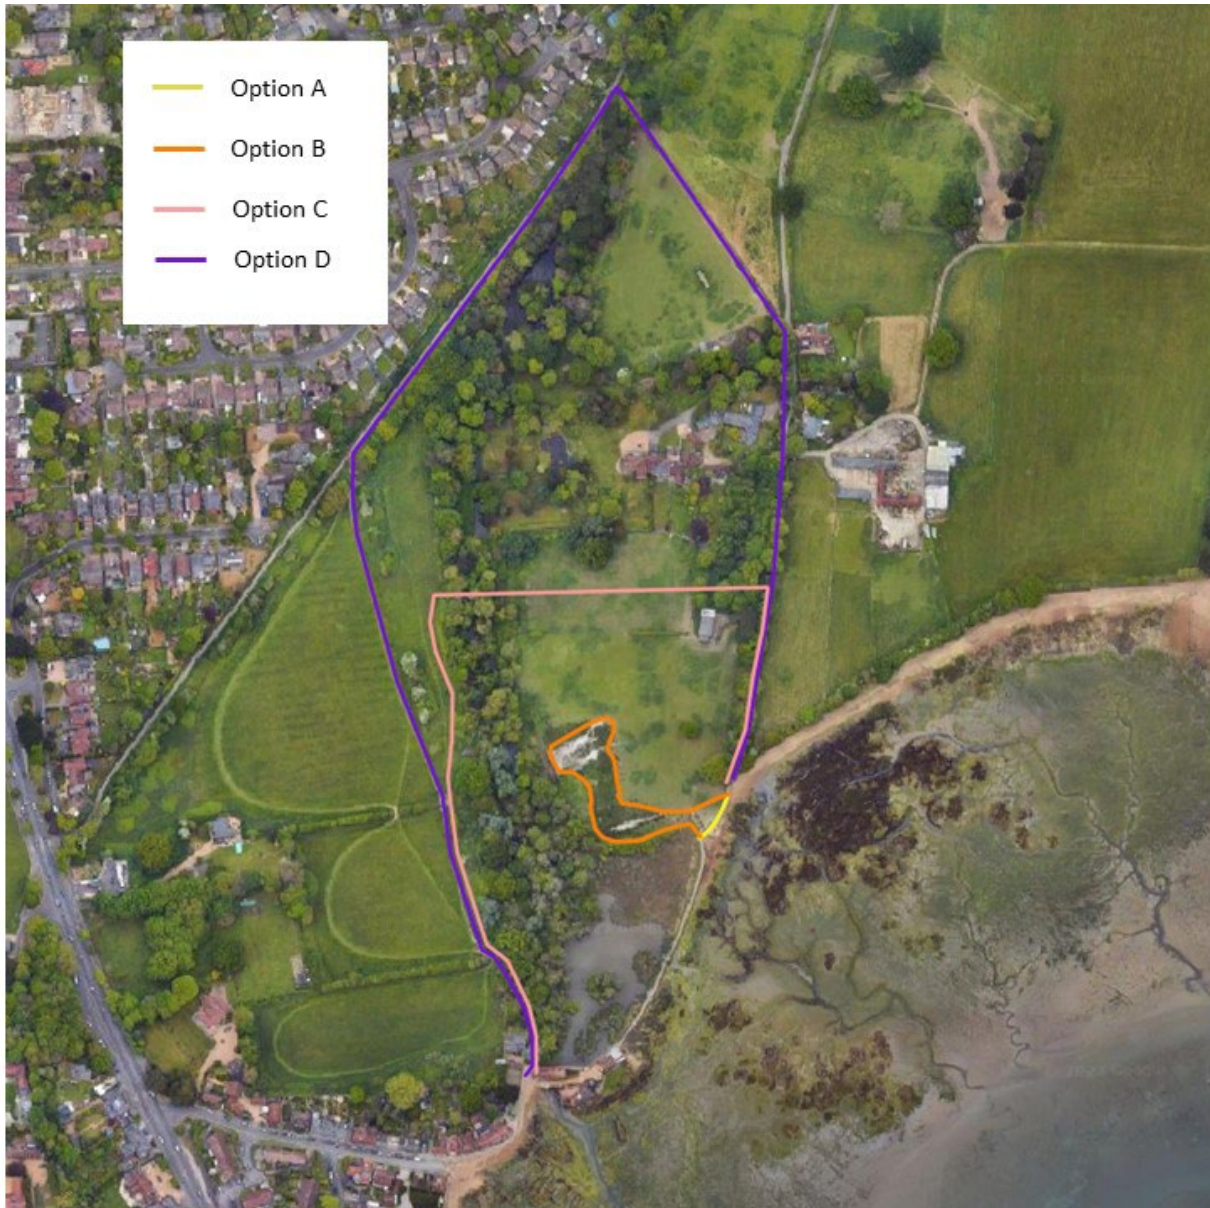
Figure 32 Location of potential footpath options

A summary of the footpath options is presented in **Table 10** and **Figure 32**.

D	Reroute the footpath through Langstone Meadows, along the lane that runs by Lymbourne stream and down Wade Lane. This will be required when the entire coastal footpath becomes inaccessible due to frequency of overtopping or breaching of the sea wall. At this point, the coastline will be located further inland.	1.2 km	Will depend on the condition of the sea wall and the timing of future breaches in front of Langstone Mill Pond.	No cost – uses existing footpaths
