Hayling Island Defence Condition Assessment

Hayling Island Funding and Implementation Strategy

Havant Borough Council

May 2019

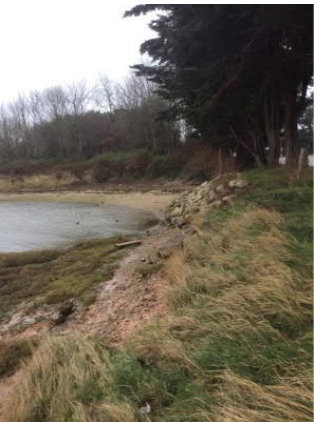
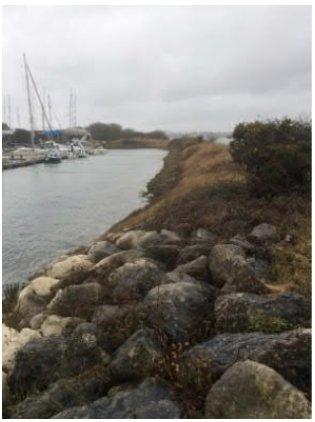
Defence Element:	5AHI01 (Length: 1100m)	Defence Section:	B

Foreshore Description:				
Mixture of fine and coarse gravel.				
Defence Condition and Grade:	Good	Residual Life (no maintenance):	15-20 years	
Generally good condition. Well vegetated structure with good crest width (5m). Minimal displacement of rock armour toe, good embedment.				
Owner (HBC/P/HA/HCC/EA/SWS/EH):	P	Maintainer (HBC/P/HA/HCC/EA/SWS/EH):	P	
Comments:

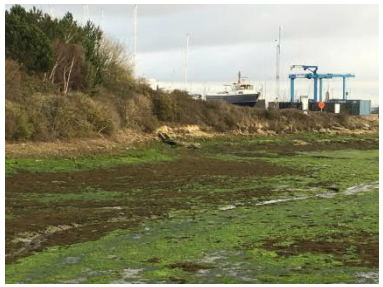
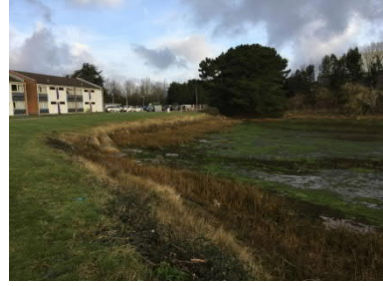
Defence Element:	5AHI01 (Length: 465m)	Defence Section:	C

Defence Condition and Grade:	Fair	Residual Life (no maintenance):	10-15 years	
Naturalised bank. Evidence of erosion in some localised places along the frontage.				
Owner (HBC/P/HA/HCC/EA/SWS/EH):	P	Maintainer (HBC/P/HA/HCC/EA/SWS/EH):	P

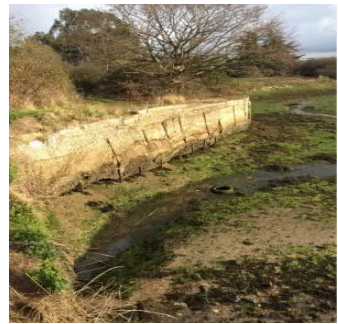
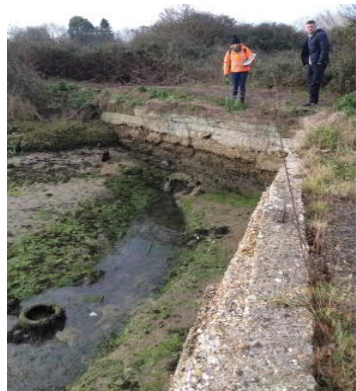
Defence Element:	5AHI01 (Length: 30m)	Defence Section:	D

Foreshore Description:				
Mud flats to the toe of the structure.				
Defence Condition and Grade:	Poor	Residual Life (no maintenance):	<10 years	
Voids. Crumbling over in places although still upright. Concrete missing with cracks. Toe erosion and undermining evident.				
Owner (HBC/P/HA/HCC/EA/SWS/EH):	HBC	Maintainer (HBC/P/HA/HCC/EA/SWS/EH):	HBC	
Comments:

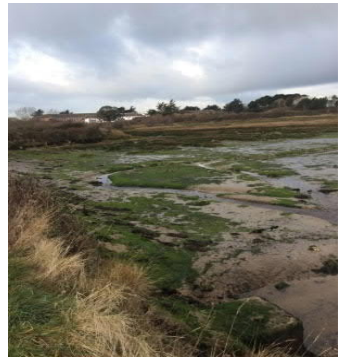
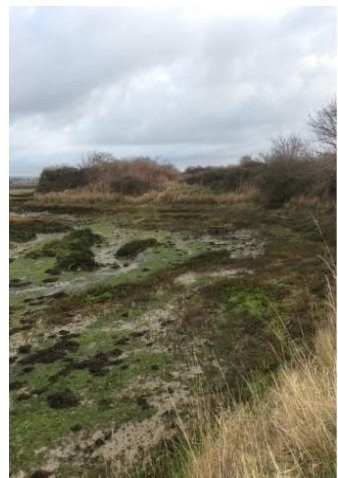
Defence Element:	5AHI01 (Length: 750m)	Defence Section:	E

Construction Material:	Earth			
Foreshore Description:				
Mud flats to the toe of structure.				
Defence Condition and Grade:	Fair	Residual Life (no maintenance):	10-15 years	
Vegetated embankment, non-uniform structure shape.				
Owner (HBC/P/HA/HCC/EA/SWS/EH):	HBC	Maintainer (HBC/P/HA/HCC/EA/SWS/EH):	HBC	
Comments:

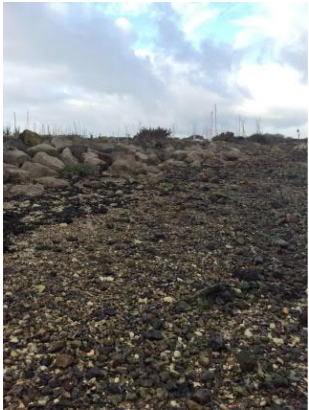
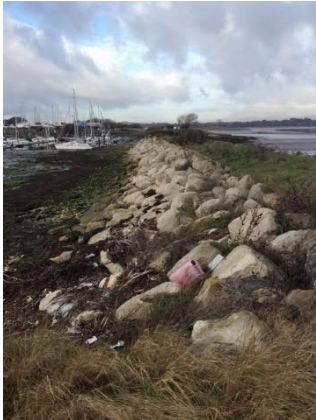
Defence Element:	5AHI01 (Length: 68m)	Defence Section:	F

Construction Material:	Rock			
Foreshore Description:				
Coarse shingle at the toe of the structure.				
Defence Condition and Grade:	Good	Residual Life (no maintenance):	15-20 years	
Small voids but no major evidence of voiding. Uniform structure shape, no sign of settlement.				
Owner (HBC/P/HA/HCC/EA/SWS/EH):	P	Maintainer (HBC/P/HA/HCC/EA/SWS/EH):	P	
Comments:

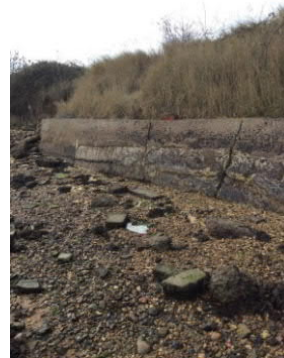
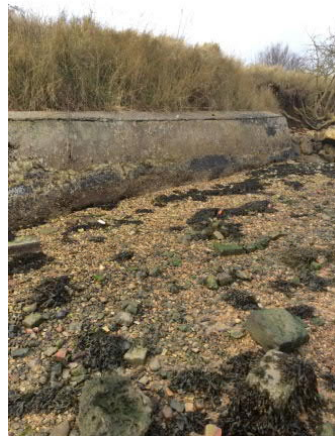
Defence Element:	5AHI01 (Length: 20m)	Defence Section:	G

Construction Material:	Concrete			
Foreshore Description:				
Coarse shingle and beach material.				
Defence Condition and Grade:	Poor	Residual Life (no maintenance):	<10 years	
Large cracks within the structure. Evidence of the toe being undermined. Spalling of the concrete face.				
Owner (HBC/P/HA/HCC/EA/SWS/EH):	HBC	Maintainer (HBC/P/HA/HCC/EA/SWS/EH):	HBC	
Comments:

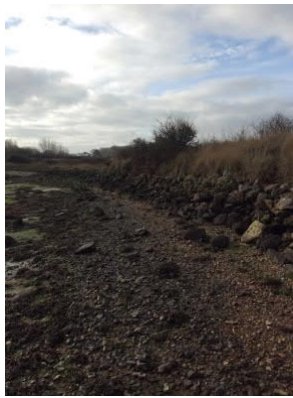
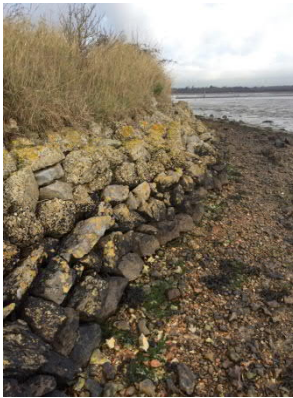
Defence Element:	5AHI01 (Length: 230m)	Defence Section:	H

Construction Material:	Rock			
Foreshore Description:				
Shingle material to the toe of the structure. Mud in places.				
Defence Condition and Grade:	Fair	Residual Life (no maintenance):	10-15 years	
Majority of the rock armour has a particularly steep profile, some voids in places. Toe exposed.				
Owner (HBC/P/HA/HCC/EA/SWS/EH):	HBC	Maintainer (HBC/P/HA/HCC/EA/SWS/EH):	HBC	
Comments:

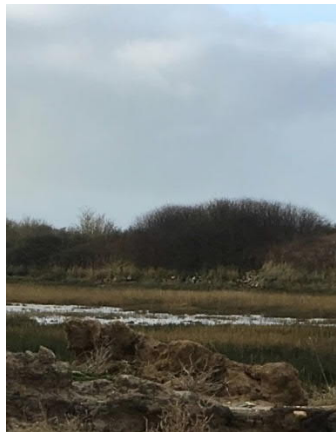
Defence Element:	5AHI01 (Length: 350m)	Defence Section:	I

Location:	West of Northney Farm	Year of Construction:	Unknown	
Defence Description:				
Natural verge/embankment structure.				
Construction Material:	Earth			
Foreshore Description:				
Saltmarsh and mudflats.				
Defence Condition and Grade:	Fair	Residual Life (no maintenance):	10-15 years	
Embankment is heavily vegetated.				
Owner (HBC/P/HA/HCC/EA/SWS/EH):	HBC	Maintainer (EA/LA/MOD/P):	HBC	
Comments:

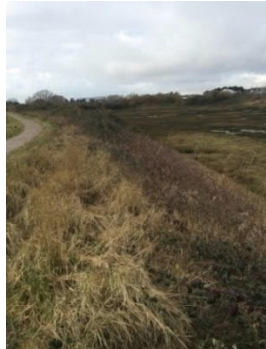
Defence Element:	5AHI01 (Length: 445m)	Defence Section:	J

Defence Condition and Grade:	Good	Residual Life (no maintenance):	15-20 Years	
No sign of voids. Good shape, uniform structure. Toe well buried with lots of vegetation across the structure.				
Owner (HBC/P/HA/HCC/EA/SWS/EH):	HBC	Maintainer (EA/LA/MOD/P):	HBC/EA

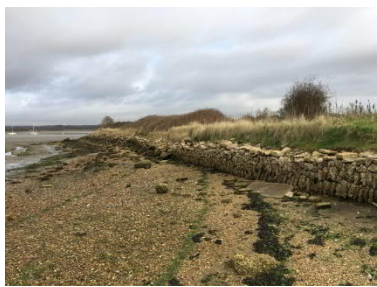
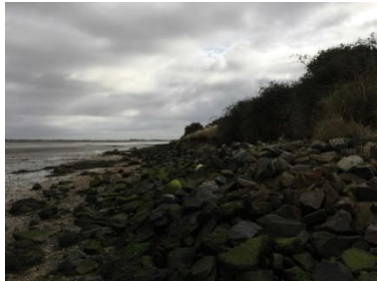
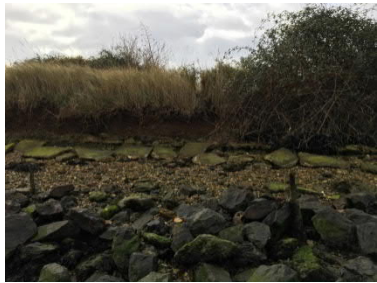
Defence Element:	5AHI01 (Length: 275m)	Defence Section:	K

Toe undermined in various places, voids also present in the revetment. Loose rubble on foreshore. Contaminated land behind which is actively eroding in places.				
Owner (HBC/P/HA/HCC/EA/SWS/EH):	HBC	Maintainer (HBC/P/HA/HCC/EA/SWS/EH):	EA	
Comments:

Contaminated land behind the structure which is actively eroding.

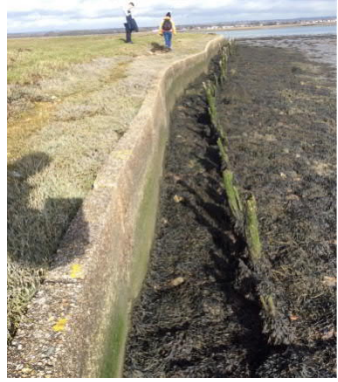
Defence Element:	5AHI02 (Length: 575m)	Defence Section:	A

Construction Material:	Concrete			
Foreshore Description:				
Mud at the foreshore. Build-up of seaweed and material from tidal waters.				
Defence Condition and Grade:	Very poor	Residual Life (no maintenance):	Failed Otherwise < 5year	
Defence failed in places, exposing embankment behind to erosion. Crest level not uniform and areas with bad undermining.				
Owner (HBC/P/HA/HCC/EA/SWS/EH):	P	Maintainer (HBC/P/HA/HCC/EA/SWS/EH):	P	
Comments:

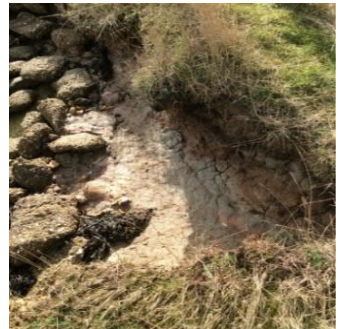
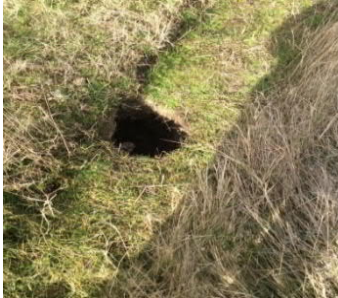
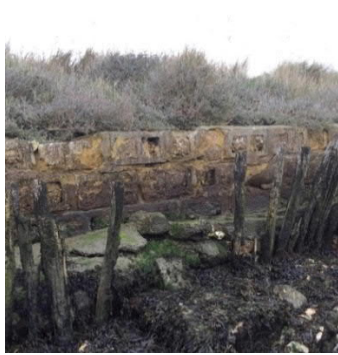
Defence Element:	5AHI02 (Length: 300m)	Defence Section:	B

Defence Condition and Grade:	Poor	Residual Life (no maintenance):	<10yrs	
Blockwork generally in poor condition. Piling is corroded. Crest level non uniform with localised settling evident. A number of voids which require re pointing. Areas with bad undermining.				
Owner (HBC/P/HA/HCC/EA/SWS/EH):	P	Maintainer (HBC/P/HA/HCC/EA/SWS/EH):	P

Comments:				
Wall was breached last year (2018) and repairs undertaken by infilling with clay material.

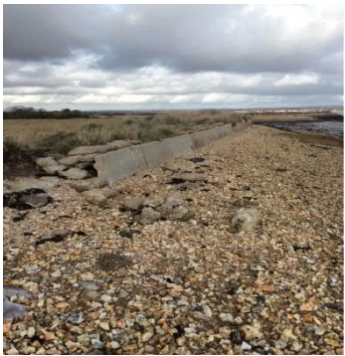
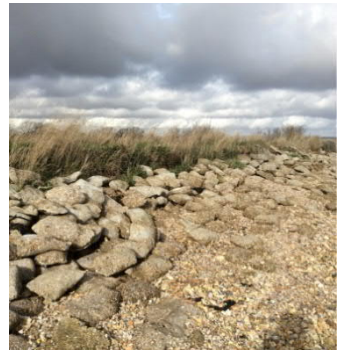
Defence Element:	5AHI02 (Length: 265m)	Defence Section:	C

Construction Material:	Concrete			
Foreshore Description:				
Shingle and coarse beach material to the toe of the structure.				
Defence Condition and Grade:	Poor/Very Poor	Residual Life (no maintenance):	<10 years, failed in places	
Large cracks, profile of the structure is slumping forward. Concrete bags have no uniform structure with lots of voids. Failed in places, close to breaching in numerous locations.				
Owner (HBC/P/HA/HCC/EA/SWS/EH):	P	Maintainer (HBC/P/HA/HCC/EA/SWS/EH):	P	
Comments:

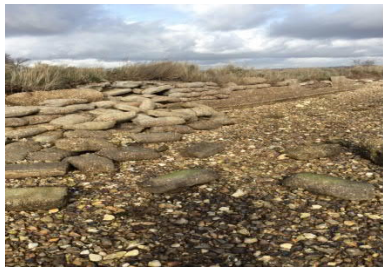
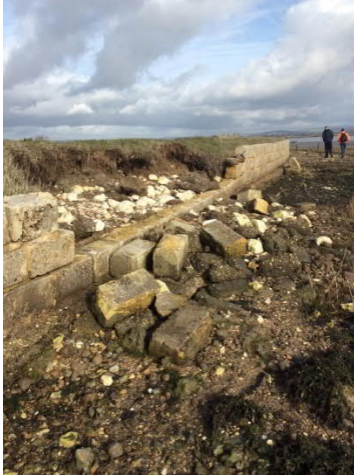
Defence Element:	5AHI02 (Length: 85m)	Defence Section:	D

Construction Material:	Blockwork			
Foreshore Description:				
Saltmarsh along the majority of it's length.				
Defence Condition and Grade:	Poor/Very Poor	Residual Life (no maintenance):	<10 years, failed in places	
Structure has failed in places along the length, exposing embankment behind to erosion. Various types of failures.				
Owner (HBC/P/HA/HCC/EA/SWS/EH):	P	Maintainer (HBC/P/HA/HCC/EA/SWS/EH):	P	
Comments:

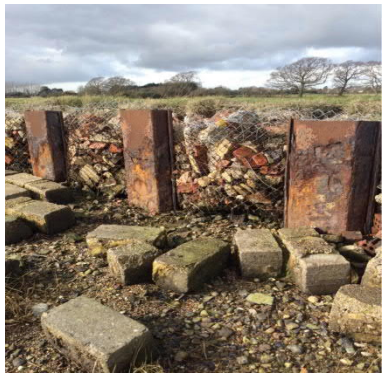
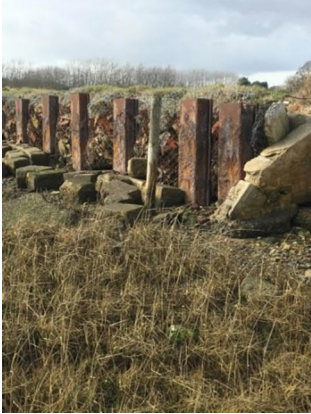
Defence Element:	5AHI02 (Length: 220m)	Defence Section:	E

Construction Material:	Wire			
Foreshore Description:				
Saltmarsh and gravel to the toe. Rubble blockwork to the toe of the structure.				
Defence Condition and Grade:	Poor	Residual Life (no maintenance):	< 10 years	
Poor condition. Loss of shape and structure to the gabions. Intermediate sheet piles are attempting to maintain the toe alignment of the gabions.				
Owner (HBC/P/HA/HCC/EA/SWS/EH):	P	Maintainer (HBC/P/HA/HCC/EA/SWS/EH):	P	
Comments:

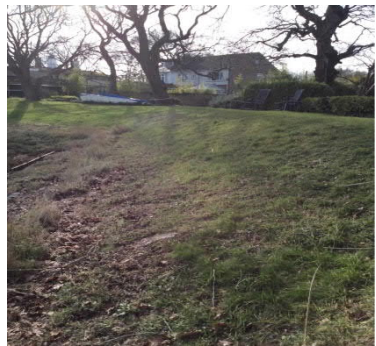
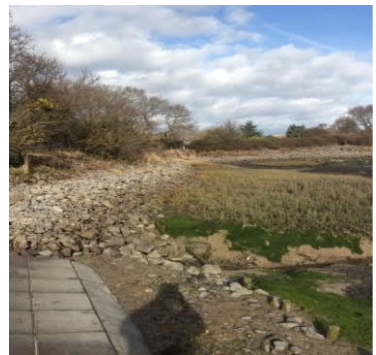
Defence Element:	5AHI03 (Length: 45m)	Defence Section:	A

Good condition throughout. Rock armour has maintained uniform shape and profile. No obvious signs of slippage, voids or undercutting of toe. Embankment of a uniform height.				
Owner (HBC/P/HA/HCC/EA/SWS/EH):	P	Maintainer (HBC/P/HA/HCC/EA/SWS/EH):	P	
Comments:

Outfall has a flap valve which residents report does not function properly due to the build-up of material at the invert preventing it from closing. Water ingress occurs which fills up the ditch during high tide conditions.

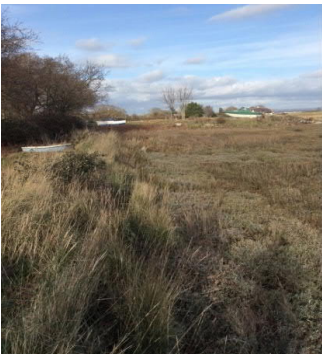
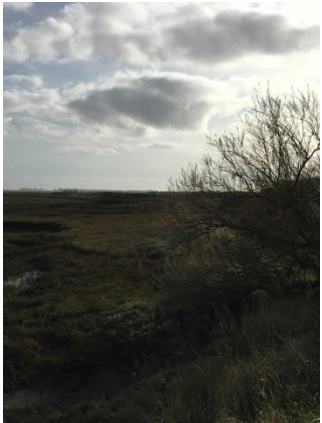
Defence Element:	5AHI03 (Length: 210m)	Defence Section:	B

Construction Material:	Earth			
Foreshore Description:				
Extensive area of saltmarsh.				
Defence Condition and Grade:	Fair	Residual Life (no maintenance):	10-15 years	
Structure heavily vegetated, uniform profile and height.				
Owner (HBC/P/HA/HCC/EA/SWS/EH):	P	Maintainer (HBC/P/HA/HCC/EA/SWS/EH):	P	
Comments:

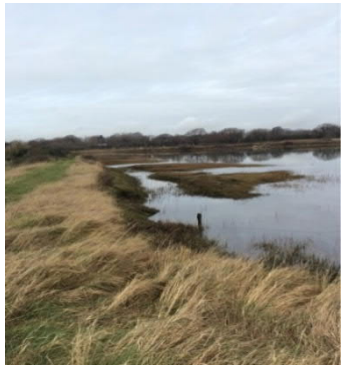
Defence Element:	5AHI03 (Length: 2210m)	Defence Section:	C

Defence Condition and Grade:	Fair	Residual Life (no maintenance):	10-15 years	
Fair- Good condition. Some surface slips. Heavily vegetated along full length.				
Owner (HBC/P/HA/HCC/EA/SWS/EH):	P	Maintainer (HBC/P/HA/HCC/EA/SWS/EH):	EA

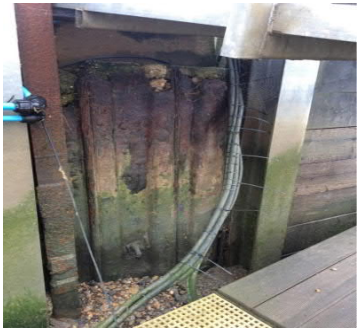
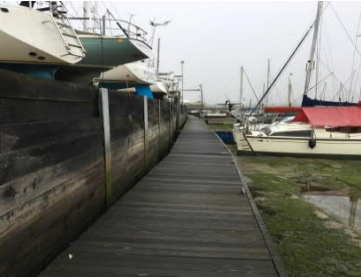
Defence Element:	5AHI03 (Length: 88m)	Defence Section:	D

Construction Material:	Sheet Pile			
Foreshore Description:				
Pontoon and mooring to front of piles. Mud flats visible at low tide.				
Defence Condition and Grade:	Fair	Residual Life (no maintenance):	10-15 years	
Fair – poor condition. Minor lateral movement and few gaps at clutches. Localised corrosion of the steel piles where visible, estimated to be significant.				
Owner (HBC/P/HA/HCC/EA/SWS/EH):	P	Maintainer (HBC/P/HA/HCC/EA/SWS/EH):	P	
Comments:

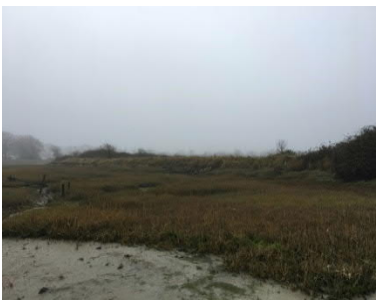
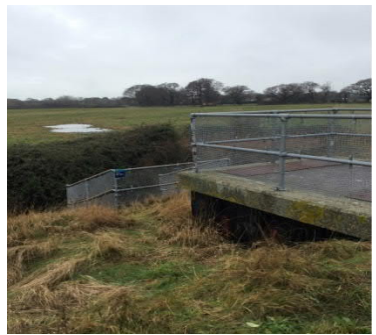
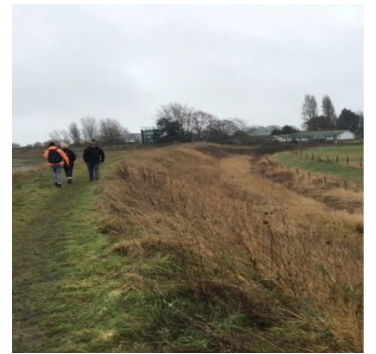
Defence Element:	5AHI03 (Length: 215m)	Defence Section:	E

Foreshore Description:				
Mud flats- low tide. Scrub and rubble to the toe of the structure				
Defence Condition and Grade:	Good	Residual Life (no maintenance):	15-20 years

Good condition- well vegetated embankment.				
Owner (HBC/P/HA/HCC/EA/SWS/EH):	P	Maintainer (HBC/P/HA/HCC/EA/SWS/EH):	P	
Comments:

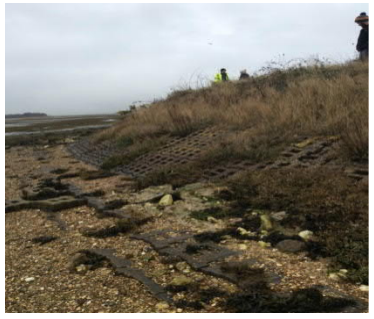
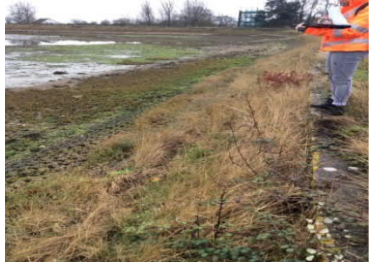
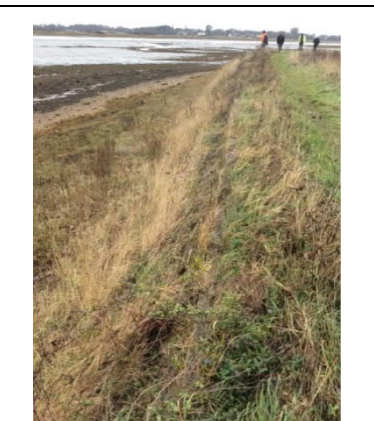
Defence Element:	5AHI03 (Length: 265m)	Defence Section:	F

Foreshore Description:				
Mud flats and scrub to toe of the structure. Sandy gravel in some locations.				
Defence Condition and Grade:	Good	Residual Life (no maintenance):	10-15 years

Good- fair condition. Light grass growth across the structure. Little root penetration in most areas. Roots in two locations. Cosmetic damage to the concrete at the crest.				
Owner (HBC/P/HA/HCC/EA/SWS/EH):	P	Maintainer (HBC/P/HA/HCC/EA/SWS/EH):	EA	
Comments:

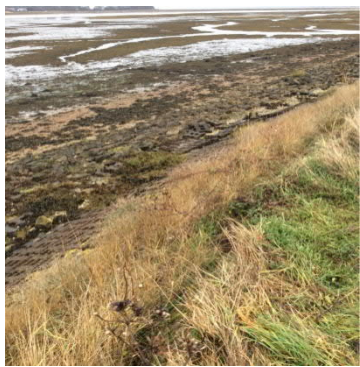
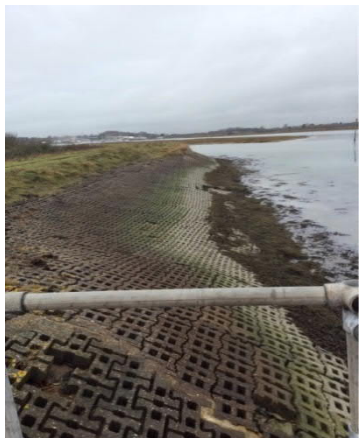
Defence Element:	5AHI03 (Length: 680m)	Defence Section:	G

Construction Material:	Armorloc			
Foreshore Description:				
Gravelly sand and shrub to the toe- at low tide. High water does not appear to reach much of the structure. Light rock armour protection at the toe of the structure on the exposed outcrop corner.				
Defence Condition and Grade:	Fair	Residual Life (no maintenance):	10-15 years	
Structure covered in grass vegetation. Roots in two or three locations. Minor damage and loss of material to some of the structure.				
Owner (HBC/P/HA/HCC/EA/SWS/EH):	P	Maintainer (HBC/P/HA/HCC/EA/SWS/EH):	EA	
Comments:				
Although not surveyed during visit, EA asset information indicates a setback defence is located perpendicular to the revetment, orientated south-west across the field behind.

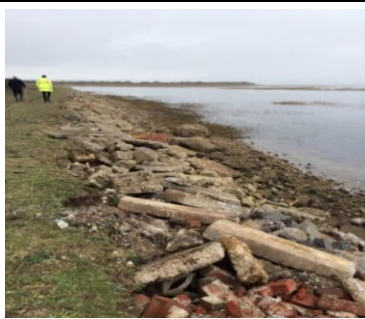
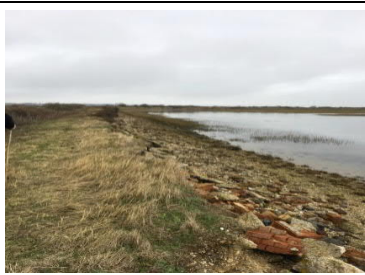
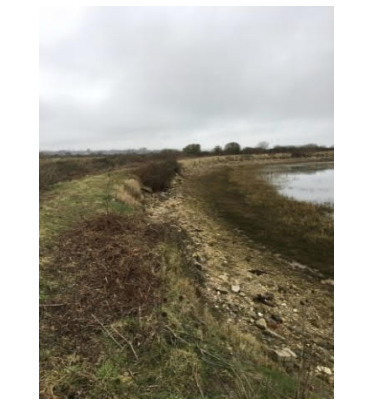
Defence Element:	5AHI03 (Length: 1265m)	Defence Section:	H

Foreshore Description:				
Rubble at the upper toe. Sandy gravel along entire length at the middle. Salt marsh at one localised section on the foreshore				
Defence Condition and Grade:	Poor/Very Poor	Residual Life (no maintenance):	<10 years, failed in places

Poor to very poor. Some sections are actively failing and eroding. Evidence of slips occurring in some areas. Owner has undertaken partial patch repairs with clay material over the past 6 months.				
Owner (HBC/P/HA/HCC/EA/SWS/EH):	P	Maintainer (EA/LA/MOD/P):	P	
Comments:

Owner is regularly maintaining the structure as and when required (as best as possible).

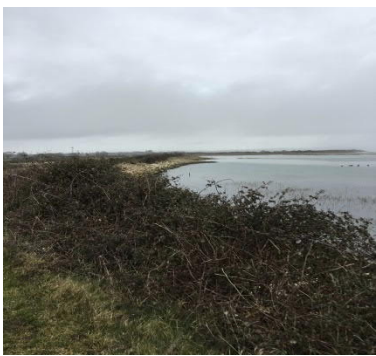
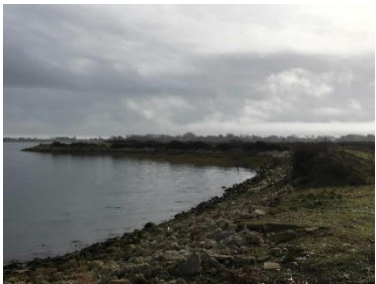
Defence Element:	5AHI03 (Length: 600m)	Defence Section:	I

Construction Material:	Rock			
Foreshore Description:				
Gravel and sand to the middle. Smaller chalk rock armour to the toe of the structure.				
Defence Condition and Grade:	Good	Residual Life (no maintenance):	15-20 years	
Chalk rock revetment in good condition. Some weathered material in areas.				
Owner (HBC/P/HA/HCC/EA/SWS/EH):	P	Maintainer (HBC/P/HA/HCC/EA/SWS/EH):	P	
Comments:

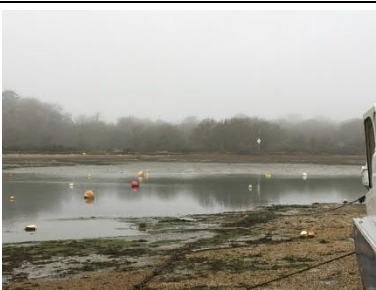
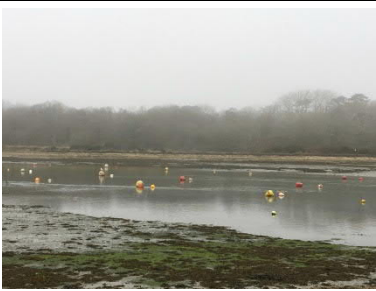
Defence Element:	5AHI03 (Length: 775m)	Defence Section:	K

Foreshore Description:				
Gravel at the upper. Mud flats to the middle and lower.				
Defence Condition and Grade:	N/A	Residual Life (no maintenance):	N/A	
Eroding section of shoreline. No defence present, not graded.				
Owner (HBC/P/HA/HCC/EA/SWS/EH):	P	Maintainer (HBC/P/HA/HCC/EA/SWS/EH):	P	
Comments:				
No direct access granted. Photographs were taken from the opposite bank.

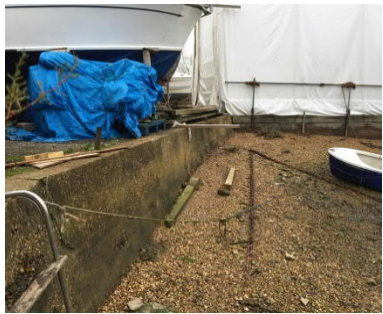
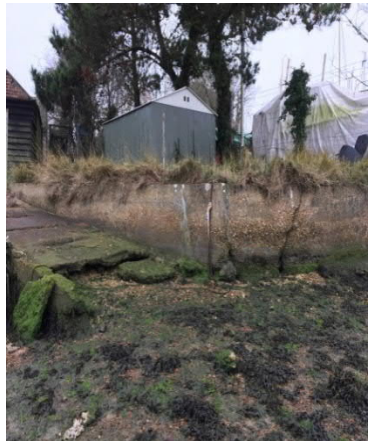
Defence Element:	5AHI04 (Length: 60m)	Defence Section:	A

Concrete in-situ wall, 1m high, with a short section of concrete apron.				
Construction Material:	Concrete			
Foreshore Description:				
Gravel at the toe of the structure. Mud flats at the middle.				
Defence Condition and Grade:	Poor	Residual Life (no maintenance):	<10 years	
Poor condition, structural cracks in the lateral direction. Evidence of buckling at the corner sections.				
Owner (HBC/P/HA/HCC/EA/SWS/EH):	P	Maintainer (HBC/P/HA/HCC/EA/SWS/EH):	EA	
Comments:

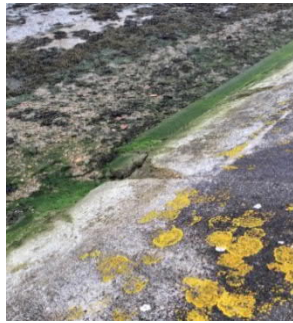
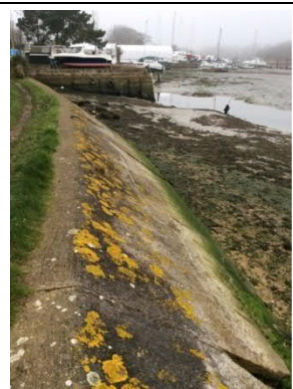
Defence Element:	5AHI04 (Length 85m)	Defence Section:	B

Construction Material:	Concrete			
Foreshore Description:				
Sandy gravel at the toe of the structure. Mud flats to the middle.				
Defence Condition and Grade:	Fair	Residual Life (no maintenance):	10-15 years	
Numerous hairline cracks in the structure. One localised section with damage to the toe of the structure.

Owner (HBC/P/HA/HCC/EA/SWS/EH):	P	Maintainer (HBC/P/HA/HCC/EA/SWS/EH):	EA	
Comments:				
Tideflex outfall at end of structure

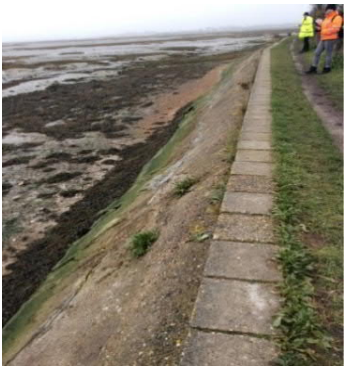
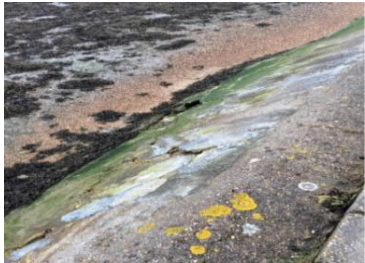
Defence Element:	5AHI04 (Length: 220m)	Defence Section:	D

Construction Material:	Concrete			
Foreshore Description:				
Mud flats and gravel to the toe. Seaweed present along the structure toe.				
Defence Condition and Grade:	Fair	Residual Life (no maintenance):	10-15 years	
Poor condition. Concrete revetment sprawling in areas. Patch repairs to some areas. Root ball growth in the crest of the structure. Heave of the structure in one area. Undercutting of the toe.				
Owner (HBC/P/HA/HCC/EA/SWS/EH):	P	Maintainer (HBC/P/HA/HCC/EA/SWS/EH):	EA	
Comments:

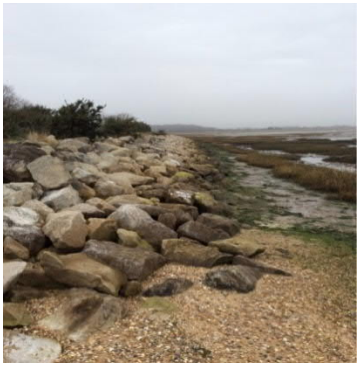
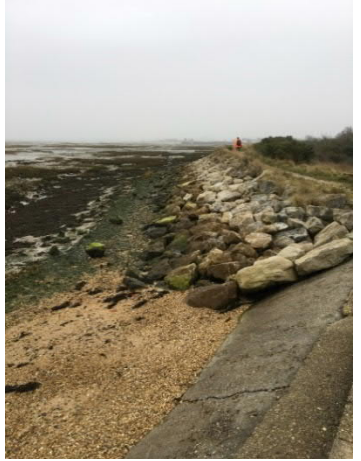
Defence Element:	5AHI04 (Length: 235m)	Defence Section:	E

Construction Material:	Rock			
Foreshore Description:				
Mud flats to the toe of the structure. Salt marsh to the middle.				
Defence Condition and Grade:	Very good	Residual Life (no maintenance):	>20 years	
Very good condition. Good toe embedment and shape. No loss of material. EA carried out restoration works to the defence in 2012.				
Owner (HBC/P/HA/HCC/EA/SWS/EH):	P	Maintainer (HBC/P/HA/HCC/EA/SWS/EH):	EA	
Comments:				
Work to recondition the defence carried out in 2012 by the EA. This involved restoring the embankment, providing a new defence consisting of a limestone rock revetment on the seaward face of the existing embankment. Low points on the crest were reshaped to give a consistent level.

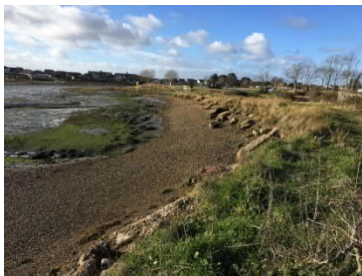
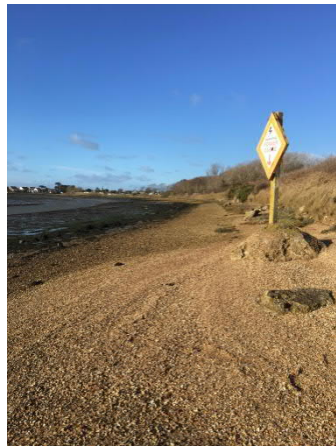
Defence Element:	5AHI04 (Length: 1,140m)	Defence Section:	G

Foreshore Description:				
Saltmarsh to upper. Mud flats to the middle and lower.				
Defence Condition and Grade:	Poor	Residual Life (no maintenance):	<10 years Local areas where verge is actively eroding	
Earth verge is generally in a poor condition, showing signs of slippage and local erosion.				
Owner (HBC/P/HA/HCC/EA/SWS/EH):	P HBC	Maintainer (HBC/P/HA/HCC/EA/SWS/EH):	P / HBC / EA (EA: north / east section)	
Comments:				
Number of outfalls are present along the tidal creek. Contaminated land located along the north section of frontage. EA maintain north and east section of the frontage; spanning from the eastern end of the defence to the Camp site.

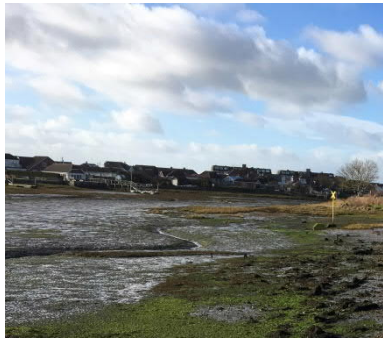
Defence Element:	5AHI04 (Length: 655m)	Defence Section:	H

Location:	Eastoke Avenue	Year of Construction:	Unknown	
Defence Description:				
Combination of concrete retaining structures and brick retaining structure. (1.5m high). A number of slipways along the frontage.				
Construction Material:	Concrete			
Foreshore Description:				
Mud flats & salt marsh				
Defence Condition and Grade:	Unknown	Residual Life (no maintenance):	N/A	
Unknown, unable to access				
Owner (HBC/P/HA/HCC/EA/SWS/EH):	P	Maintainer (HBC/P/HA/HCC/EA/SWS/EH):	P	
Comments:				
Access was not granted and could only be photographed from the opposite bank.

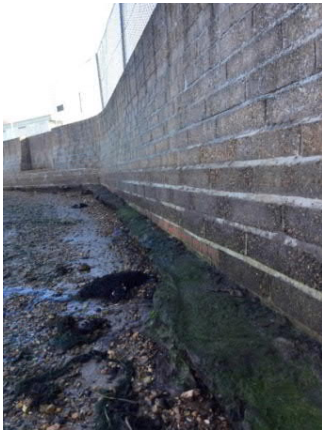
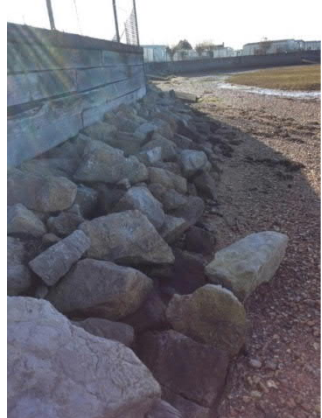
Defence Element:	5AHI04 (Length: 30m)	Defence Section:	J

Foreshore Description:				
Gravel to the upper. Salt marsh and mud flats to the middle.				
Defence Condition and Grade:	Good	Residual Life (no maintenance):	15-20 years	
Rock armour is in good condition. Sheet piling in fair condition (secondary defence), some corrosion with loss of material thickness.				
Owner (HBC/P/HA/HCC/EA/SWS/EH):	P	Maintainer (HBC/P/HA/HCC/EA/SWS/EH):	EA	
Comments:				
Rock armour protection and sheet piled wall is interspersed with sections of raised blockwork walls which have evidence of lowering foreshore and exposure/scour at the toe in some locations.

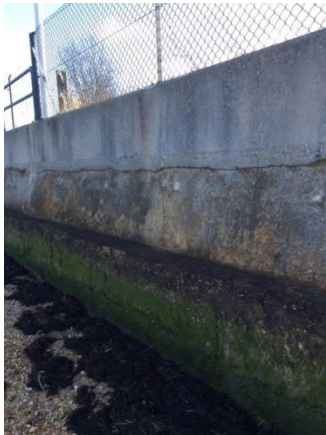
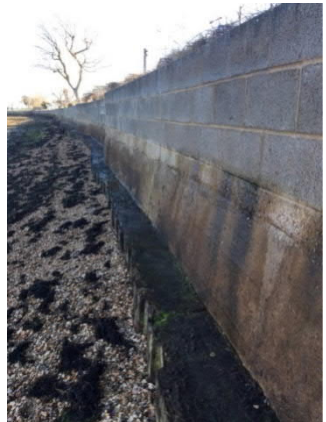
Defence Element:	5AHI04 (Length: 330m)	Defence Section:	K

Construction Material:	Concrete			
Foreshore Description:				
Gravel at the upper. Salt marsh to the middle. Mud flats to the lower.				
Defence Condition and Grade:	Fair	Residual Life (no maintenance):	10-15 years	
Fair condition overall. Recently raised section of breeze blocks is in good condition. Lateral cracks to the concrete wall. Holes in structure, resulting in loss of aggregate. Sheet pile toe has corroded (minor reduction in thickness). Eastern end of concrete structure has some reinforcement exposed.				
Owner (HBC/P/HA/HCC/EA/SWS/EH):	P	Maintainer (HBC/P/HA/HCC/EA/SWS/EH):	EA	
Comments:

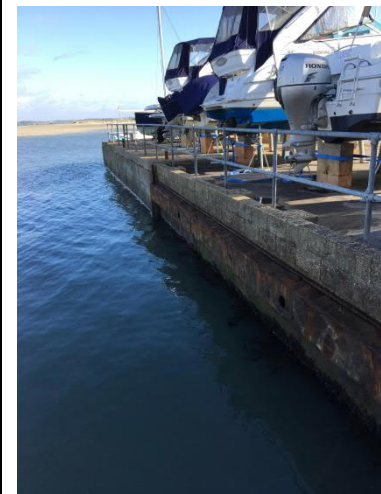
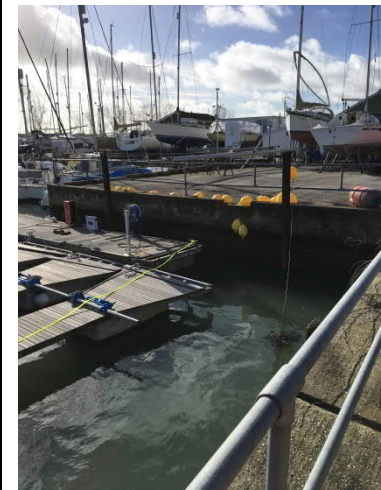
Defence Element:	5AHI04 (Length: 185m)	Defence Section:	M
Location:	Sparkes marina	Year of Construction:	Unknown.
Defence Description:			
Concrete block work structure. Depth unknown. Wailing beam across the front face of the block work (corroded).			
Construction Material:	Blockwork		
Foreshore Description:			
Unknown, unable to assess.			
Defence Condition and Grade:	Fair	Residual Life (no maintenance):	10-15 years
Joint cracking in structure. Evidence of heave and subsidence in some areas of the structure. Settlement of some land behind the structure. Wailing beam very corroded.			
Owner (HBC/P/HA/HCC/EA/SWS/EH):	P	Maintainer (HBC/P/HA/HCC/EA/SWS/EH):	P
Comments:			
Unable to assess toe of structure due to high tide conditions.

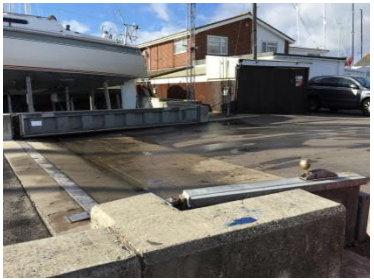
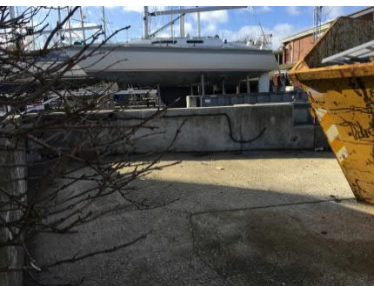
Defence Element:	5AHI04 (Length: 175m)	Defence Section:	N

Foreshore Description:				
Unknown, unable to assess due to high water level.				
Defence Condition and Grade:	Good	Residual Life (no maintenance):	15-20 years

Good condition. Minor surface cracks to the lower (older) part of the structure. Light abrasion evident, but no defects to the structure integrity.				
Owner (HBC/P/HA/HCC/EA/SWS/EH):	P	Maintainer (HBC/P/HA/HCC/EA/SWS/EH):	P	
Comments:

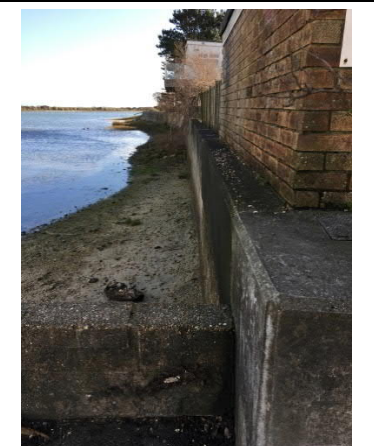
Concrete retaining wall (varies in height). Flood gates to the western extent of the wall. Areas of the concrete wall appear to have been raised recently.				
Construction Material:	Concrete

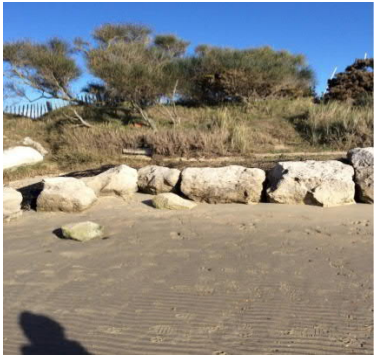
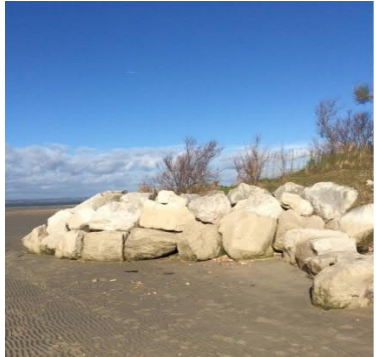
Defence Element:	5AHI05 (Length: 20m)	Defence Section:	A

Location:	Hayling Island Sailing Club (HISC)	Year of Construction:	Unknown	
Defence Description:				
Rock revetment on outcrop of land, 20m total length.

Construction Material:	Rock			
Foreshore Description:				
Wide, sandy beach to the toe- sheltered.				
Defence Condition and Grade:	Good	Residual Life (no maintenance):	15-20 years	
Good condition.				
Owner (HBC/P/HA/HCC/EA/SWS/EH):	P	Maintainer (HBC/P/HA/HCC/EA/SWS/EH):	P	
Comments:

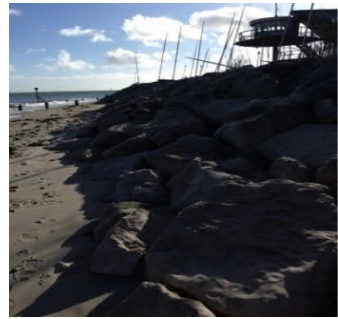
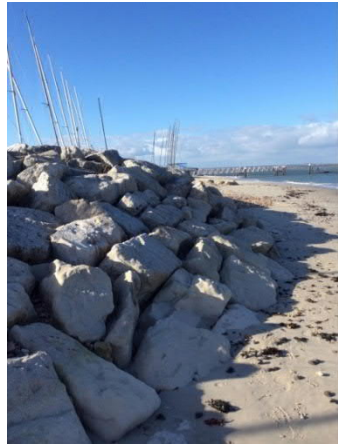
Defence Element:	5AHI05 (Length: 200m)	Defence Section:	C

Location:	Hayling Island Sailing Club (HISC)	Year of Construction:	Unknown	
Defence Description:				
Rock Armour revetment, 5m total width.

Construction Material:	Rock			
Foreshore Description:				
Fine sand and gravel to the toe of the structure. One slip way with a flood gate installed at low level.

Defence Condition and Grade:	Good	Residual Life (no maintenance):	15-20 years	
Minor movement of structure. Rock density consistent. Crest height still in-tact. Minor movement in the toe alignment.				
Owner (HBC/P/HA/HCC/EA/SWS/EH):	P	Maintainer (HBC/P/HA/HCC/EA/SWS/EH):	P

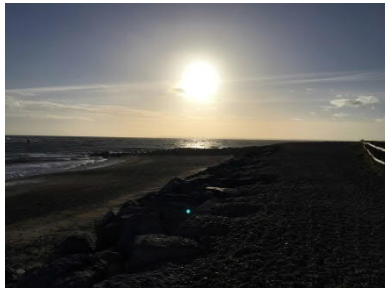
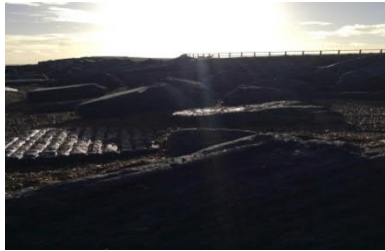
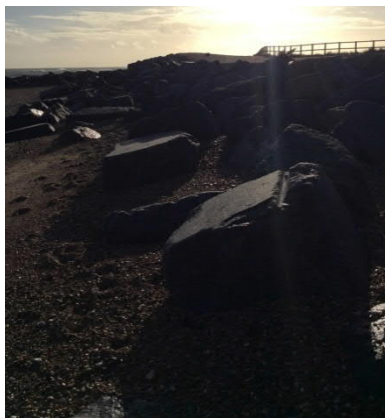
Defence Element:	5AHI05 (Length: 129m)	Defence Section:	E

Location:	Hayling beach	Year of Construction:	Unknown.	
Defence Description:

Rock armour revetment.				
Construction Material:	Rock

Foreshore Description:				
Sand & shingle to the toe. Sand & Shingle to the rear of the structure.				
Defence Condition and Grade:	Fair	Residual Life (no maintenance):	10-15 years

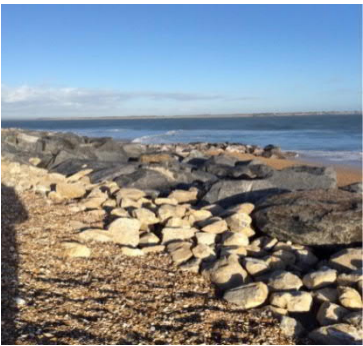
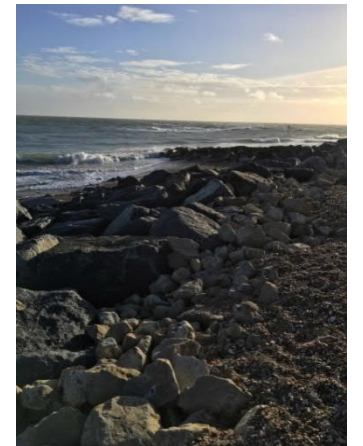
Defence Element:	5AHI05 (Length: 107m)	Defence Section:	F

Location:	Hayling Beach	Year of Construction:	Unknown.	
Defence Description:				
Rock armour revetment. Repairs to the crest of the structure in some areas, with smaller rock armour material.

Construction Material:	Rock			
Foreshore Description:				
Sand and shingle to the toe and rear of the structure.				
Defence Condition and Grade:	Good	Residual Life (no maintenance):	15-20 years	
Good. Minor settlement of crest. Localised undermining of the structure in one location, with short section of sliding. Good coverage of rock material across the width.				
Owner (HBC/P/HA/HCC/EA/SWS/EH):	HBC	Maintainer (HBC/P/HA/HCC/EA/SWS/EH):	HBC	
Comments:

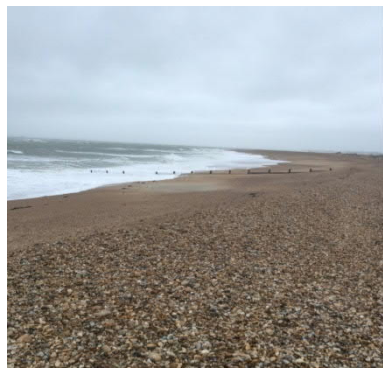
Defence Element:	5AHI05 (Length 200m)	Defence Section:	M

Location:	South of Hayling Golf Club	Year of Construction:	Unknown	
Defence Description:				
Timber revetment, approx. 1-2m high.

Construction Material:	Timber			
Foreshore Description:				
Shingle beach.				
Defence Condition and Grade:	Poor	Residual Life (no maintenance):	<10 years	
Poor condition. Numerous planks missing in areas, rotted material. End section appears to have been removed.				
Owner (HBC/P/HA/HCC/EA/SWS/EH):	HBC	Maintainer (HBC/P/HA/HCC/EA/SWS/EH):	HBC	
Comments:

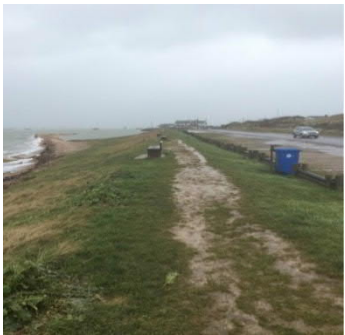
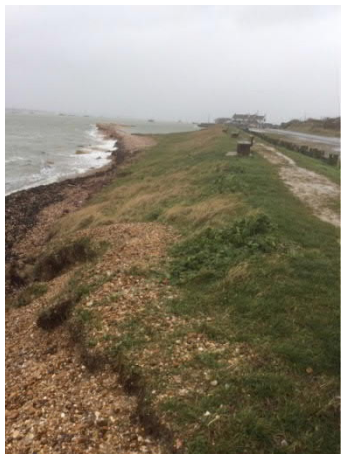
Defence Element:	5AHI05 (Length: 240m)	Defence Section:	T

Location:	West of Hayling Golf Club	Year of Construction:	Unknown	
Defence Description:				
Vegetated embankment. 2m crest width.

Construction Material:	Earth			
Foreshore Description:				
Shingle to the toe.				
Defence Condition and Grade:	Fair	Residual Life (no maintenance):	10-15 years	
Fair condition, locally poor. Toe has been eroded in areas. Non-uniform embankment throughout. Gravel to the toe in many areas.				
Owner (HBC/P/HA/HCC/EA/SWS/EH):	P	Maintainer (HBC/P/HA/HCC/EA/SWS/EH):	P	
Comments:

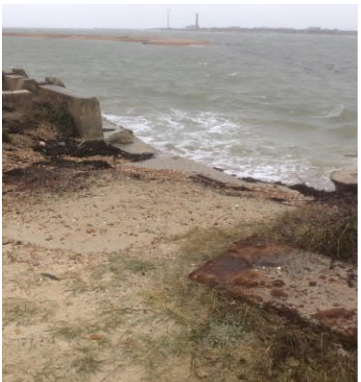
Defence Element:	5AHI05 (Length: 65m)	Defence Section:	U

Location:	Ferryboat Inn	Year of Construction:	Unknown	
Defence Description:				
Concrete buttress wall.				
Construction Material:	Concrete			
Foreshore Description:				
Unable to view due to high water level.				
Defence Condition and Grade:	Good	Residual Life (no maintenance):	15-20 years	
Good condition. One section missing, risk of breach at high level.				
Owner (HBC/P/HA/HCC/EA/SWS/EH):	P	Maintainer (HBC/P/HA/HCC/EA/SWS/EH):	P	
Comments:

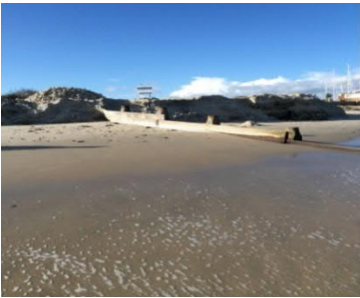
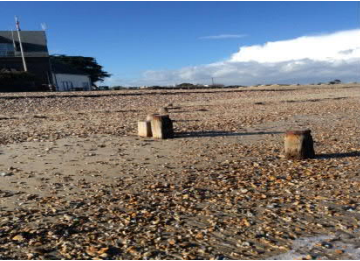
Defence Element:	5AHI05 (Length: N/A)	Defence Section:	Groynes 1-9

Location:	RNLI Beach	Year of Construction:	Unknown	
Defence Description:				
9 No. timber groynes.

Construction Material:	Timber			
Foreshore Description:				
Fine sand and shingle along each of the structures. Some structures buried with beach material at a high level.

Defence Condition and Grade:	3- Good 2- Fair 4- N/A (Buried)	Residual Life (no maintenance) Yrs:	15-20 years 10-15 years N/A	
Good – Fair Condition throughout. No Missing planks or gaps between panels. Minor defects to the timber, but no severe rot. Timber panels buckling in some areas.				
Owner (HBC/P/HA/HCC/EA/SWS/EH):	P	Maintainer (HBC/P/HA/HCC/EA/SWS/EH):	P	
Comments:				
4 timber groynes were unable to be surveyed due to high beach level.

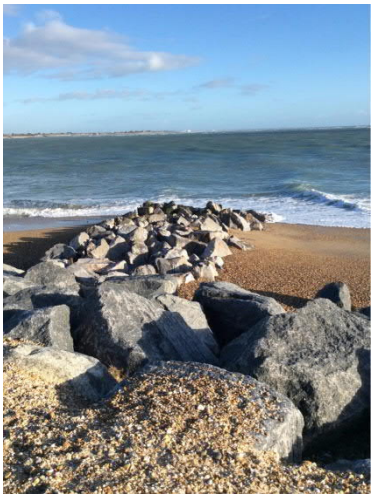
Defence Element:	5AHI05 (Length: 20m)	Defence Section:	Groyne 10

Location:	Hayling beach	Year of Construction:	Unknown.	
Defence Description:				
Rock groyne.				
Construction Material:	Rock			
Foreshore Description:				
Sand and shingle to the toe of the structure.				
Defence Condition and Grade:	Good	Residual Life (no maintenance):	15-20 years	
Good condition. Occasional voids in the structure. Rock of regular shape, infilled with beach material & shingle in the structure due to displacement of the rock stones.				
Owner (HBC/P/HA/HCC/EA/SWS/EH):	HBC	Maintainer (HBC/P/HA/HCC/EA/SWS/EH):	HBC	
Comments:

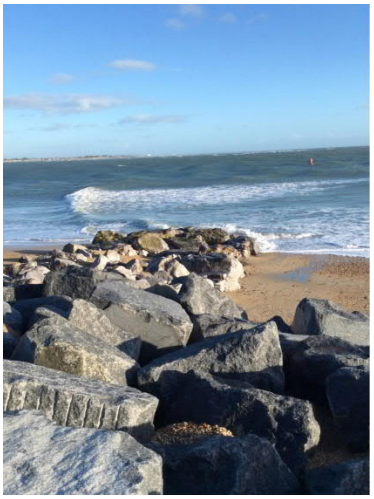
Defence Element:	5AHI05 (Length: 20m)	Defence Section:	Groyne 11

Location:	Hayling beach	Year of Construction:	Unknown.	
Defence Description:				
Rock groyne.				
Construction Material:	Rock			
Foreshore Description:				
Sand and shingle to the toe of the structure.				
Defence Condition and Grade:	Fair	Residual Life (no maintenance):	10-15 years	
Fair condition. Occasional voids in structure. Rock of regular shape, infill of shingle within structure due to displacement of rocks				
Owner (HBC/P/HA/HCC/EA/SWS/EH):	HBC	Maintainer (HBC/P/HA/HCC/EA/SWS/EH):	HBC	
Comments:

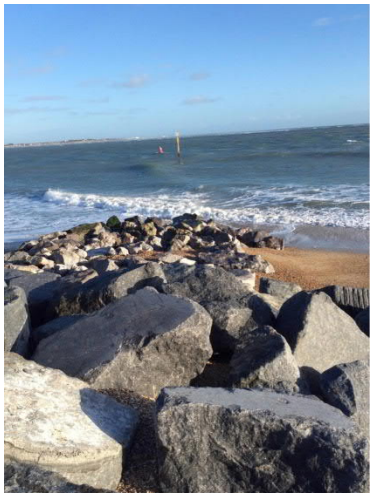
Defence Element:	5AHI05 (Length: 20m)	Defence Section:	Groyne 12

Location:	Hayling beach	Year of Construction:	Unknown.	
Defence Description:				
Rock groyne.				
Construction Material:	Rock			
Foreshore Description:				
Sand and shingle to the toe of the structure.				
Defence Condition and Grade:	Good	Residual Life (no maintenance):	15-20 years	
Good condition. Occasional voids in the structure. Rock of regular shape, infilled with beach material & shingle in the structure due to minor displacement of the rock stones.				
Owner (HBC/P/HA/HCC/EA/SWS/EH):	HBC	Maintainer (HBC/P/HA/HCC/EA/SWS/EH):	HBC	
Comments:

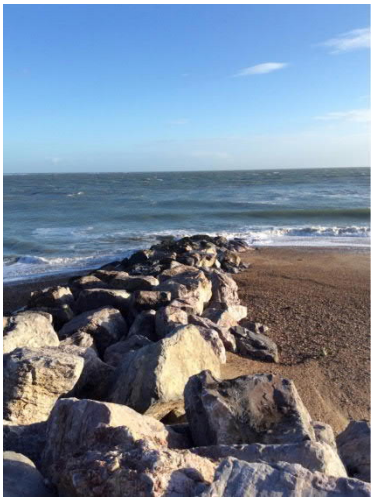
Defence Element:	5AHI05 (Length: 20m)	Defence Section:	Groyne 13

Location:	Hayling Beach	Year of Construction:	Unknown	
Defence Description:				
Rock groyne.				
Construction Material:	Rock			
Foreshore Description:				
Sand and shingle to the toe of the structure.				
Defence Condition and Grade:	Very Good	Residual Life (no maintenance):	>20 years	
Hard angular rock, well compacted. No toe erosion				
Owner (HBC/P/HA/HCC/EA/SWS/EH):	HBC	Maintainer (HBC/P/HA/HCC/EA/SWS/EH):	HBC	
Comments:

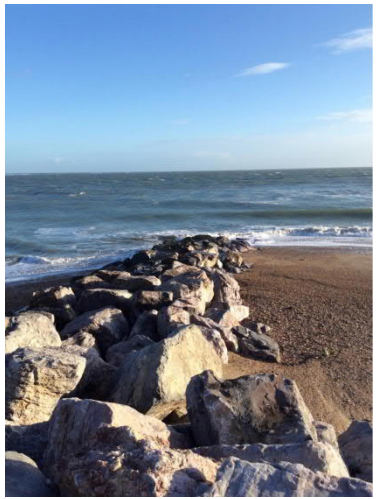
Defence Element:	5AHI05 (Length: 20m)	Defence Section:	Groyne 14

Location:	Hayling Beach	Year of Construction:	Unknown.	
Defence Description:				
Rock groyne.				
Construction Material:	Rock			
Foreshore Description:				
Sand and shingle to the toe of the structure.				
Defence Condition and Grade:	Good	Residual Life (no maintenance):	15-20 years	
Minor displacement of rocks creating some voids. Generally well packed structure, loss of toe alignment and erosion in some areas.				
Owner (HBC/P/HA/HCC/EA/SWS/EH):	HBC	Maintainer (HBC/P/HA/HCC/EA/SWS/EH):	HBC	
Comments:

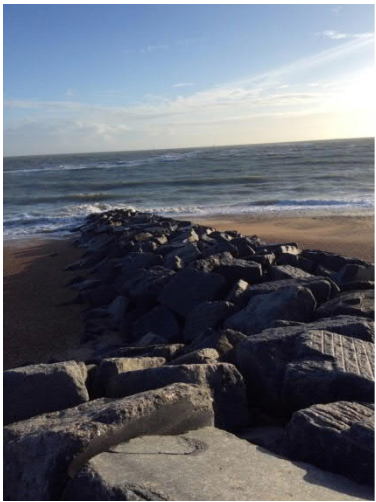
Defence Element:	5AHI05 (Length: 20m)	Defence Section:	Groyne 15

Location:	Hayling Beach	Year of Construction:	Unknown.	
Defence Description:				
Rock groyne.				
Construction Material:	Rock			
Foreshore Description:				
Sand & shingle to the toe of the structure.				
Defence Condition and Grade:	Very Good	Residual Life (no maintenance):	>20 years	
Large angular rock, well compacted with good density. No evidence of erosion at the toe.				
Owner (HBC/P/HA/HCC/EA/SWS/EH):	HBC	Maintainer (HBC/P/HA/HCC/EA/SWS/EH):	HBC	
Comments:

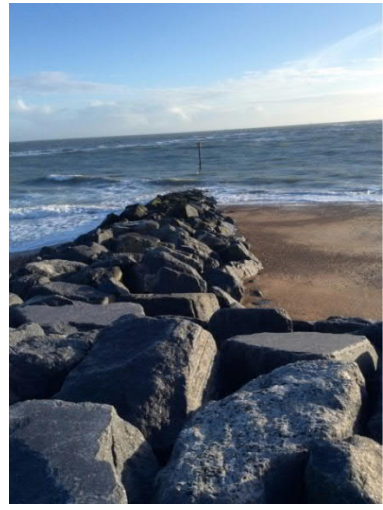
Defence Element:	5AHI05 (Length: 20m)	Defence Section:	Groyne 16

Location:	Hayling Beach	Year of Construction:	Unknown.	
Defence Description:				
Rock groyne.				
Construction Material:	Rock			
Foreshore Description:				
Sand & shingle to the toe of the structure.				
Defence Condition and Grade:	Very Good	Residual Life (no maintenance):	>20 years	
Large angular rock, well compacted with good density. No evidence of erosion at the toe.				
Owner (HBC/P/HA/HCC/EA/SWS/EH):	HBC	Maintainer (HBC/P/HA/HCC/EA/SWS/EH):	HBC	
Comments:

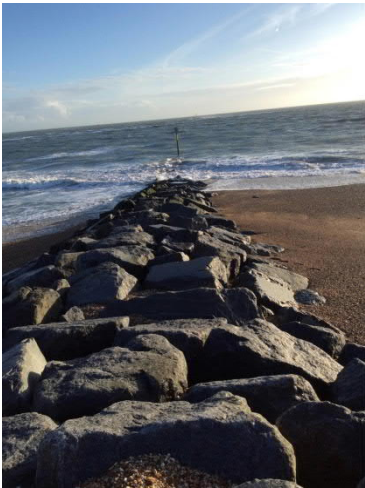
Defence Element:	5AHI05 (Length: 20m)	Defence Section:	Groyne 17

Location:	Hayling Beach	Year of Construction:	Unknown.	
Defence Description:				
Rock groyne.				
Construction Material:	Rock			
Foreshore Description:				
Sand & shingle to the toe of the structure.				
Defence Condition and Grade:	Good	Residual Life (no maintenance):	15-20 years	
Minor displacement of rocks, creating some voids within the structure. Shingle and beach material has deposited in these pockets. Generally good density to the structure, some minor loss of the toe alignment.				
Owner (HBC/P/HA/HCC/EA/SWS/EH):	HBC	Maintainer (HBC/P/HA/HCC/EA/SWS/EH):	HBC	
Comments:

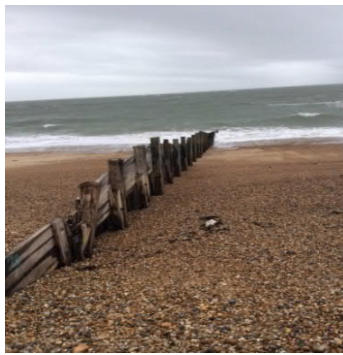
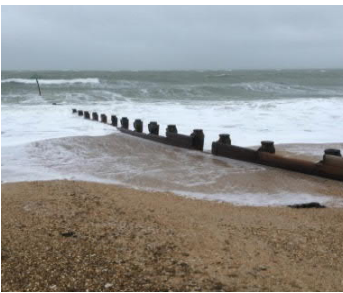
Defence Element:	5AHI05 (Length: N/A)	Defence Section:	Groynes 18 - 51

Location:	Hayling Beach	Year of Construction:	Unknown	
Defence Description:				
34 Timber groynes, along Hayling Beach frontage.

Construction Material:	Timber			
Foreshore Description:				
Fine sand and shingle along the structures to the east. Large shingle at the structures along the central and western end.

Defence Condition and Grade:	25 – Very Good 6- Good 2- Fair 1- Very Poor	Residual Life (no maintenance):	>20 years 15-20 years 10-15 years <5 years	
Very Good – Very Poor Condition throughout. Generally very good condition. Very poor graded groyne due to broken or rotten panels.				
Owner (HBC/P/HA/HCC/EA/SWS/EH):	HBC	Maintainer (EA/LA/MOD/P):	HBC

Comments:				
Very good groynes; 19, 20, 21, 22, 23, 24, 25, 29, 30, 31, 32, 33, 34, 36, 37, 40 ,41, 42, 44, 45, 46, 47, 48, 50, 51 Good groynes; 18, 27, 38, 39, 43, 49 Fair groynes; 26, 28 Very poor groyne; 35

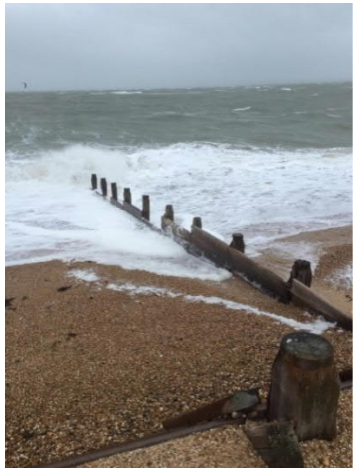
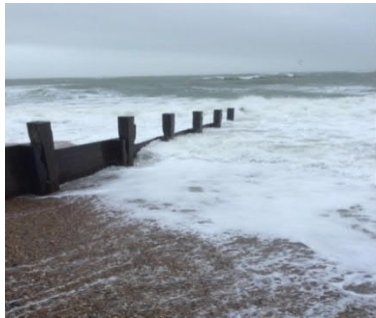
Defence Element:	5AHI05 (N/A)	Defence Section:	Groynes 52 - 55

Location:	South of car park adjacent to Hayling Golf Club	Year of Construction:	Unknown	
Defence Description:				
4 No. timber groyne.				
Construction Material:	Timber

Foreshore Description:				
Sand at the toe. High wave action during the survey date.				
Defence Condition and Grade:	3 - Fair 1 - Poor	Residual Life (no maintenance):	10-15 years <10 years	
3 fair condition groynes. Some planks missing, due to weathering or damage. Stable beach level either side. 1 poor condition groyne.				
Owner (HBC/P/HA/HCC/EA/SWS/EH):	HBC	Maintainer (EA/LA/MOD/P):	HBC	
Comments:				
Fair groynes; 52, 53, 54 Poor groyne; 55

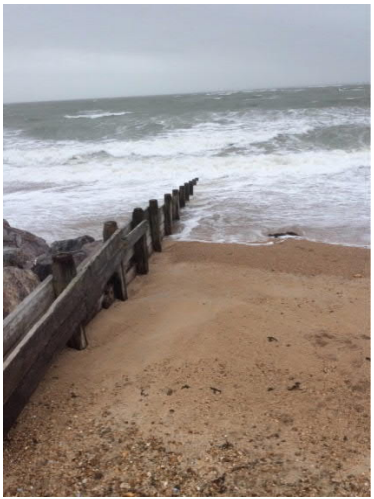
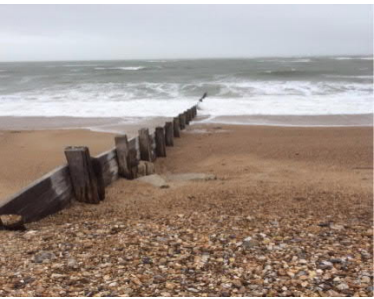
Defence Element:	5AHI05 (Length: N/A)	Defence Section:	Groynes 56 - 59

Location:	South of Hayling Golf Club	Year of Construction:	Unknown	
Defence Description:				
4 No. timber groynes				
Construction Material:	Timber			
Foreshore Description:

Sand and gravel to the toe of the structure.				
Defence Condition and Grade:	1- Fair 3- Poor	Residual Life (no maintenance):	10 -15 years < 10 years	
3 groynes in poor condition. 1 groyne in fair condition. Appears to be some dismantling of the groynes taking place along the frontage. Some planks missing, minor rotting of wood in some areas.				
Owner (HBC/P/HA/HCC/EA/SWS/EH):	HBC	Maintainer (HBC/P/HA/HCC/EA/SWS/EH):	HBC	
Comments:				
Fair groyne; 55 Poor groynes; 56, 57, 59

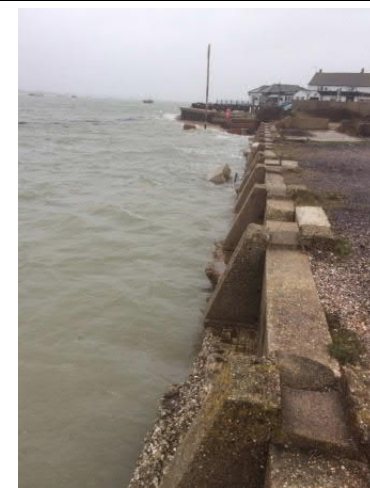
Defence Element:	5AHI06 (Length: 125m)	Defence Section:	A
Location:	Langstone Harbour Board	Year of Construction:	Unknown
Defence Description:			
Concrete quay wall. Frontage shown in distance of attached photo.			
Construction Material:	Concrete		
Foreshore Description:			
Unknown - not visible at high tide during survey. Expected to be gravel and shingle, as per adjacent areas			
Defence Condition and Grade:	Good	Residual Life (no maintenance):	15-20 years
Good condition throughout. Minor surface defects and loss of mortar at joints. Section of sheet piling in the middle of the frontage- fair condition (amount of corrosion).			
Owner (HBC/P/HA/HCC/EA/SWS/EH):	P	Maintainer (HBC/P/HA/HCC/EA/SWS/EH):	P
Comments:

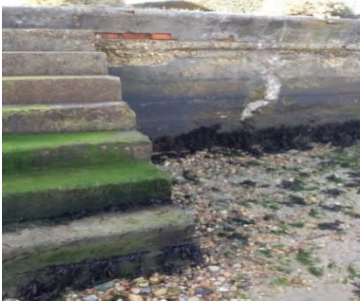
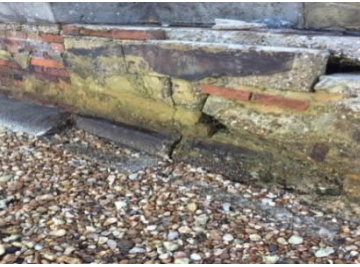
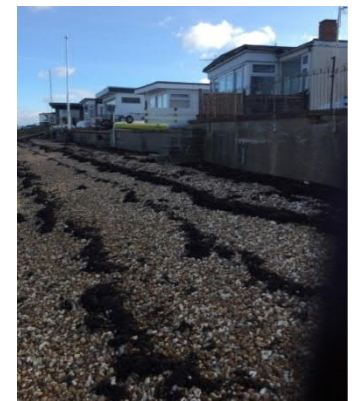
Defence Element:	5AHI06 (Length: 470m)	Defence Section:	B

Foreshore Description:				
Gravel (where visible). Shallow foreshore.				
Defence Condition and Grade:	Fair	Residual Life (no maintenance):	10-15 years

Fair condition where visible. Unable to access majority of length.				
Owner (HBC/P/HA/HCC/EA/SWS/EH):	P	Maintainer (HBC/P/HA/HCC/EA/SWS/EH):	P	
Comments:
