Hayling Island Defence Condition Assessment

Hayling Island Funding and Implementation Strategy

Havant Borough Council

May 2019

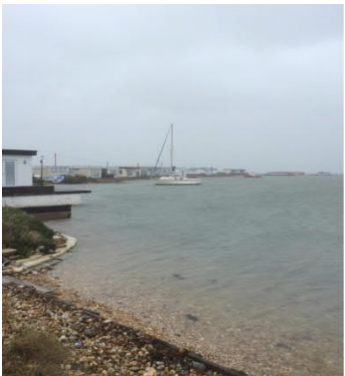
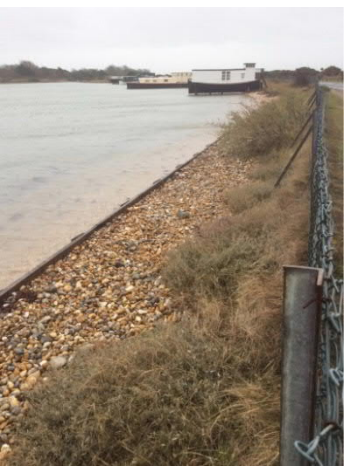
Defence Element:	5AHI06 (Length: 220m)	Defence Section:	C

Construction Material:	Earth			
Foreshore Description:				
Gravel at the foreshore.				
Defence Condition and Grade:	Good	Residual Life (no maintenance):	15-20 years	
Good condition. Natural profile, 0.5m high.				
Owner (HBC/P/HA/HCC/EA/SWS/EH):	P	Maintainer (HBC/P/HA/HCC/EA/SWS/EH):	P	
Comments:

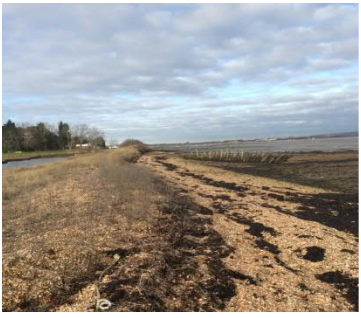
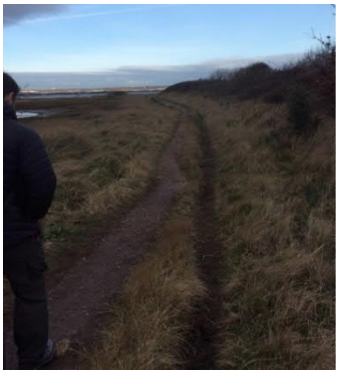
Defence Element:	5AHI06 (Length: 940m)	Defence Section:	D

Foreshore Description:				
Long stretch of Saltmarsh to the toe.				
Defence Condition and Grade:	Good	Residual Life (no maintenance):	15-20 years	
Good condition. Shallow natural structure, but well vegetated. Small signs of undercutting at the toe.				
Owner (HBC/P/HA/HCC/EA/SWS/EH):	P	Maintainer (HBC/P/HA/HCC/EA/SWS/EH):	P	
Comments:

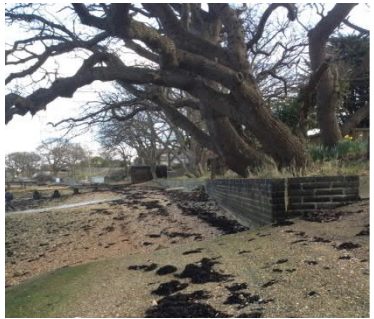
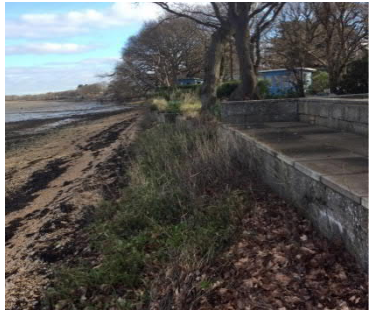
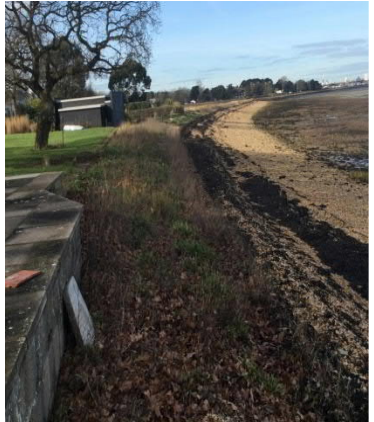
Defence Element:	5AHI06 (Length: 170m)	Defence Section:	F

Ad-hoc breeze blockwork structures. Build-up of shingle has developed at the toe of the structure. Walls vary in height (around 1m high).				
Construction Material:	Blockwork

Foreshore Description:				
Build-up of shingle. Some seaweed.				
Defence Condition and Grade:	Good	Residual Life (no maintenance):	15-20 years	
Walls in good condition. Many have been raised over the past 30 years				
Owner (HBC/P/HA/HCC/EA/SWS/EH):	P	Maintainer (HBC/P/HA/HCC/EA/SWS/EH):	P	
Comments:

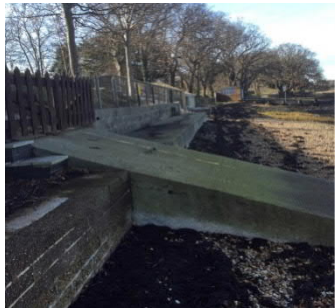
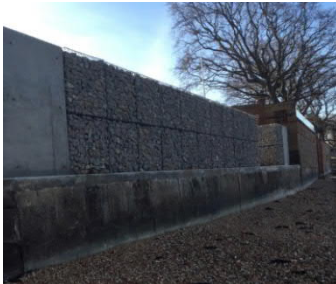
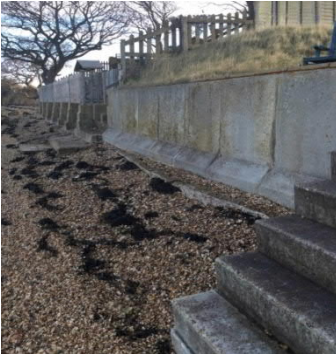
Defence Element:	5AHI06 (Length: 450m)	Defence Section:	G

Defence Condition and Grade:	Fair	Residual Life (no maintenance):	10-15 years	
Fair condition (some good). Cracking of the stonework structure. Loss of mortar. Some lowered sections of the wall at risk of being out flanked.				
Owner (HBC/P/HA/HCC/EA/SWS/EH):	P	Maintainer (HBC/P/HA/HCC/EA/SWS/EH):	P

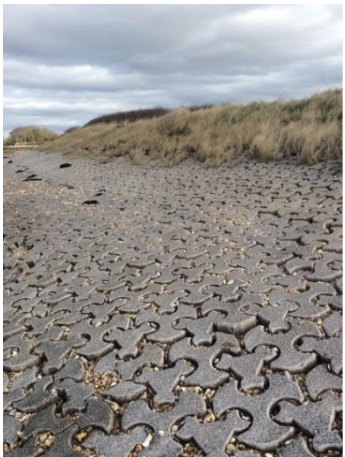
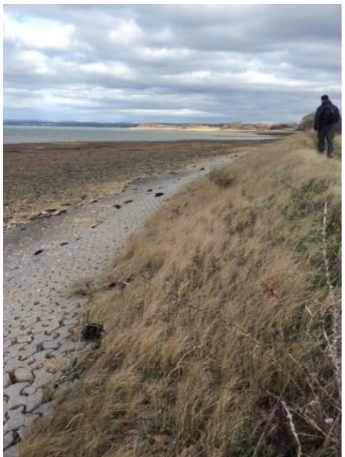
Defence Element:	5AHI07 (Length: 95m)	Defence Section:	B

Foreshore Description:				
Shingle beach to the toe. Sand and gravel to the middle.				
Defence Condition and Grade:	Good	Residual Life (no maintenance):	15-20 years	
Good (locally fair). Minor settle of crest. Minor movement of the embankment profile. No loss of material. Well vegetated. Small section of the toe has been undermined and in fair condition.				
Owner (HBC/P/HA/HCC/EA/SWS/EH):	P	Maintainer (HBC/P/HA/HCC/EA/SWS/EH):	EA	
Comments:

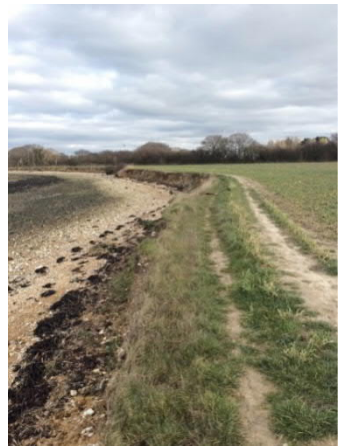
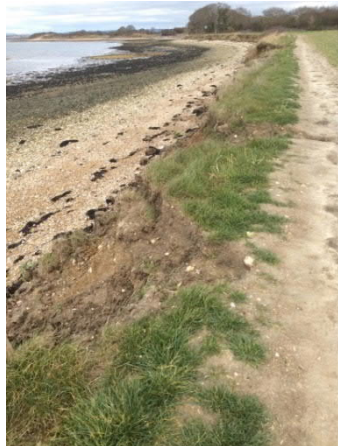
Defence Element:	5AHI07 (Length: 385m)	Defence Section:	C

Construction Material:	Earth			
Foreshore Description:				
Gravel and sand to the toe.				
Defence Condition and Grade:	Poor	Residual Life (no maintenance):	<5 years	
Poor condition. Signs of erosion, with cliffing occurring along the whole structure. No vegetation on the front face. Rotational slip of material evident in many locations.				
Owner (HBC/P/HA/HCC/EA/SWS/EH):	P	Maintainer (HBC/P/HA/HCC/EA/SWS/EH):	P	
Comments:

The defences in 5AH107 along sections C to F are in a poor or very poor condition. The majority of the frontage is comprised of an earth embankment which is generally well vegetated. However, the embankment is showing signs of undermining at the toe and there are numerous slips that have occurred.

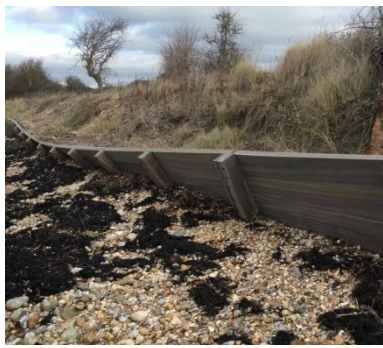
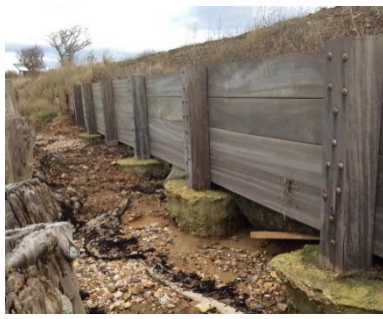
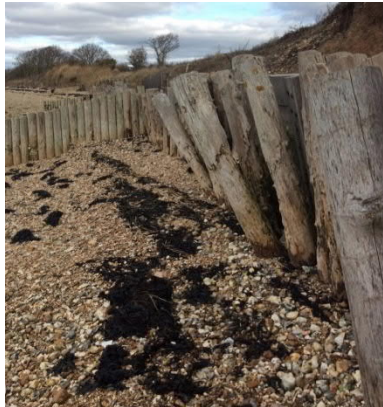
Defence Element:	5AHI07 (Length: 285m)	Defence Section:	D

Foreshore Description:				
Shingle material to the toe.				
Defence Condition and Grade:	Very poor	Residual Life (no maintenance):	<5 years, failed in places	
Very poor. Rear backboard is failing in retaining the billy line path and its embankment material. Timber piles are fair-poor. Number of piles have failed, many are out of alignment. Wet rot in some piles.				
Owner (HBC/P/HA/HCC/EA/SWS/EH):	HCC	Maintainer (HBC/P/HA/HCC/EA/SWS/EH):	HCC	
Comments:

In sections D and F timber defences have been installed to help reduce erosion of the embankment. However, the timber defences have largely failed, rotated or undermined and the embankment behind has continued to erode. The photographs in Figure 7-6 demonstrate this.

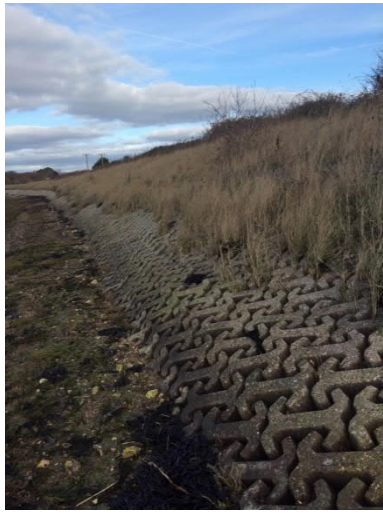
Defence Element:	5AHI08 (Length: 275m)	Defence Section:	A

Foreshore Description:				
Grasslands and coarse material at the toe.				
Defence Condition and Grade:	Fair	Residual Life (no maintenance):	10-15 years	
Non uniform. Minor movement and root growth. Toe exposed.				
Owner (HBC/P/HA/HCC/EA/SWS/EH):	HCC	Maintainer (HBC/P/HA/HCC/EA/SWS/EH):	EA	
Comments:

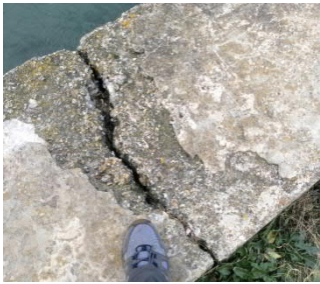
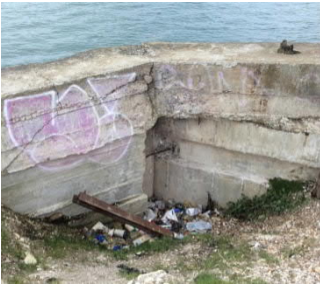
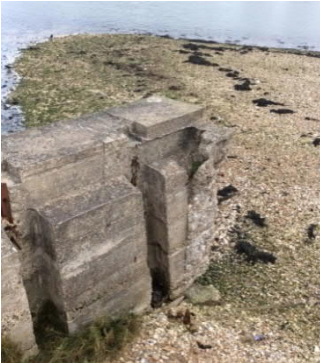
Defence Element:	5AHI08 (Length: 92m)	Defence Section:	H

Defence Condition and Grade:	Poor	Residual Life (no maintenance):	5-10 years	
Toe in poor condition, otherwise fair.				
Owner (HBC/P/HA/HCC/EA/SWS/EH):	HCC	Maintainer (HBC/P/HA/HCC/EA/SWS/EH):	HCC

The toe of the seawall in section H is in a poor condition. There are substantial structural cracks and a loss of fill material behind the seawall.

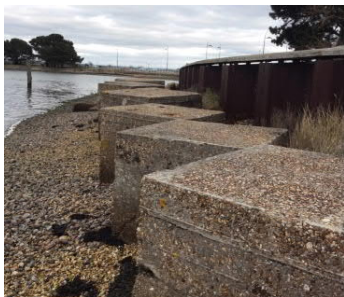
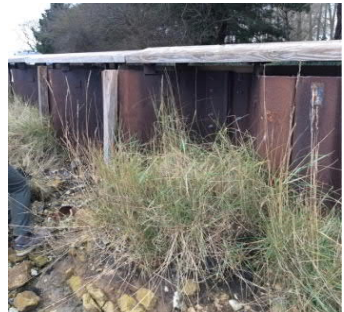
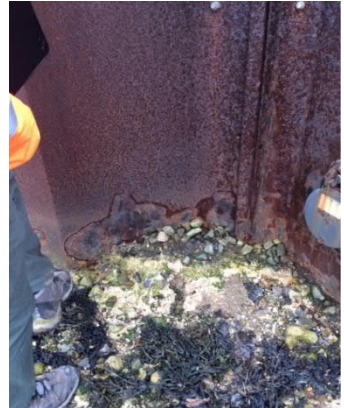
Defence Element:	5AHI08 (Length: 165m)	Defence Section:	K

Defence Condition and Grade:	Good	Residual Life (no maintenance):	15-20 years	
Wear, some minor corrosion to the piles.				
Owner (HBC/P/HA/HCC/EA/SWS/EH):	HCC	Maintainer (HBC/P/HA/HCC/EA/SWS/EH):	HCC

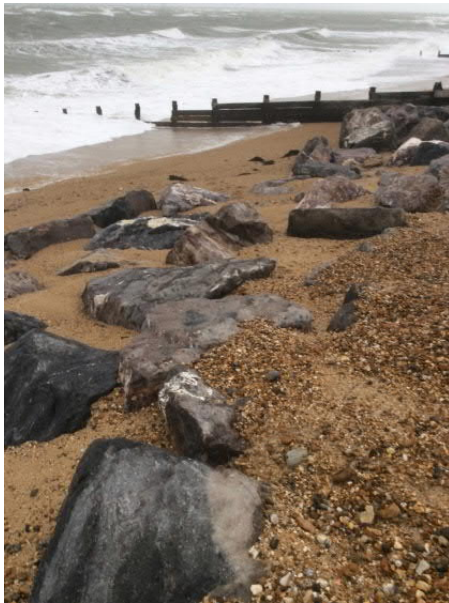
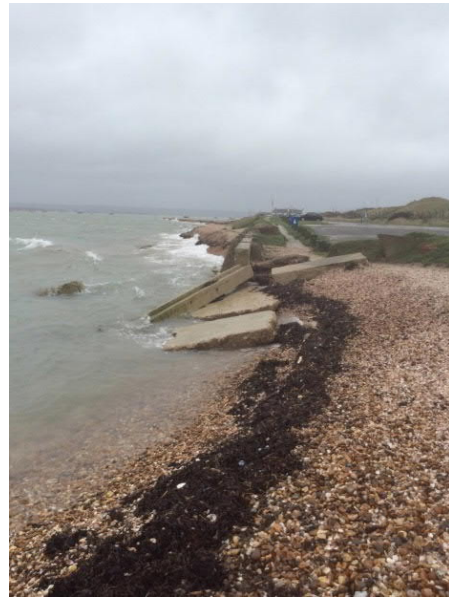
Figure 7-4. Photographs of rock revetment and concrete blockwork in 5AH105

In section O the rock armour revetment has lost its structure and intended alignment. The toe has been undermined and there is sporadic coverage of rocks across the beach area. In section S the concrete blockwork has failed, and the structure has lost its integrity and breached in several locations. The car park behind the defence appears to be at risk of erosion. The photographs in Figure 7-4 show the poor condition of the defences in these locations.

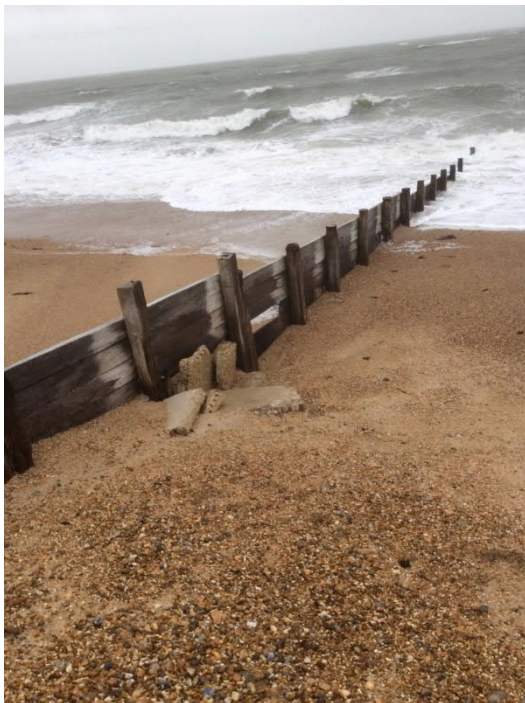
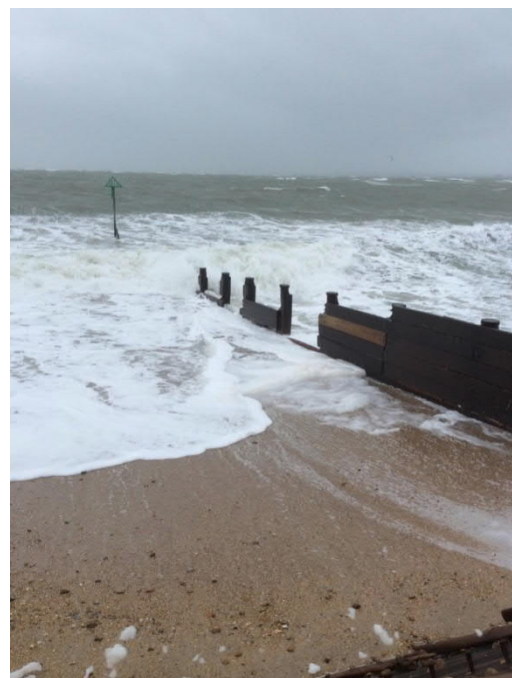
Figure 7-5. Photographs of groynes in unit 5AH105

Generally the timber groynes in unit 5AH105 are in a good or very good condition. However, there are exceptions where individual groynes are in a poor or very poor condition due to broken or rotted panels; the photographs shown in Figure 7-5 show examples where panels are missing. Whilst a small number of individual panels missing from a limited number of the groynes is unlikely to significantly reduce the performance of the groyne field, exposed bolts and fittings or splintered timber could pose a risk to public health and safety. Since undertaking the survey it is understood that repair work has been undertaken on the HBC owned groynes to reduce the H&S risk in the identified locations.

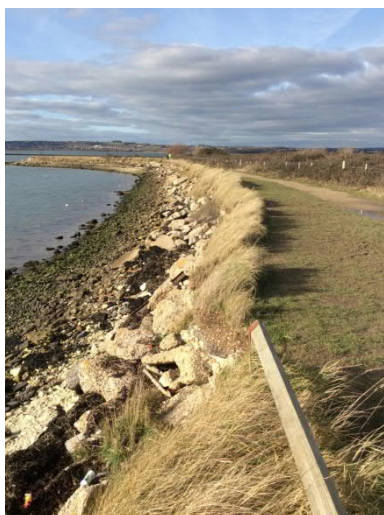
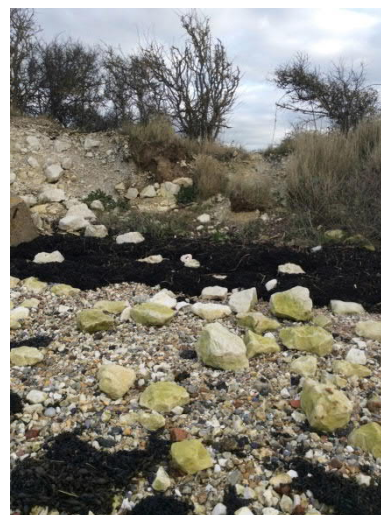
Figure 7-7. Defence in section D and gabions in section F

The rubble revetment in sections D and G are in a poor condition. The toe of the structure is exposed and the residual life is expected to be less than 5 years. The Billy Line footpath is adjacent to this defence and would be at risk of erosion should the defence fail.

In section F the earth embankment is protected by rock gabions at its toe. These gabions are in a poor condition with the wire split in numerous places and the form of the structure is being lost. Figure 7-7 illustrates a section of the failed gabions, alongside a photograph of the rubble revetment in section D.

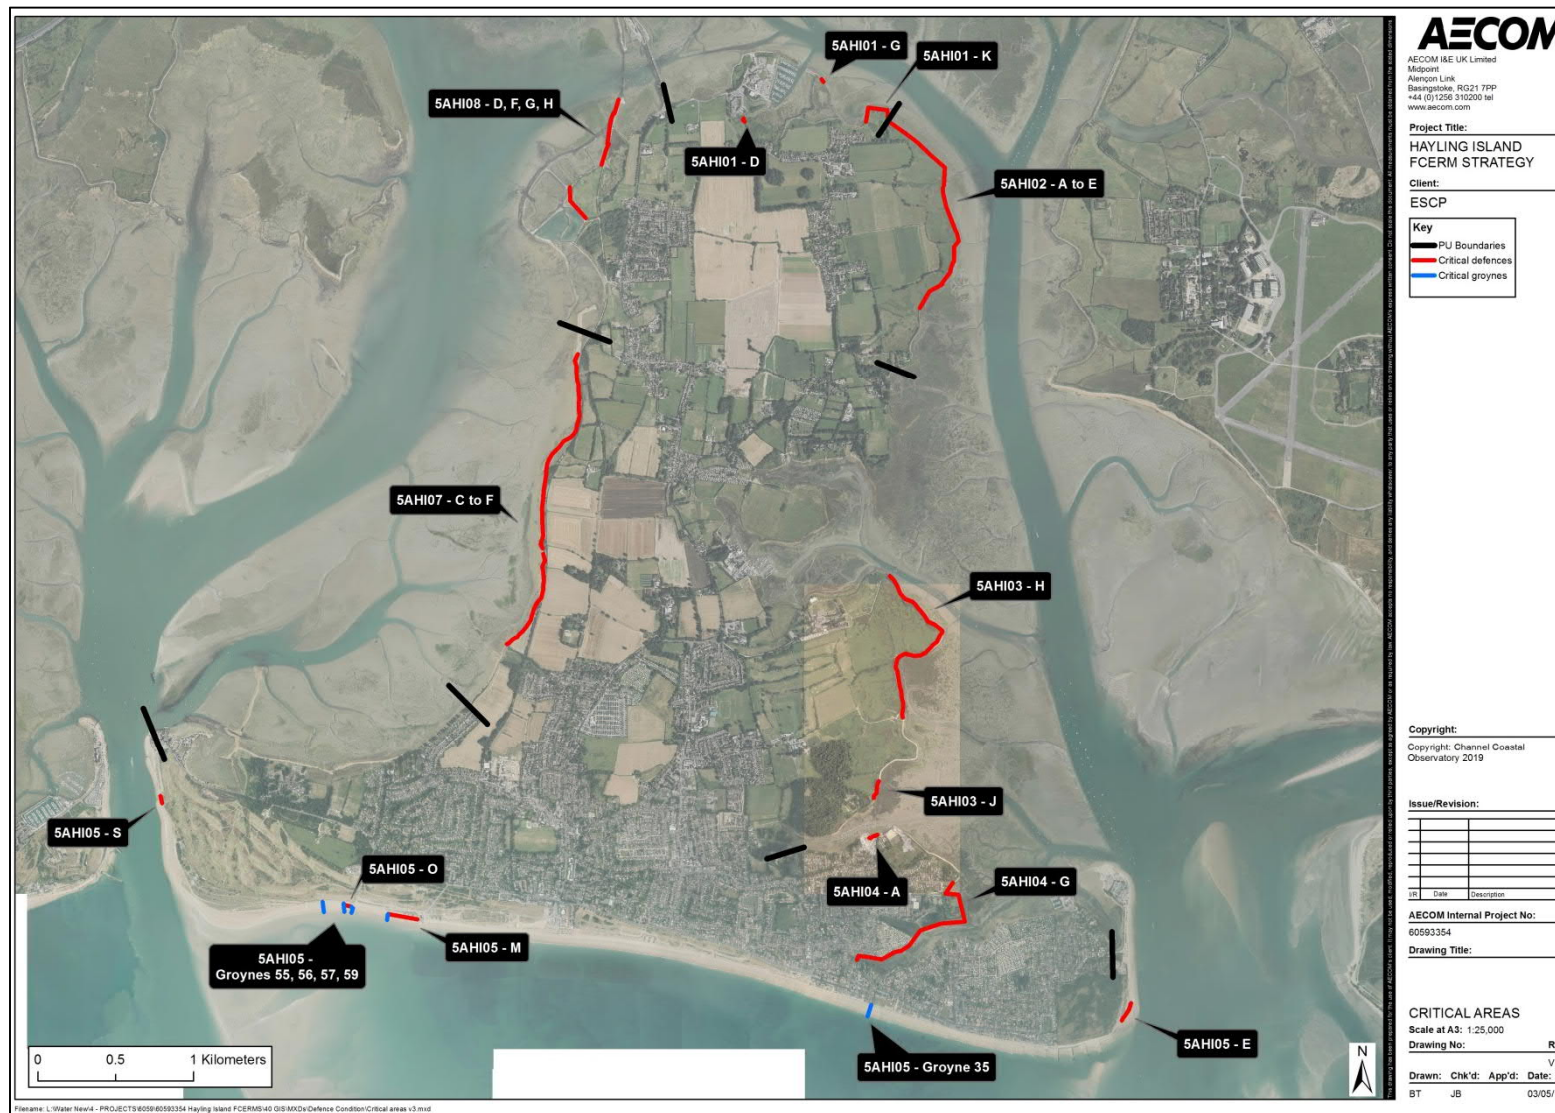
Figure 7-8. Location of critical areas

A map showing the critical area locations around Hayling Island is provided in Figure 7-8. The critical areas are where the defence condition is considered to be poor. No consideration of the standard of protection or the flood risk behind the defences has been made in the definition of the critical areas.
