**Executive Summary**

# SOUTH HAYLING ISLAND BEACH MANAGEMENT PLAN:

2024 – 2029

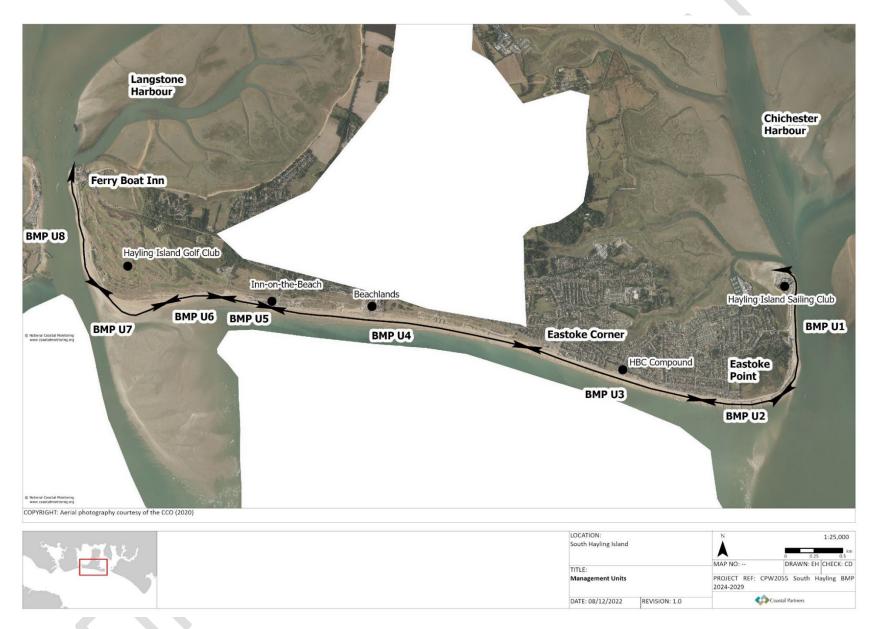
Figure 1: Location of management units along the South Hayling BMP frontage

The South Hayling frontage has been divided in to 8 discrete management units. These units are based on both ownership and coastal management policy. Although the frontage is divided in to units the coastline is seen as a single entity, whereby the individual units work together to provide a South Hayling Island wide management plan. BMP U1 is found to the east of the Island, starting at Black Point Spit, with BMP U8 at the west of the island ending at the Ferry Boat Inn. Figure 1 shows the different units along the coastline.

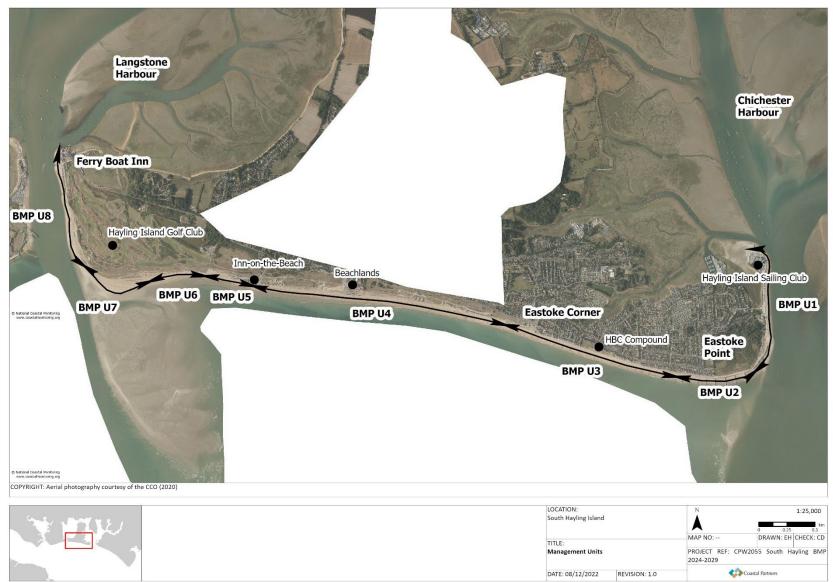
Figure 1.4: Management Units used for the BMP.

This BMP covers the whole southern frontage of Hayling Island, Hampshire, extending from the Ferry Boat Inn in the west, to the Hayling Island Sailing Club (HISC) in the east (Figure 1.4). Although the section of beach from Eastoke Corner Car Park to Eastoke Point is the only area which is actively managed by HBC, extraction of material and subsequent recycling operations along the wider Hayling Island coastline necessitate a BMP covering the whole sediment cell. The length of the managed frontage is 2.2km of the 8.3km Southern Frontage, which is unit BMP Unit 3 in Figure 1.4.

The boundaries for the BMP units (BMP Us) are influenced by a range of factors including coastal processes, existing structures, and land ownership (Figure 1.5). A summary of the key features in each BMP Management Unit in Figure 1.4 is shown in Table 1.1.

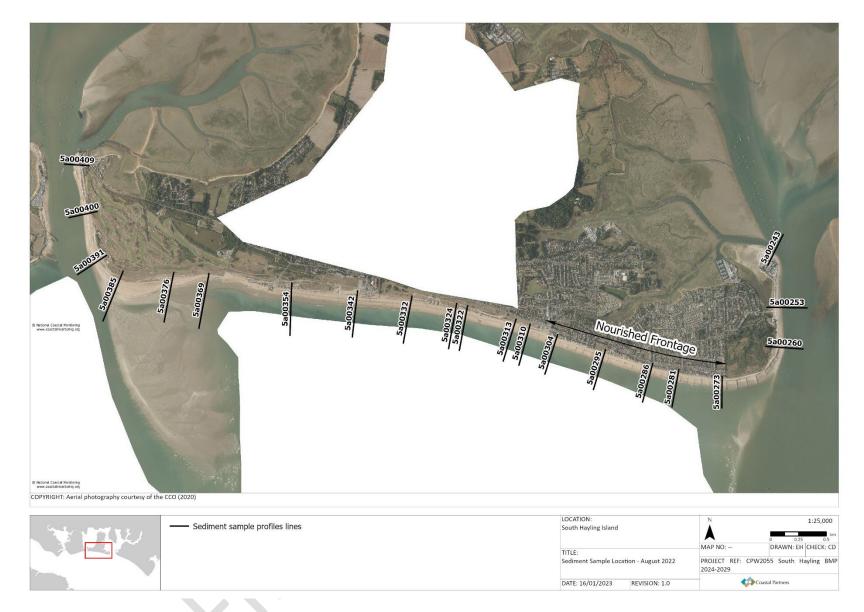
Figure 2.9: Location of sediment samples, Hayling Island

The most recent set of sediment samples were collected in May 2022, on 21 different profiles around the frontage (Figure 2.9 and Appendix A). Surface samples were collected at the beach crest, MHW, MSL and MLW along each profile.

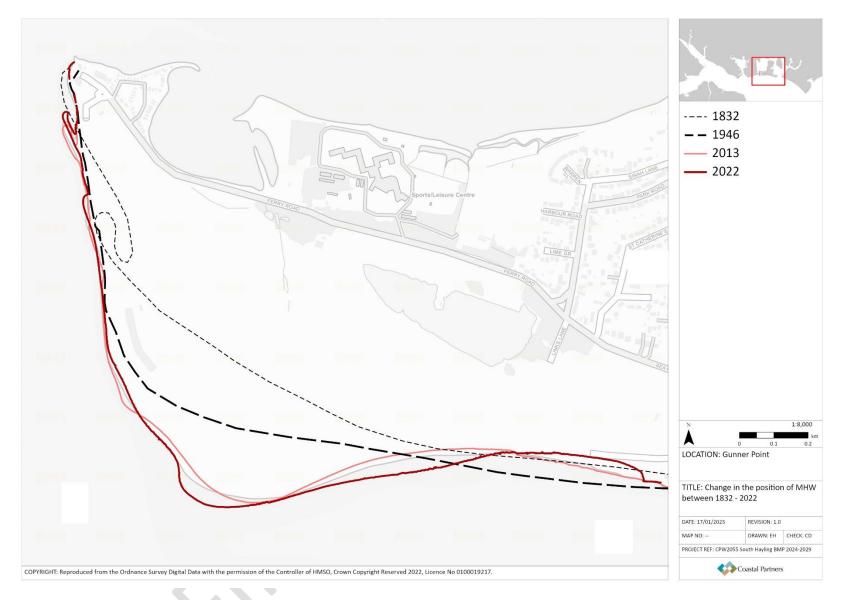
Figure 2.10: South-west Hayling Island MHW (1832 – 2022)

Several authors have published work relating to the evolution of the shoreline covering the BMP frontage, notable examples include Harlow (Ref 2.22), Whitcombe (Ref 2.23), Webber (Ref 2.24), Wallace (Ref 2.25) and DEFRA (Ref 2.26) with annual reports on more recent beach changes from CCO (Ref 2.27). In summary, the present shoreline of the East Solent is a result of very active post-glacial processes of erosion and accretion, increasingly controlled by coastal defences and Beach Management Activities over the last century. Substantial erosion and roll back of the shingle banks have occurred along the eastern frontage of Hayling Island. Concurrent accretion has occurred in the central and western parts of the frontage. This is particularly so at Gunner Point where the shoreline has moved seaward by up to 400 m since 1832 (Figure 2.10), resulting in the development of multiple shingle ridges.

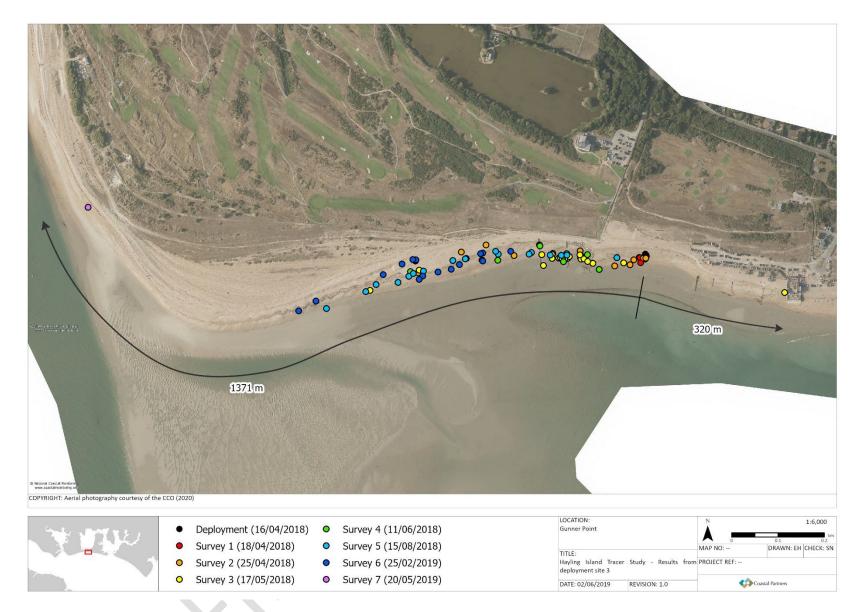
Figure 2.11: Results of the Tracer Study for Gunner Point deployment (pebbles deployed in April 2018) (Ref 2.29)

To the west of the nourished frontage net westward sediment transport is dominant. At Gunner Point there have been temporary drift reversals but a deployment of tracer pebbles in 2018 confirmed the movement of material around the point and up into the harbour entrance (Figure 2.11). Once inside the harbour entrance rates of transport fall, and beach material is either lost into the deep water channel or slowly moves north towards the Ferryboat Inn.

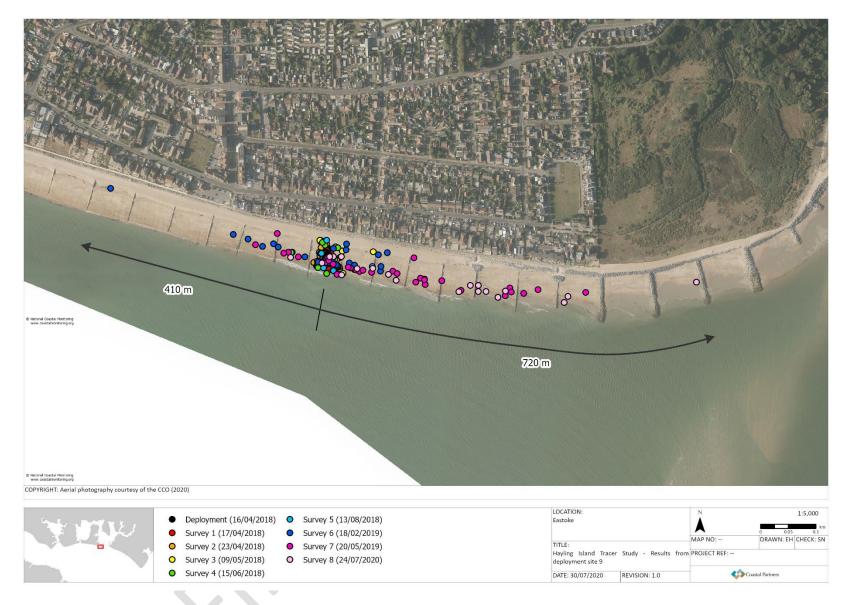
Figure 2.12: Results of the Tracer Study for Eastoke deployment (pebbles deployed in April 2018) (Ref 2.29)

The 2018-2020 tracer study at Eastoke also re-confirmed the presence of the littoral drift divide near Creek Road (Ref 2.29), with tracer pebbles deployed east of the car park tending to move eastwards around Eastoke Point, bypassing the rock groyne structures built as part of the Eastoke Point Scheme in 2013 (Figure 2.12).

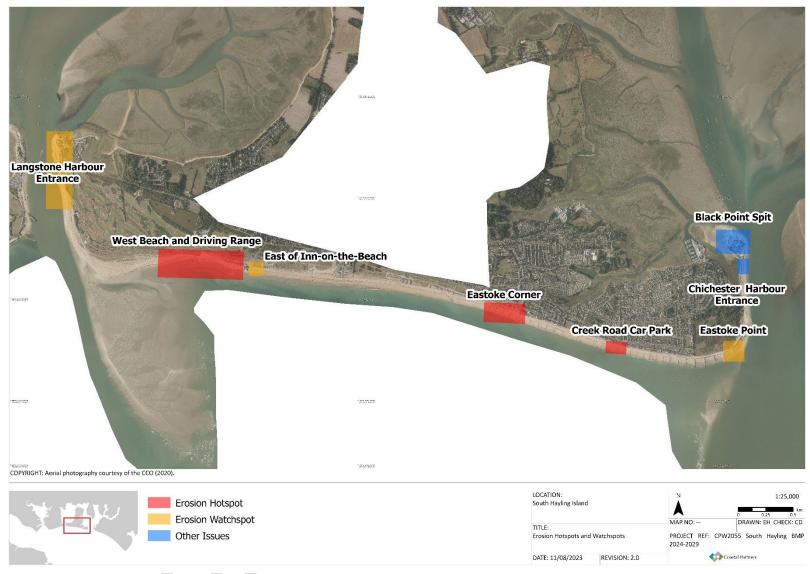
Figure 2.20: Erosion hotspots, erosion watch spots and other issues.

Figure 2.20 shows the location of all the erosion hot spots (current issues), watch spots (potential issues) and other issues around the South Hayling frontage. These are discussed in more detail below.
