EASTERN | COASTAL  
SOLENT | PARTNERSHIP

## **South Hayling Beach Management Plan**

### **Beach Management Plan**

**Report Number: ESCP-HBC-SHBMP-001**

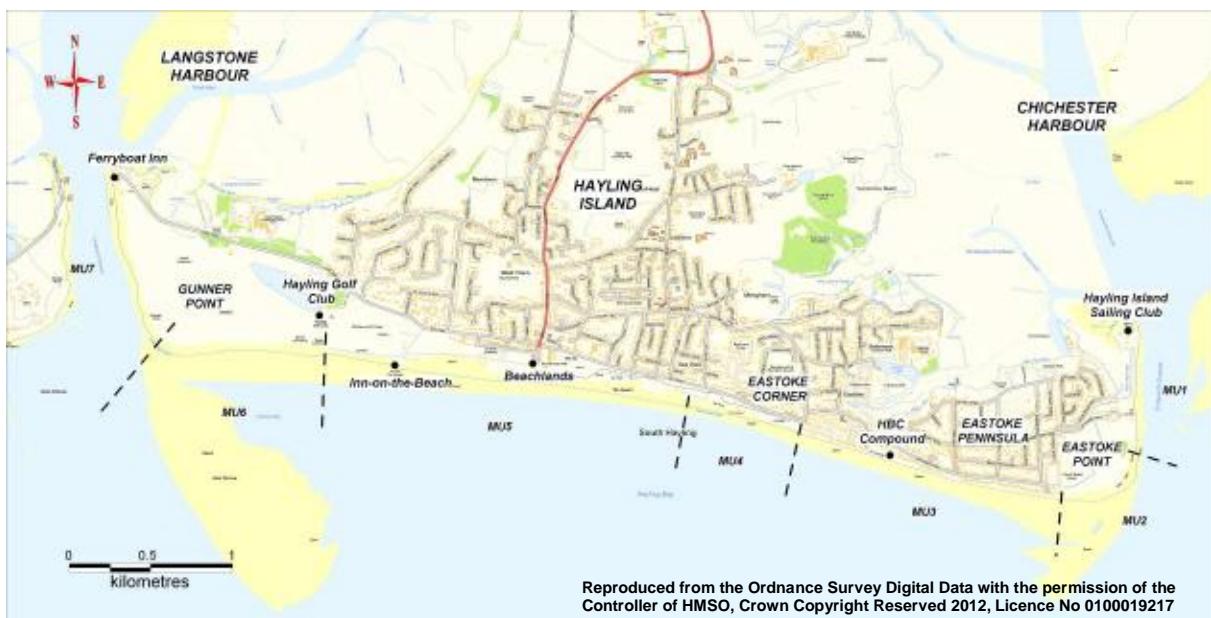
**Figure 1.1- Beach Management Plan General Location Map & Management Units**

The BMP area has been divided into seven Management Units (MUs) as shown by Figure 1.1. The boundaries for the MUs are based on the current management approach, and are influenced by a range of factors including coastal processes, existing structures and land ownership. A summary of the key features for each MU is provided in

This BMP covers the whole southern frontage of Hayling Island, Hampshire, extending from the Ferry Boat Inn in the West to the Hayling Island Sailing Club in the East (Figure 1.1). Although the section of beach from Eastoke Corner in the West to Eastoke Point is the only area which is actively managed the impact that the nourished material and subsequent recycling operations have on the wider Hayling Island coast line necessitate a BMP covering a wider area.

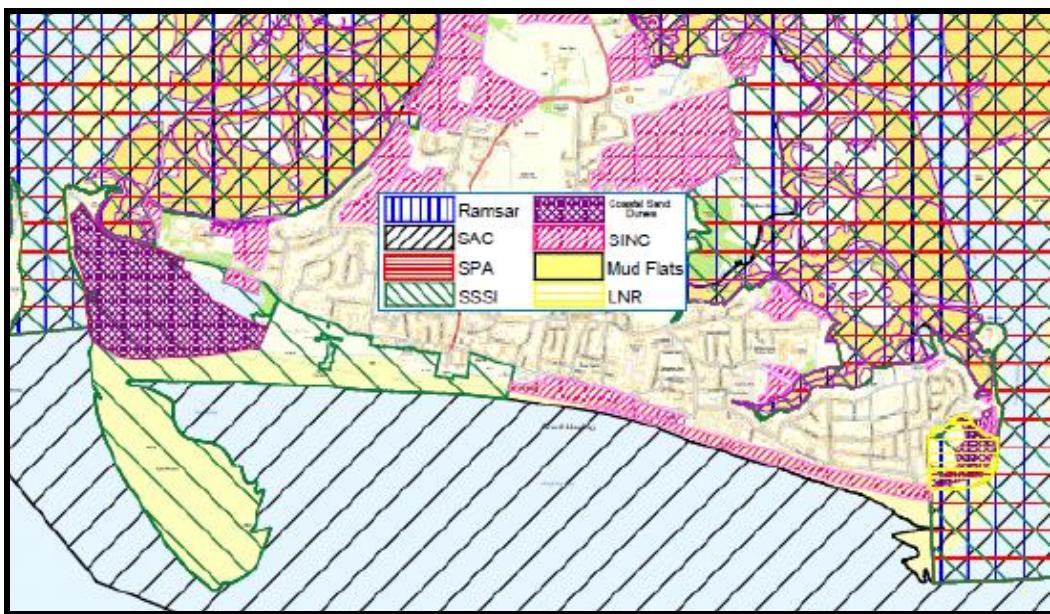
**Figure 1.2 – Nature Conservation Designations around the BMP frontage**

Figure 1.2 shows the extents of the various environmental designations in relation to the BMP area. Appendix A contains further details about these designations for ease of future reference.

As already highlighted in Section 1.3.1, the BMP area is within or near to (within 2km of) a number of designated areas. These areas are shown on Figure 1.2. Further detail on each of the designations is presented in Appendix A.

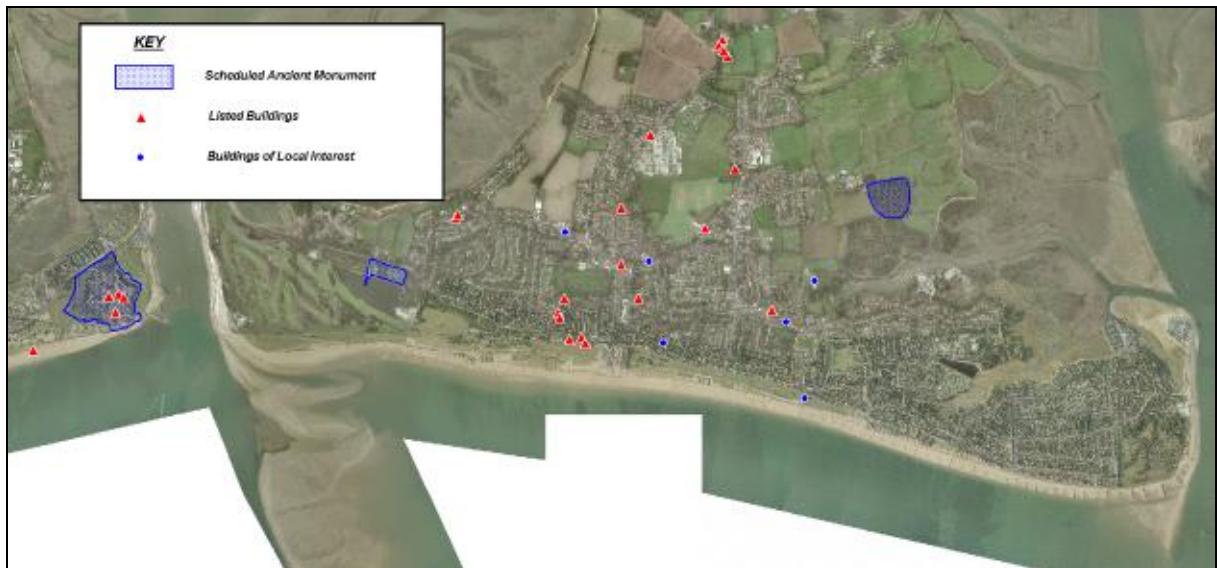
**Figure 1.3 - Historic Environment Features adjacent to BMP frontage**

There are also a range of historic environment features and assets surrounding the study area, including Scheduled Monuments and Listed Buildings. None of these historic environment features are within or immediately adjacent to the BMP frontage. The Old Lifeboat House, Seafront, is a building of local interest located 50 metres behind the active beach, Figure 1.3 shows the location of these historic environment features in relation to the BMP study area.

The Eastern Solent coastline and adjoining harbours comprise historic landscapes which have been utilised from pre-historic periods to the present day. There are a number of cultural heritage features that lie close to the BMP area, as shown on Figure 1.3.

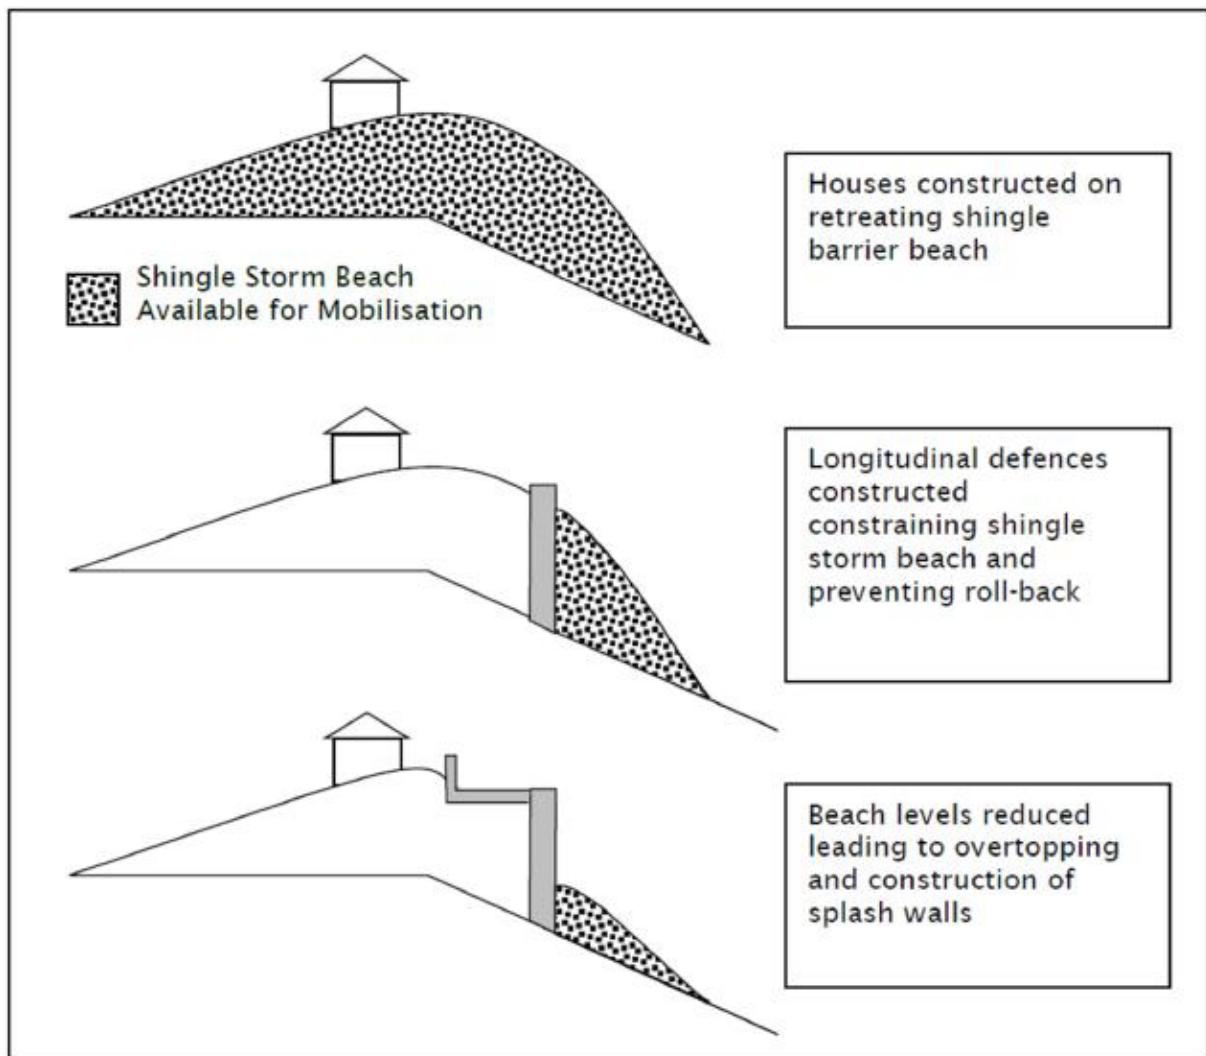
**Figure 1.4 - Process of beach constraint through construction of shore parallel defences at Eastoke, Hayling Island (Ref 1.3)**

shingle barrier beach. As houses were constructed behind the retreating barrier beach shore parallel defences were constructed in response to both erosion and wave overtopping (Figure 1.4).

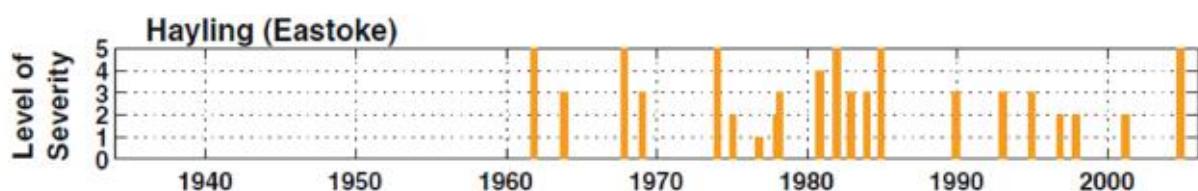
**Figure 1.5 - Incidence of flooding events at Eastoke, Hayling Island (Ref 1.4). Severity is measured according to Table X.**

Over time the beach levels in front of these defences continued to drop and the incidence and severity of flooding increased until the Hayling Island Beach Replenishment Scheme in 1985 (Figure 1.5). The areas liable to flooding prior to the 1985 scheme are shown in Figure 1.6, and the impact of extreme events illustrated in Plates 1.1, 1.2 & 1.3.

**Table 1.2 – Severity of flood events presented in Figure 1.5 (Ref 1.4)**

Severity Level	Description
5	Flooding over larger areas. Significant pumping required by emergency services. Generally more than half a day disruption to homeowners and road users. More than 15 properties affected.
4	More than 5 properties affected by flooding.
3	More than 3 road affected and / or at least one property affected.
2	Some road flooding – usually localised or shallow
1	Flooding in open areas / quay areas – no real structural damage or disruption.

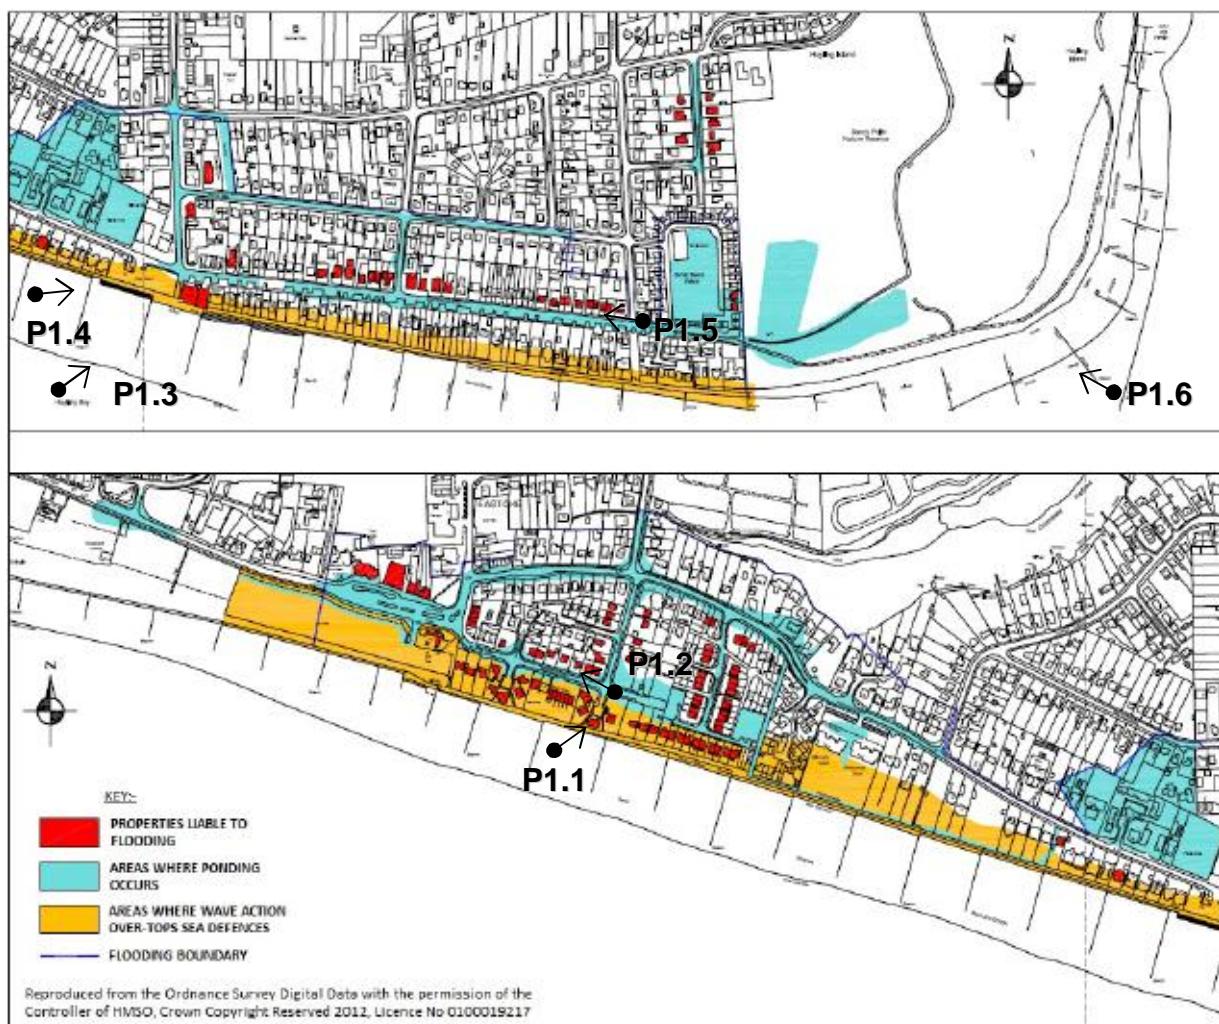
**Figure 1.6 - Areas liable to flood due to wave overtopping prior to the 1985 Beach Replenishment Scheme, based on HBC Drawing No. 1007/358, March 1977. Approximate location of Plates 1.1 – 1.6 also indicated.**

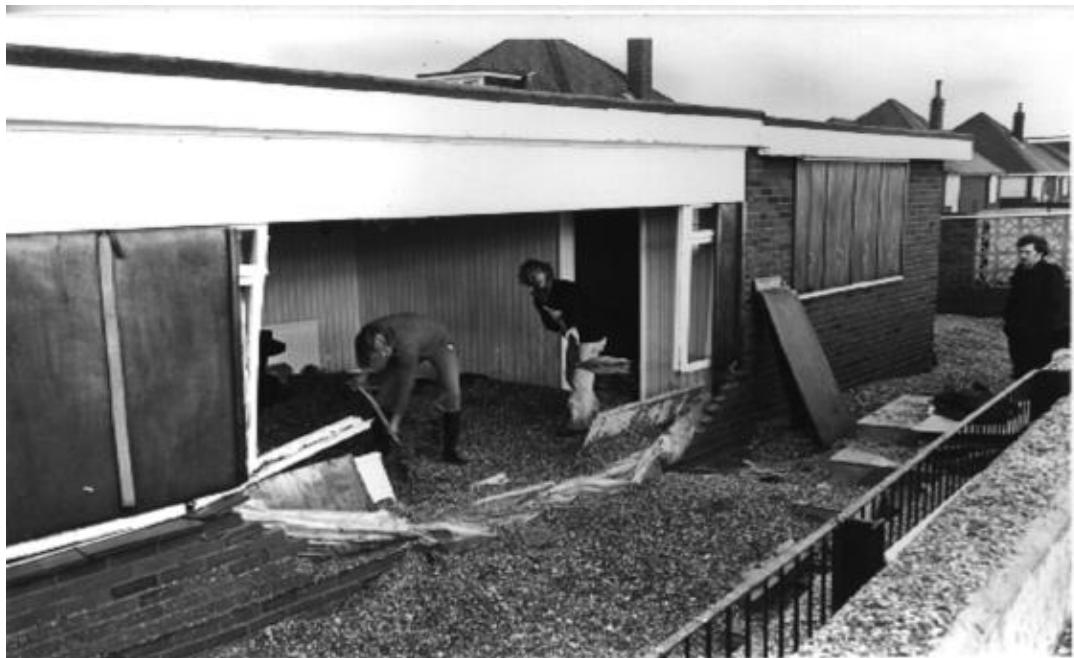
**Plate 1.1 - Storm damage to property behind the promenade, December 1978.**

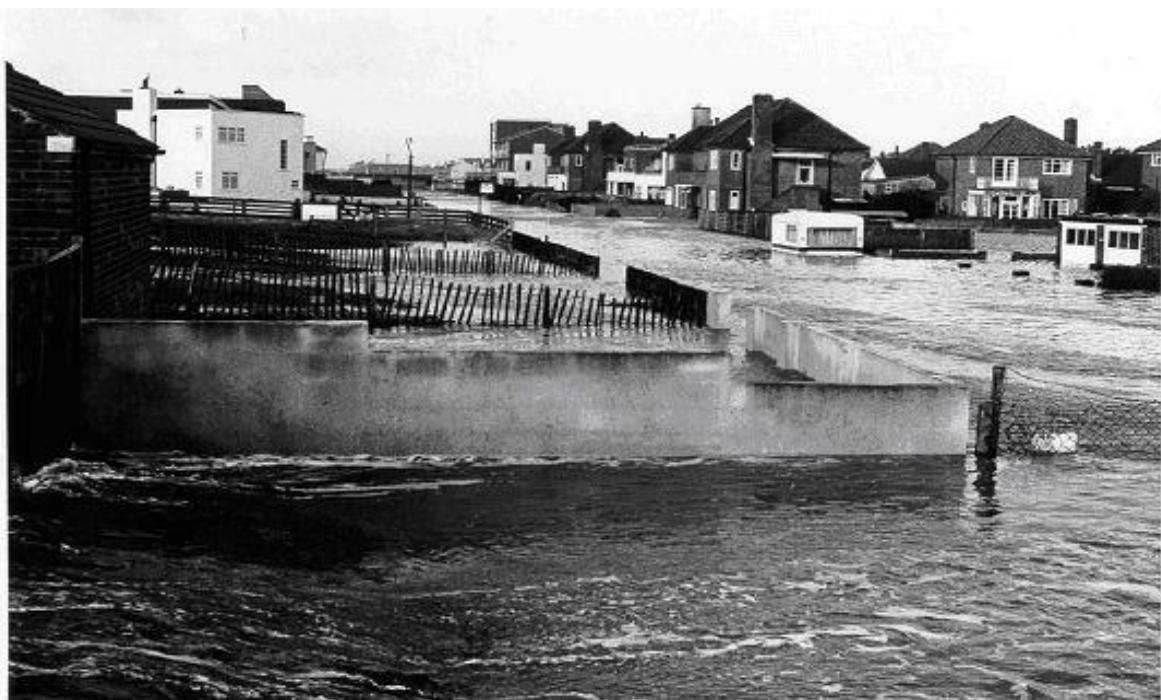
**Plate 1.2 - Storm damage to properties behind the seawall, December 1978.**

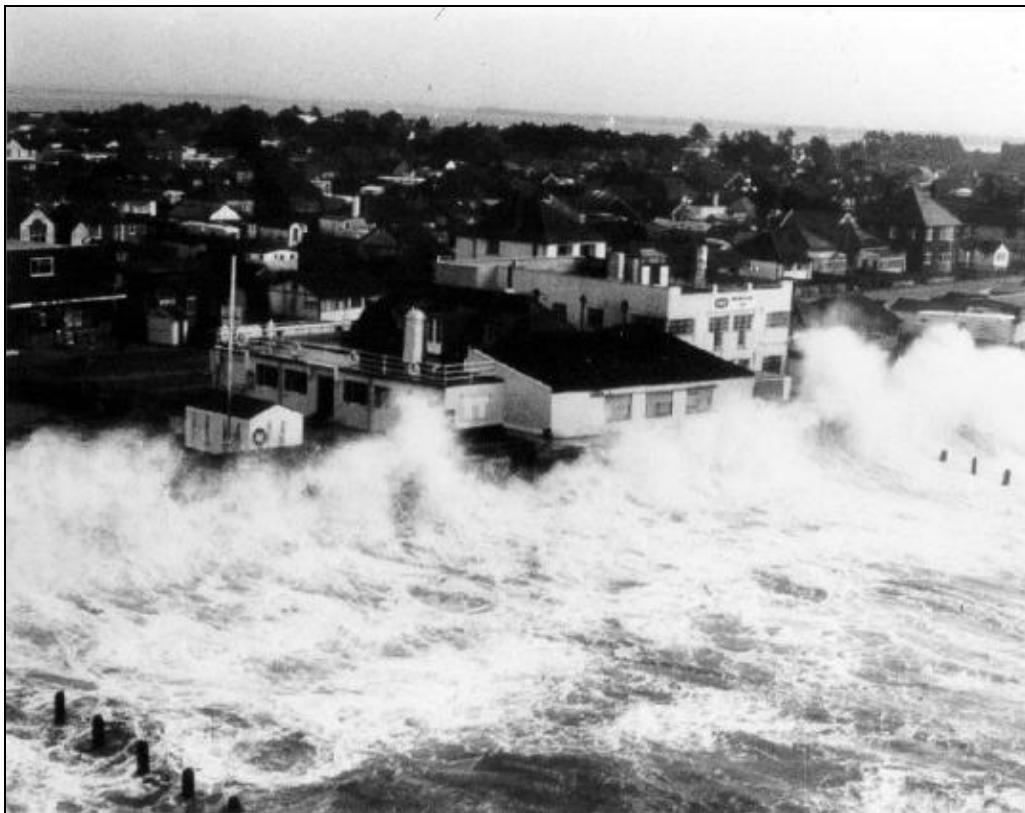
**Plate 1.3 - Wave overtopping adjacent to Creek Road car park, Pre-Beach Replenishment 1985**

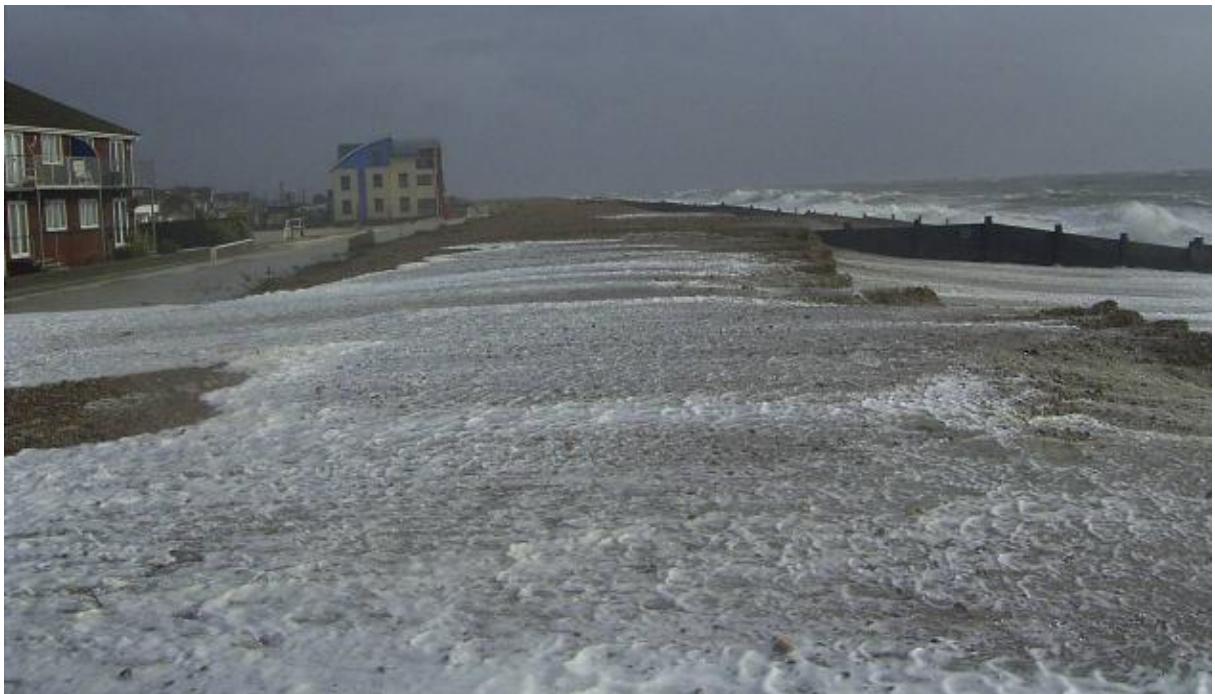
Plate 1.4 – Eastoke Nourished frontage, groyne 19, November 3<sup>rd</sup> 2005.

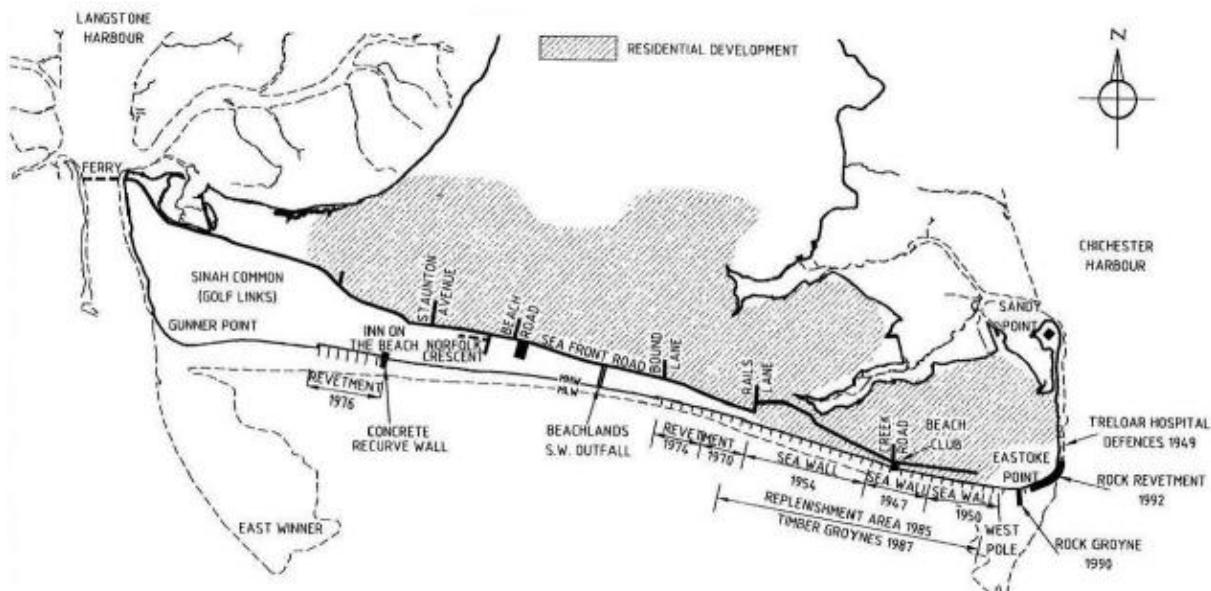
**Figure 1.7 - Historic Construction of Sea Defences Around South Hayling**

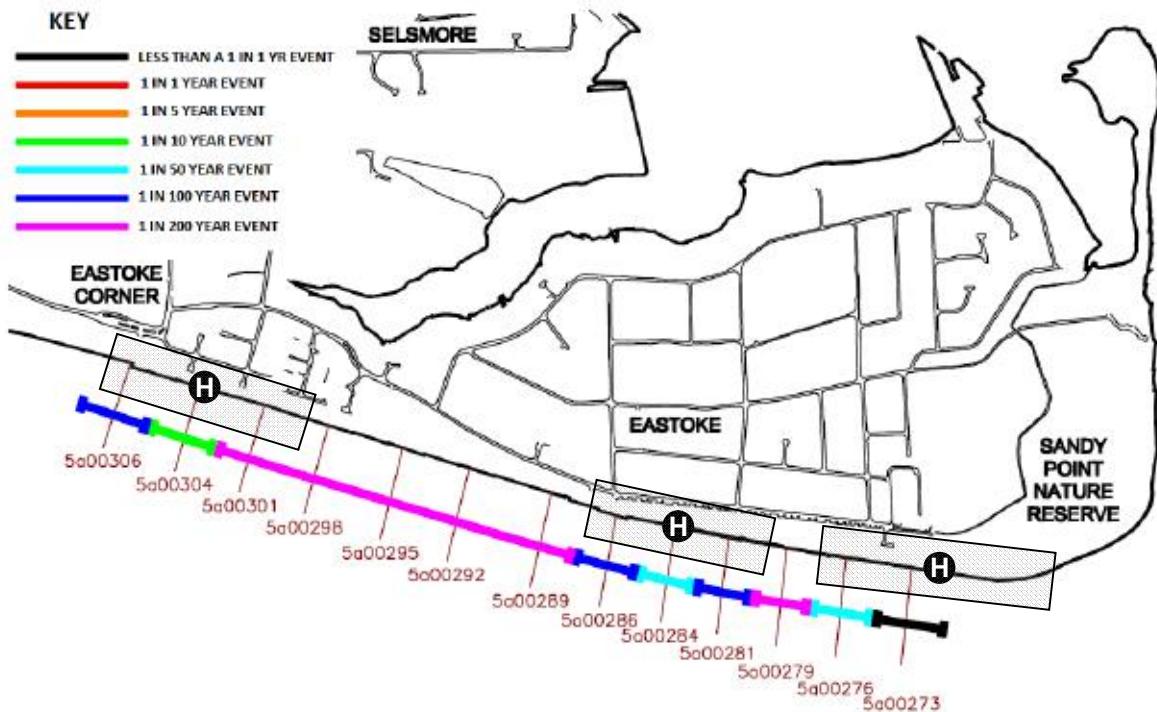
**Figure 1.8 - Current condition of nourished beach, Summer 2012, and corresponding hotspot locations (Section 2.5.3)**

The nourished beach is the primary defence along this section of the frontage and overall the volume of material on the nourished frontage is healthy (Section 2.5.2). There are three key erosion hot spots along nourished frontage where the beach crest is below design standard (Figure 1.8 & Figure 2.12), which are discussed in more detail in Section 2.5.3. The old redundant concrete sea wall is buried under the nourished beach and its condition is largely unknown. The timber groynes constructed in 1987 are generally in good condition, with ongoing maintenance and repairs carried out by HBC.

The section of nourished frontage just east of Creek Road car park is situated over the drift divide. It has proved difficult to maintain the design profile in this area, and the beach is currently below the 1 in 200 year standard of protection before the winter months (Figure 1.8). If the design profile cannot be maintained through annual recycling and recharge alone then further investigations into adjusting the control structures in this area should be carried out.

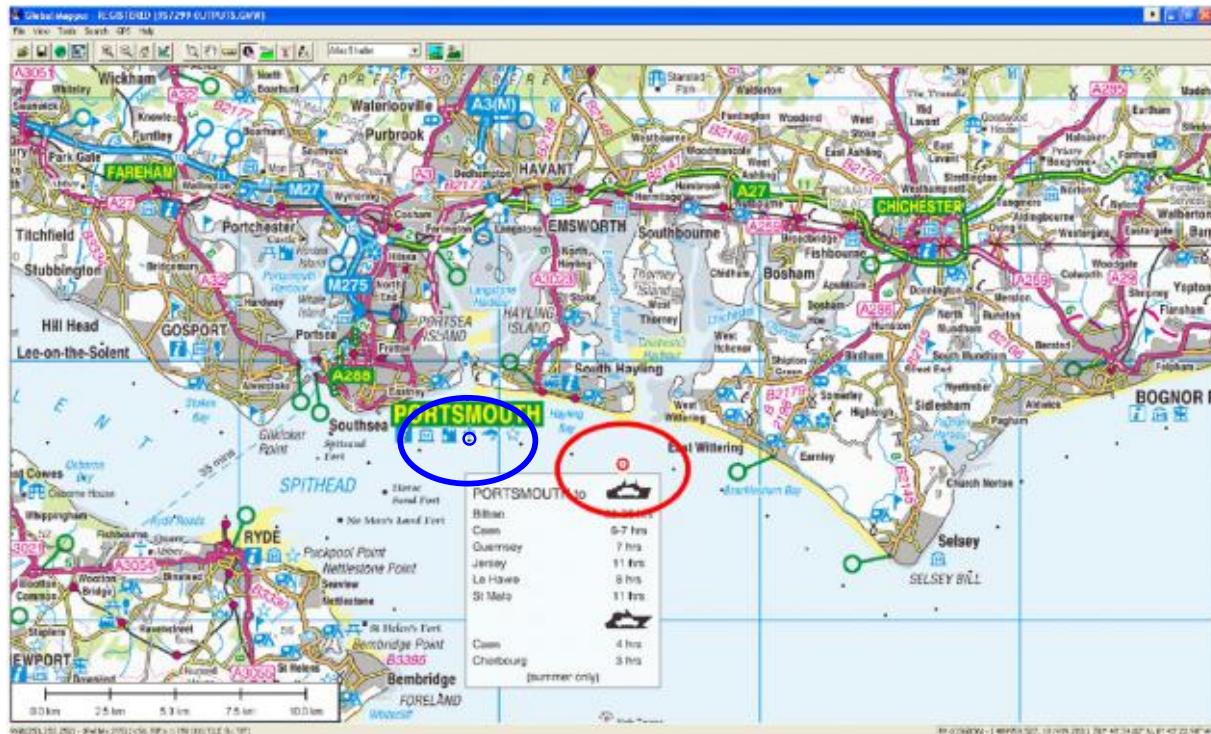
**Figure 2.1- Extreme water level grid Point 4610 (circled in blue) & Point 4604 (circled in red) from Coastal Flood Boundary Conditions for UK Mainland and Islands (Ref 2.5)**

Extreme Still Water Levels are available from the Environment Agency's Coastal Boundary Data project (Ref 2.5). A standard surge curve is also available for use in further analysis. The extreme water levels for the nearest Coastal Boundary Data grid point No. 4604 (Figure 2.1) are presented in Table 2.2. An allowance must be made for sea level rise since 2008 when using the data. The largest positive surge component measured at the nearby Portsmouth tide gauge is 1.16m, recorded on 30<sup>th</sup> October 2000.

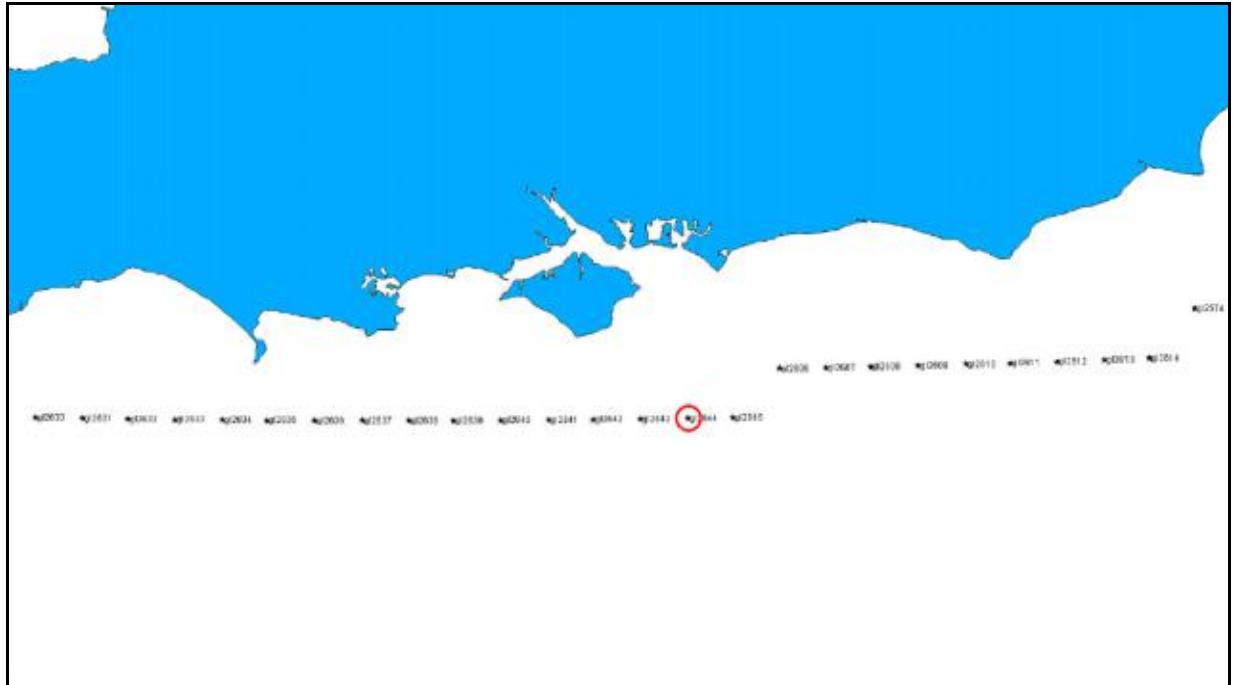
**Figure 2.2 - Coastal Flood Boundary Extreme Swell Grid Point Locations**

The published Best Practice Guidance from "Coastal Flood Boundary Conditions for UK Mainland and Islands (Ref 2.6) has been used to identify the relevant extreme (marginal) swell wave heights. The location of the grid point used is illustrated in Figure 2.2, and the outputs presented in Table 2.3 and Table 2.4.

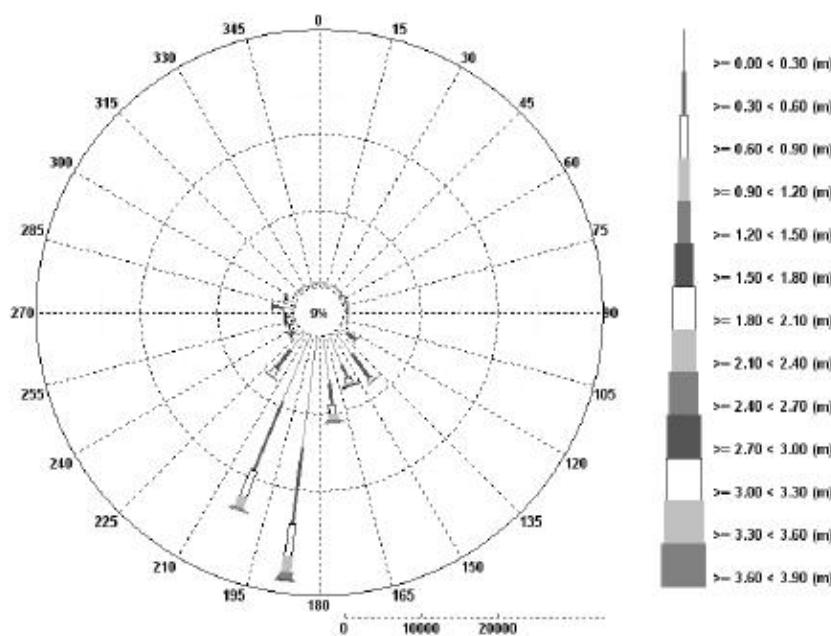
A directional Waverider buoy has been deployed off Hayling Island since July 2003 as part of the Southeast Strategic Regional Coastal Monitoring Programme, summary statistics are presented below (Figure 2.3). The wave rose of  $H_s$  and direction shows a S - SSW dominated wave climate. This matches the predominant SW winds and direction of swell waves refracting around the Isle of Wight. In March 2008 a 3.79m  $H_s$  was recorded (Ref 2.11), and a 3.33m  $H_s$  was associated with severe overtopping on 3rd November. During the November 2005 event long period waves, within a bi-modal wave climate, played a key role in overtopping the nourished beach, with a dominant wave period of over 18 seconds, in combination with a high spring tide and tidal surge.

**Figure 2.3 - Significant Wave Height and direction, Hayling Wave Buoy 01/07/2003 - 31/12/2011**

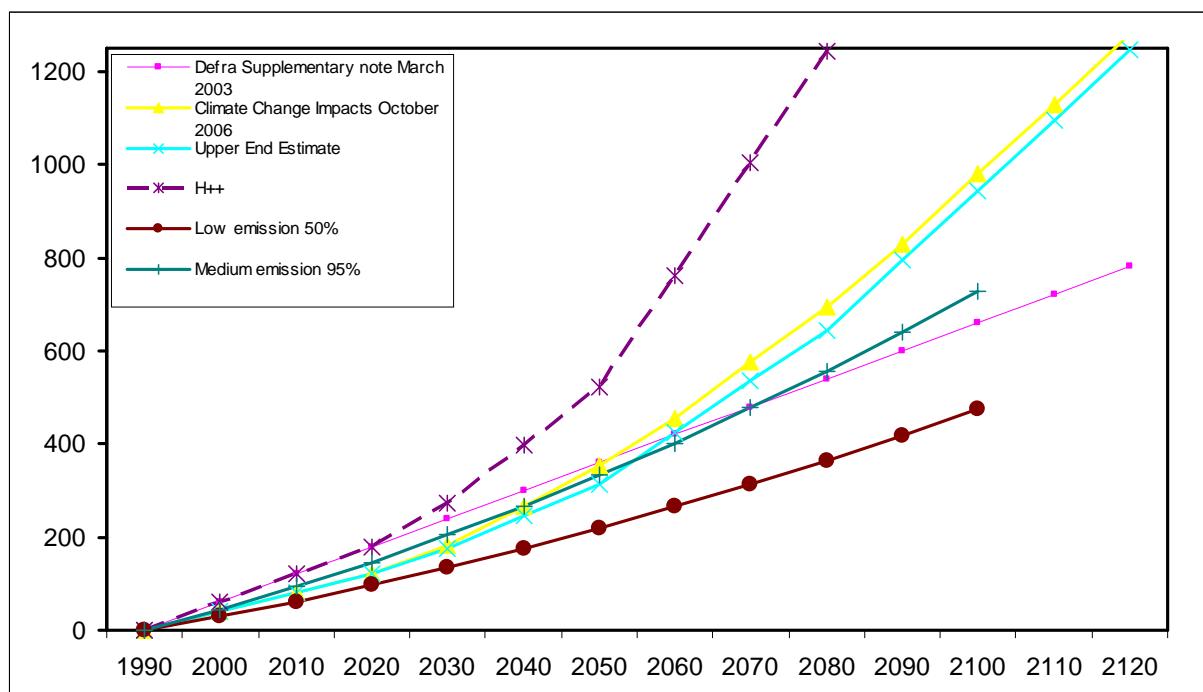
**Figure 2.4 - DEFRA 2003, 2006 & EA 2011 sea level rise predictions**

For the purpose of the BMP, long term sea level rise is secondary as the BMP only covers 5 years ahead where, based on the EA 2011 guidance a 0.027mm increase can be expected. This is within the general error margins of any of the methods employed for the joint return period analysis or beach surveys. However, for completeness the latest figures and previous predictions are compared below (Table 2.2.1 & Figure 2.2.1). For the period of the BMP (2013 – 2017) the rate of SLR predicted over 5 years is within 7mm of the previous DEFRA 2006 allowances.

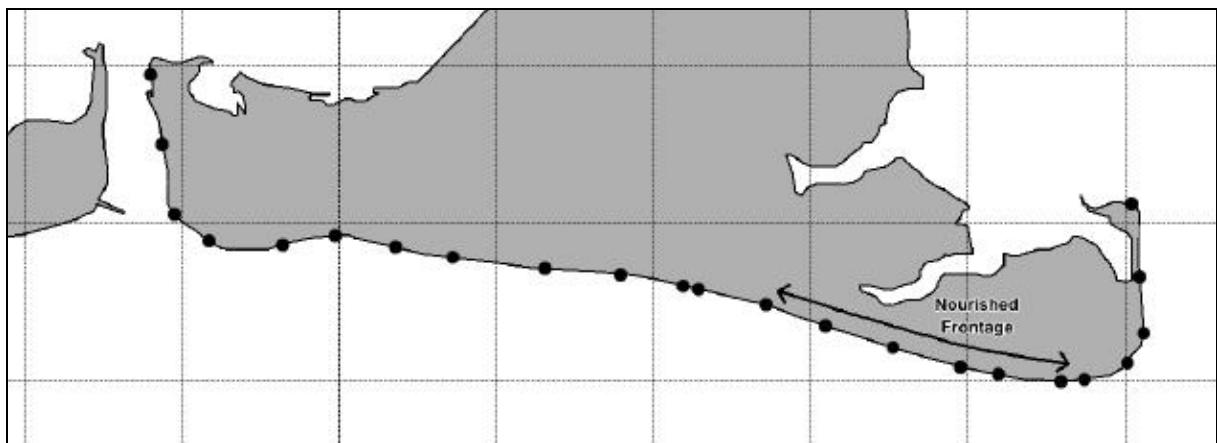
The latest set of sediment samples were collected in 2009, on 23 different profiles around the frontage (Figure 2.5 & Appendix I). Surface samples were collected at the beach crest, MHW, MSL & MLW along each profile.

**Figure 2.5 - Location of sediment samples, Hayling Island**

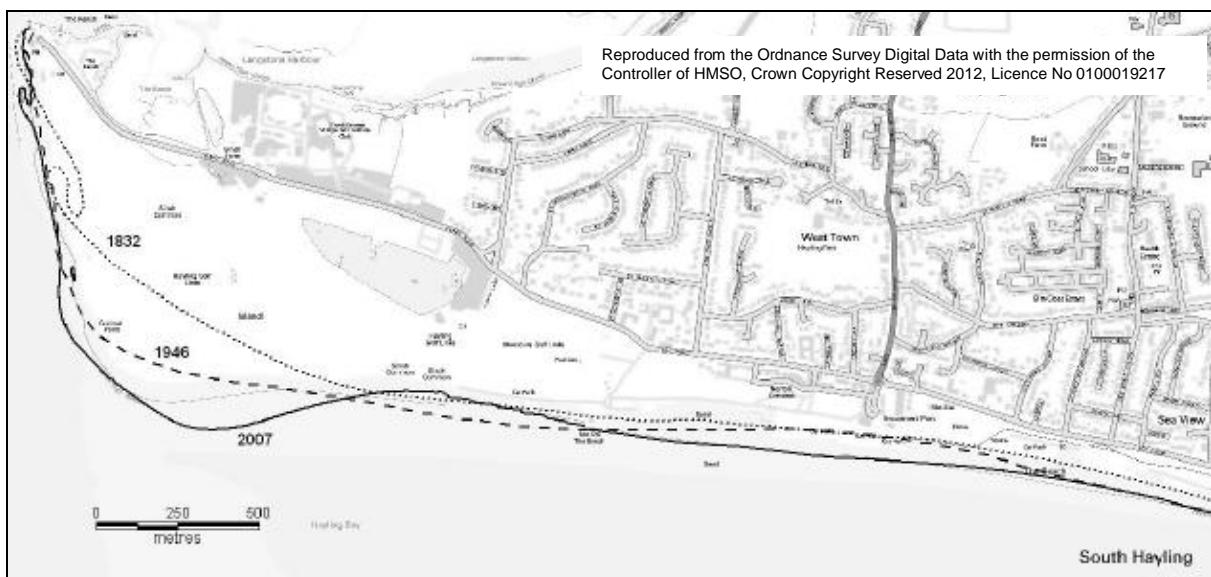
**Figure 2.6 - South West Hayling Island MHW 1832 to 2007**

Several authors have published work relating to the evolution of the shoreline covering the BMP frontage, notable examples include Harlow (Ref 2.16), Whitcombe (Ref 2.9), Webber (Ref 2.17), Wallace (Ref 2.18), Defra (Ref 2.19) and most recently CCO (Ref 2.20). In summary, the present shoreline of the East Solent is a result of very active post-glacial processes of erosion and accretion, increasingly controlled by coastal defences and beach management activities over the last century. Substantial erosion and roll back of the shingle banks has occurred along the eastern frontage of Hayling Island. Concurrent accretion has occurred from the central and western parts of the frontage. This is particularly so at Gunner Point where the shoreline has moved seaward by some 200m over the last century (Figure 2.6), resulting in the development of multiple shingle ridges.

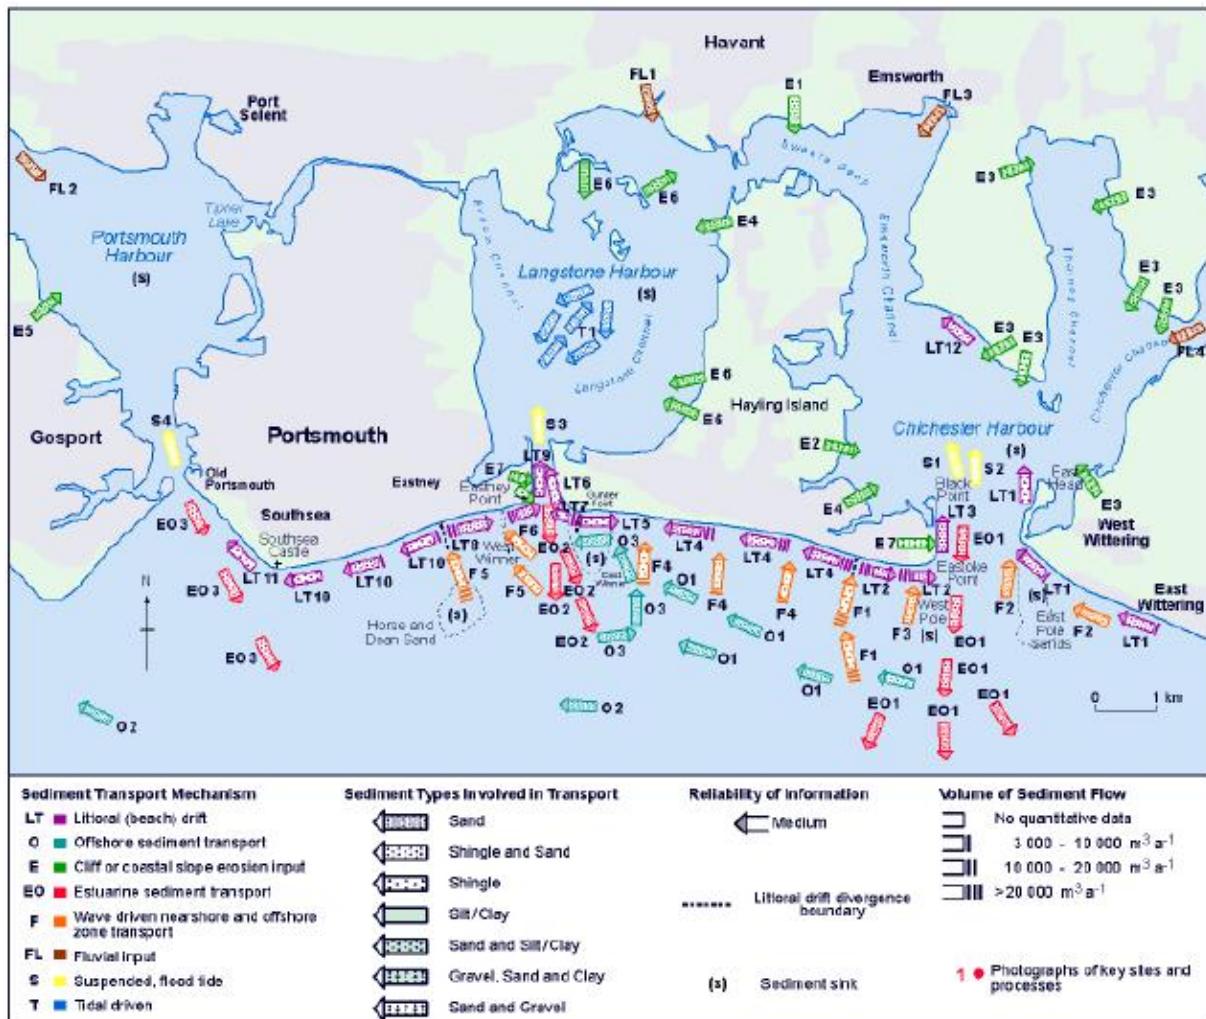
The main sediment transport pathways around the BMP frontage are shown below (Figure 2.7). At present the drift divide and westerly transport at Gunner Point are not present with ongoing tracer studies indicating dominant westerly transport of the upper storm beach. The Hayling open coast has a drift divide located at the centre of nourished frontage, just west of

Creek Road car park, where the natural supply of material onshore (F1, Ref 2.21) is not sufficient to maintain the beach to the required levels.

**Figure 2.7 - Sediment Transport Pathways (Ref 2.21)**

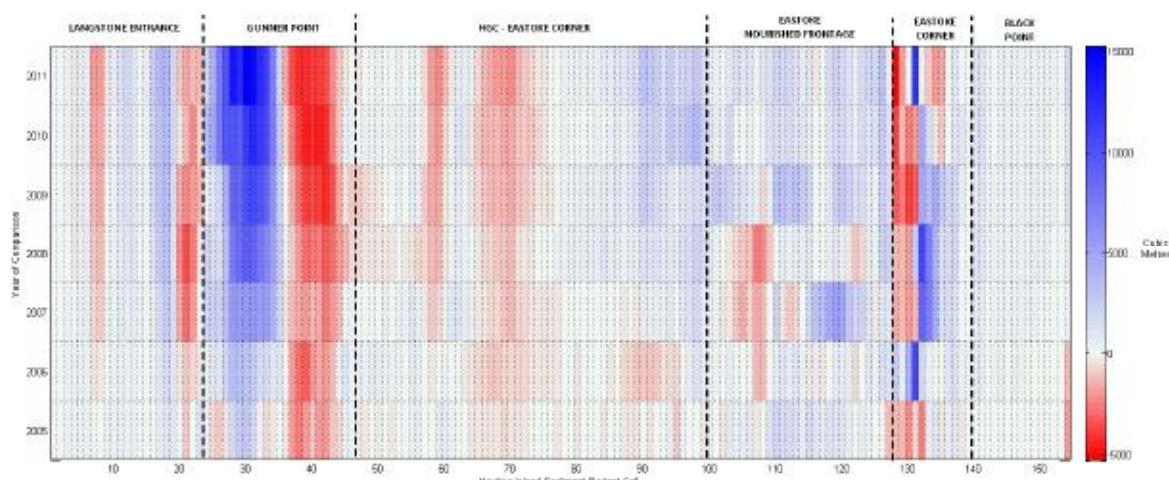
This analysis corresponds well with more detailed sediment budget analysis carried out by the ESCP using GPS walkover data collected annually since 2004. The analysis assesses changes in beach volume above MLWS. Figure 2.8 illustrates the general pattern of erosion and accretion around the South Hayling frontage.

Since 2004 there has been an overall increase in beach volume of 139,870 m<sup>3</sup> around the South Hayling frontage. Taking into account the 179,149 m<sup>3</sup> of recharge material introduced to the system over the same period this indicates an overall net decrease of 39,279 m<sup>3</sup> over the 8 year period. This equates to an average annual loss of 4,920 m<sup>3</sup> around the South Hayling frontage.

**Figure 2.8 - Net volumetric change above MLWS, relative to 2004 baseline survey, based on annual GPS walkover surveys**

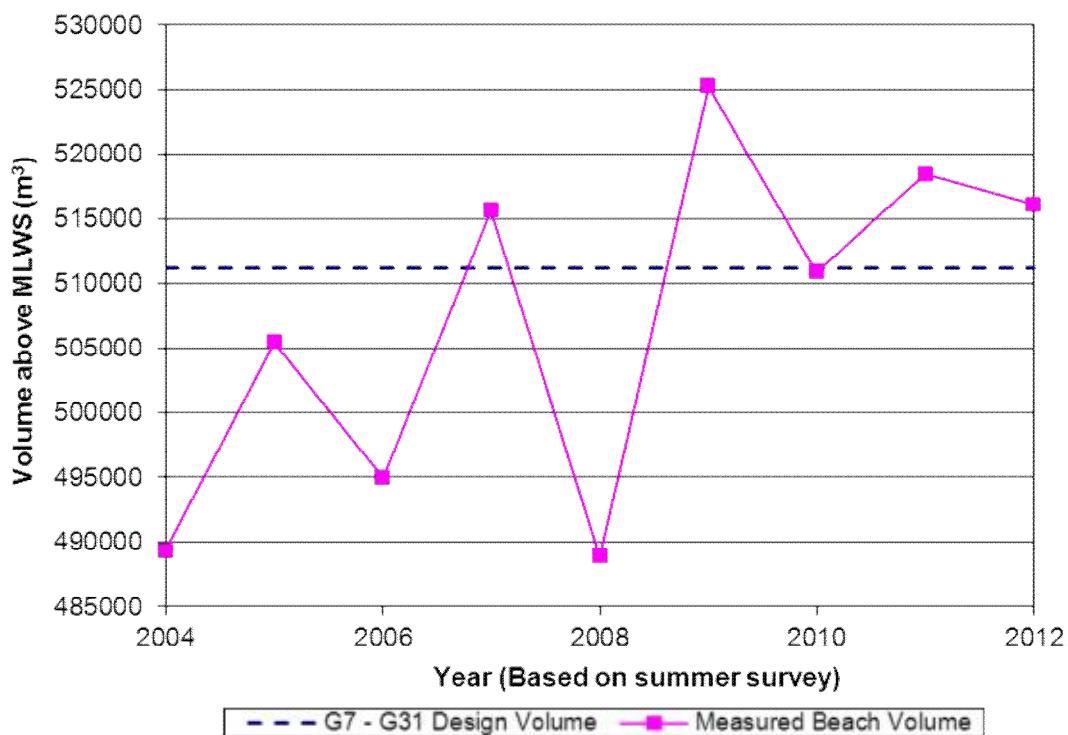
The volume of material on the nourished frontage has increased by 26,760 m<sup>3</sup> over the period of analysis (Figure 2.9). This reflects a concerted effort by HBC to bring the beach up to the design standard following flooding in November 2005. This has included marine-based recharge totalling 166,155 m<sup>3</sup> from 2007 – 2009, and a general increase in the volume of material recycled back onto the Eastoke frontage each March (Appendix J). Expanding out to consider the current extent of the annual recycling operations (Appendix K) the volume of beach has only increased by 23,615 m<sup>3</sup> over the 8 year period. This indicates a slight deficit within the current extraction areas of 3,145 m<sup>3</sup>, although over an 8 year period an annual average net loss of 395 m<sup>3</sup> is within the error bounds of the data being collected in the field.

**Figure 2.9 – Nourished beach volume (G7 – G31) against design volume (Section 3.4) based on annual GPS walkover surveys**
