# SOUTH HAYLING ISLAND BEACH MANAGEMENT PLAN 2017 - 2022

Technical Report

January 2017

<b>Document sub title</b>	<b>Technical Report</b>
<b>Status</b>	<b>Final</b>
<b>Date</b>	<b>January 2017</b>
<b>Project Name</b>	<b>South Hayling Island Beach Management Plan</b>
<b>Author(s)</b>	<b>Samantha Cope (PM) and Emily Last</b>
<b>Client</b>	<b>Havant Borough Council</b>
<b>Reference</b>	<b>SHBMP1722_TechReport</b>
<b>Prepared by</b>	<b>Samantha Cope (PM) and Emily Last</b>
<b>Checked by</b>	<b>Clare Wilkinson (BMA Project Manager)</b>
<b>Date/initials check</b>	<b>CW 20/01/2017</b>
<b>Approved by</b>	<b>Andrew Pearce (PE)</b>
<b>Date/initials check</b>	<b>AP 20/01/2017</b>

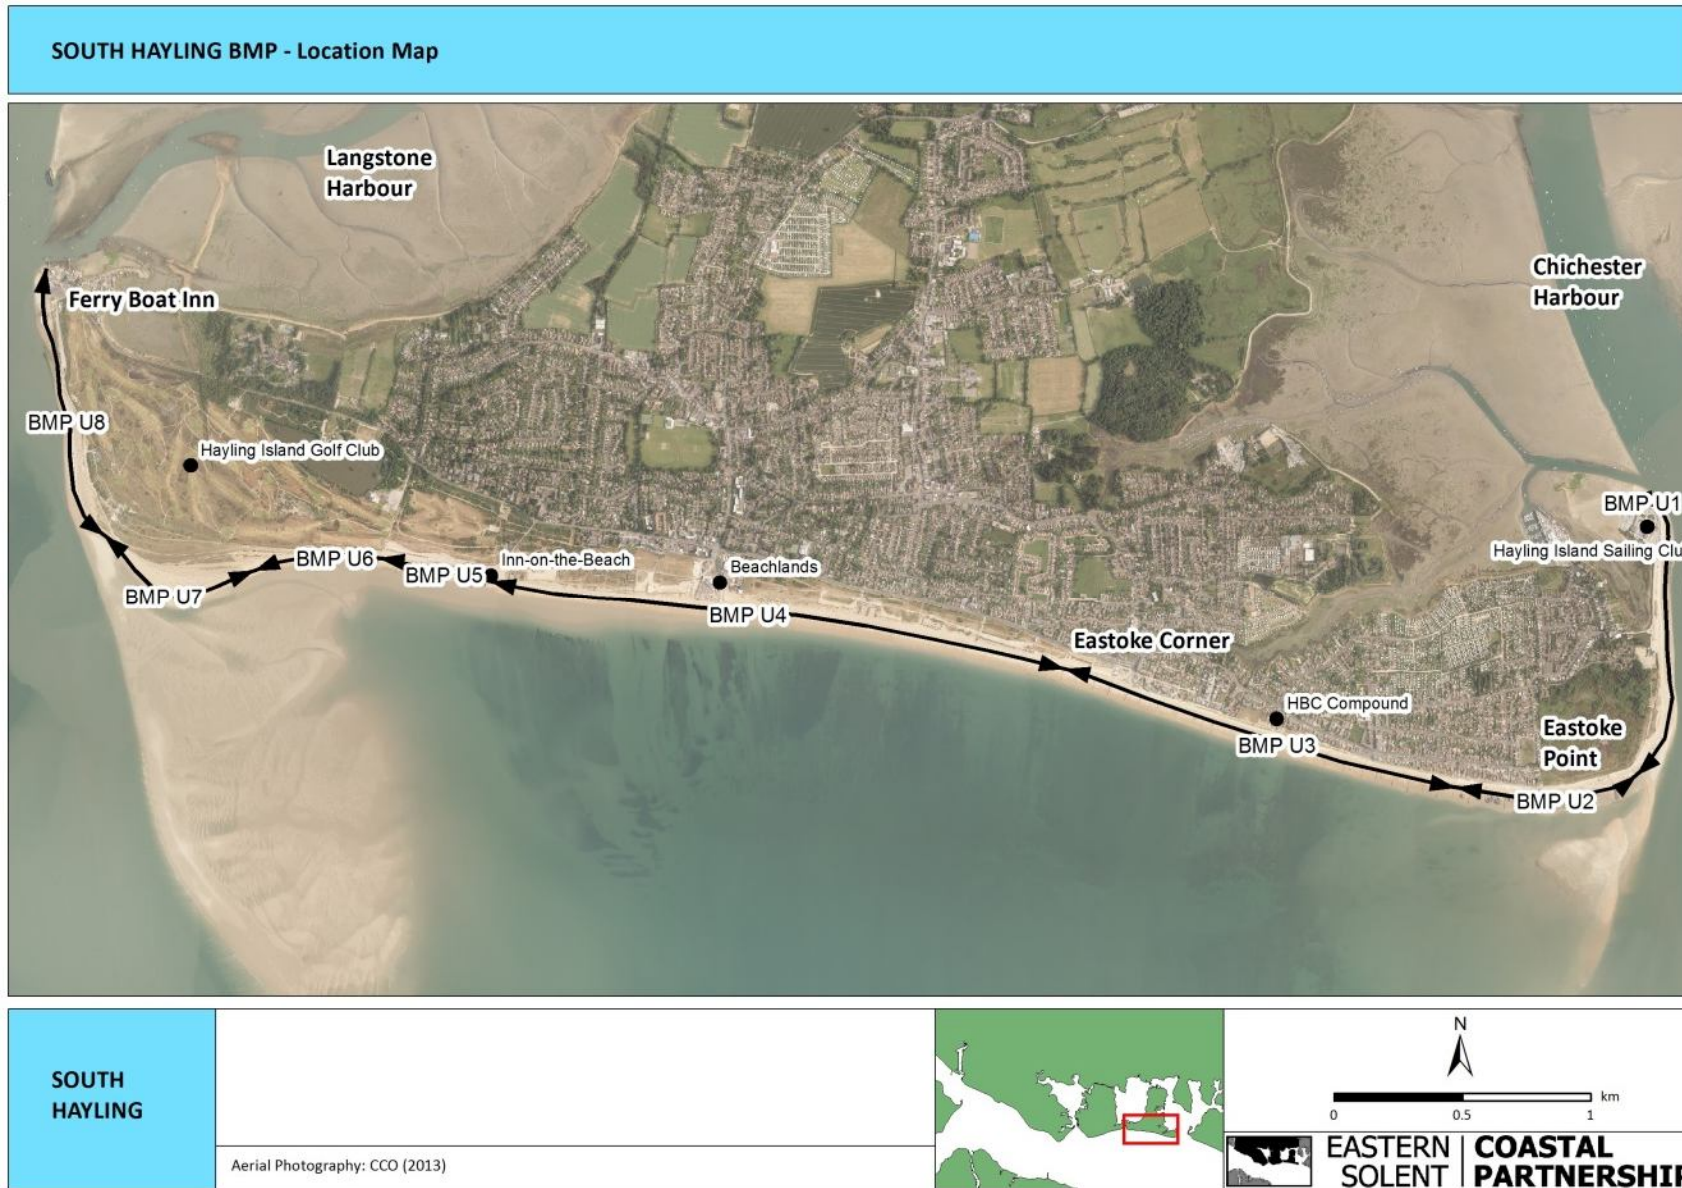
Figure 1.3 Map showing the Management Units to be used for this BMP

This BMP covers the whole southern frontage of Hayling Island, Hampshire, extending from the Ferry Boat Inn in the west to the Hayling Island Sailing Club (HISC) in the east (Figure 1.3). Although the section of beach from Eastoke Corner Car Park to Eastoke Point is the only area which is actively managed by HBC, the impact the nourished material and subsequent recycling operations have on the wider Hayling Island coastline necessitate a BMP covering a wider area. The length of the managed frontage is 2.2km of the 8.3km Southern Frontage.

The previous BMP used the SMP 1 Management Units (MUs) as boundaries, which divided the coastline into seven units. Since 1995, the coastline has altered in terms of areas of accretion and erosion, such that 8 new units have been created for this BMP revision as shown by Figure 1.3. The boundaries for the BMP units (BMP Us) are based on the current management approach, and are influenced by a range of factors including coastal processes, existing structures and land ownership (Figure 1.4). A summary of the key features in each BMP Management Unit in Figure 1.3 is shown in Table 1.1.

There are no nourishment works currently planned outside of BMP U2 and BMP U3 (Figure 1.3), only a haul route to be maintained in front of the Hayling Island Golf Club driving range in BMP U6 if recycling from Gunner Point (BMP U7) is permitted by the landowner (Figure 3.1). Allowing the nourished material to travel further along the frontage before recycling it back to Eastoke benefits the wider South Hayling frontage, as opposed to trapping the material on the nourished frontage and starving the adjacent sections of coastline. As such there is no scheme design for the wider frontage as there are few assets at flood and erosion risk, rather efforts will be made to minimise any impact of the ongoing Beach Management Activities on these areas. Table 3.1 refers to the definitions of recycling and recharge in the context of this BMP.

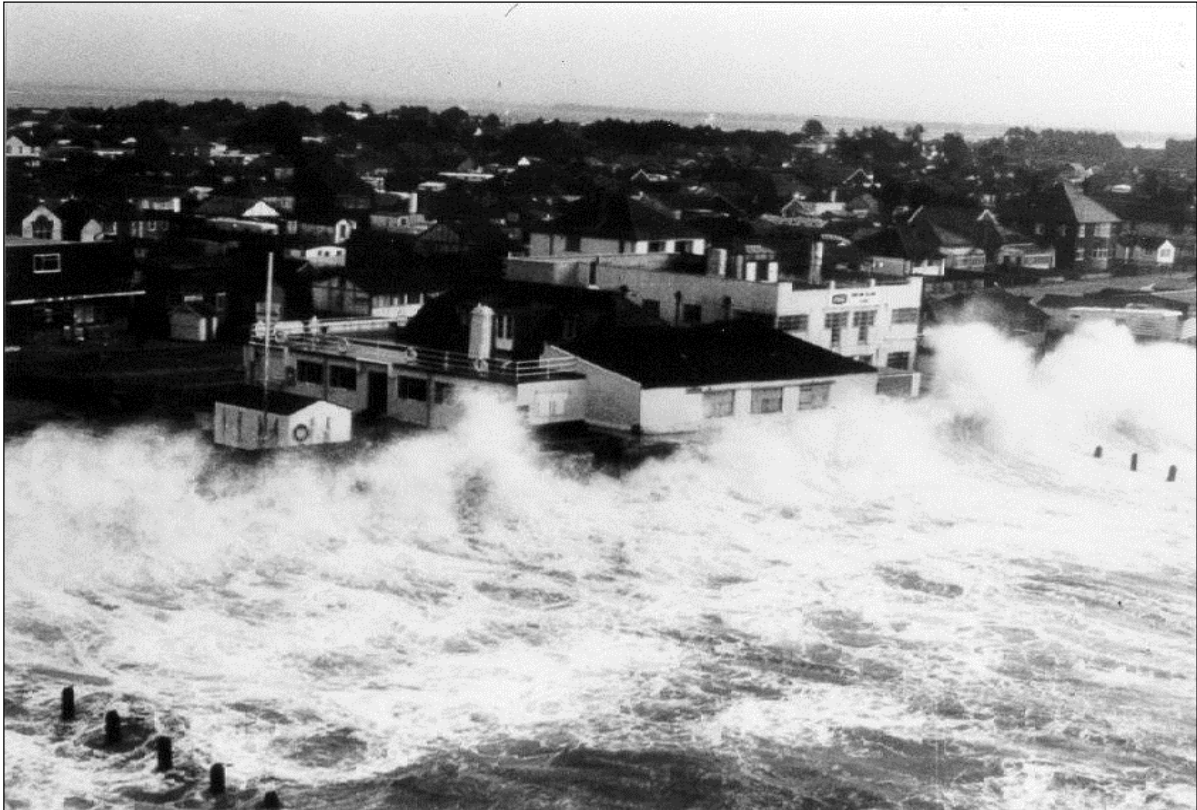
**Plate 1.3 Wave overtopping adjacent to Creek Road car park, pre Beach Replenishment 1985**

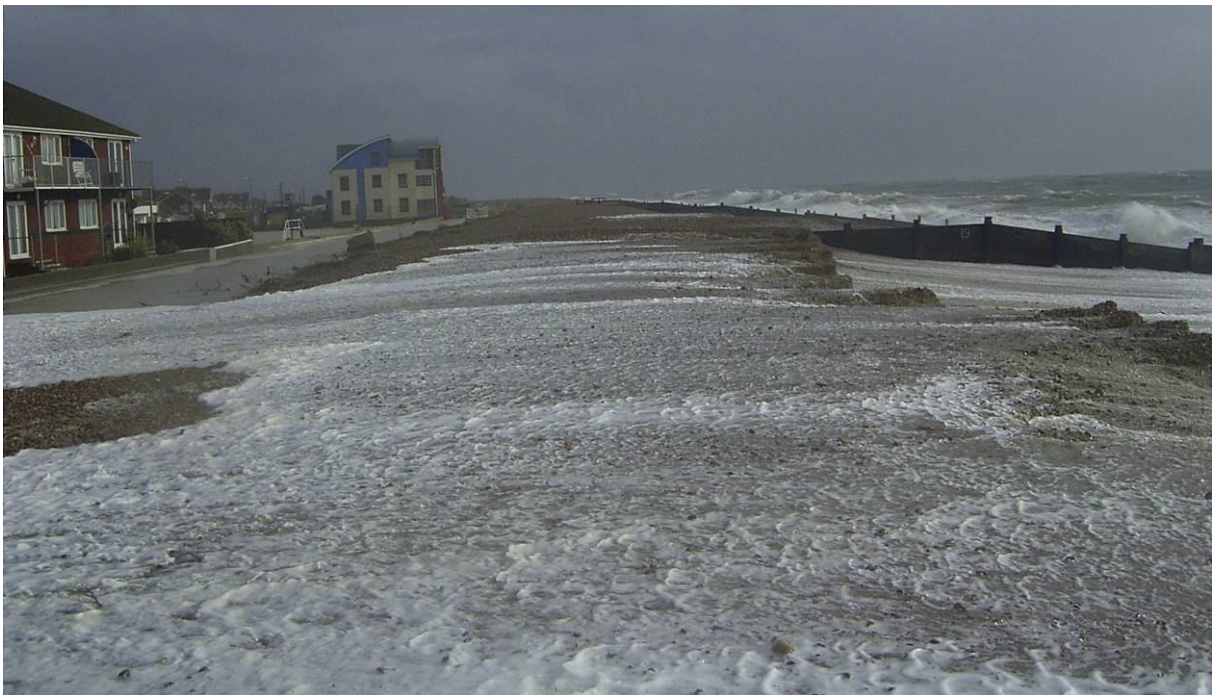
**Plate 1.4 Eastoke Nourished frontage, groyne 19, 3<sup>rd</sup> November 2005**

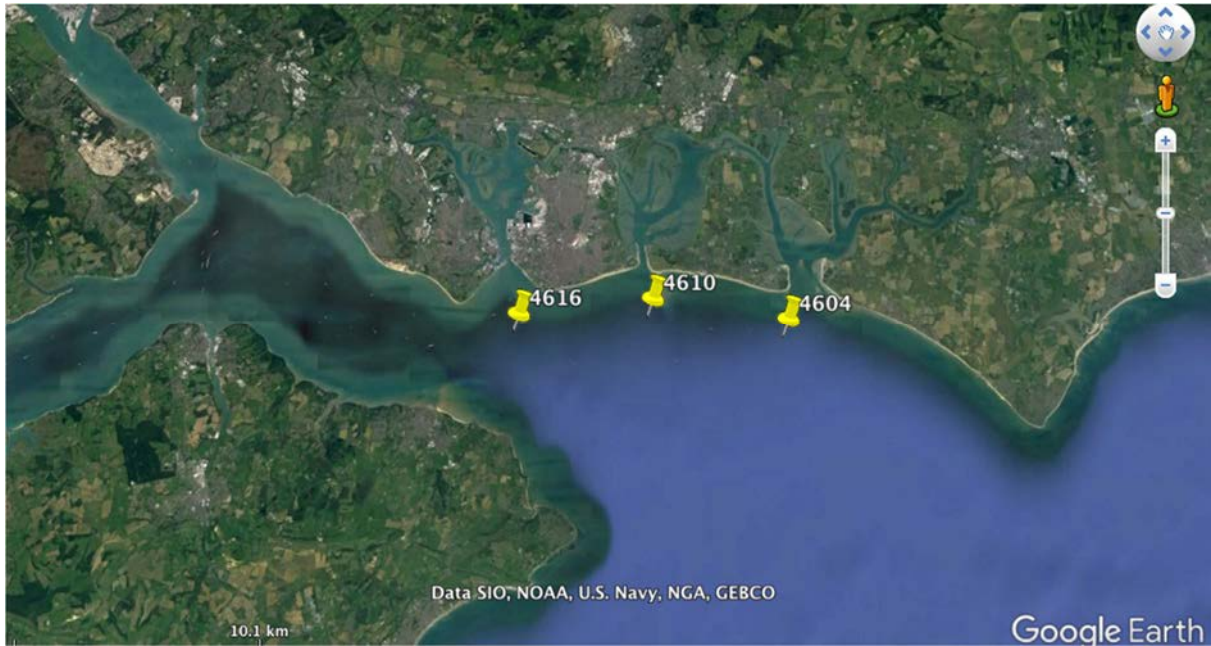
**Figure 2.2 Extreme water level grid points 4616, 4610 and 4604 from the Extreme Sea Level study within the EA’s Coastal Flood Boundary Conditions for UK Mainland and Islands guidance (Ref 2.5)**

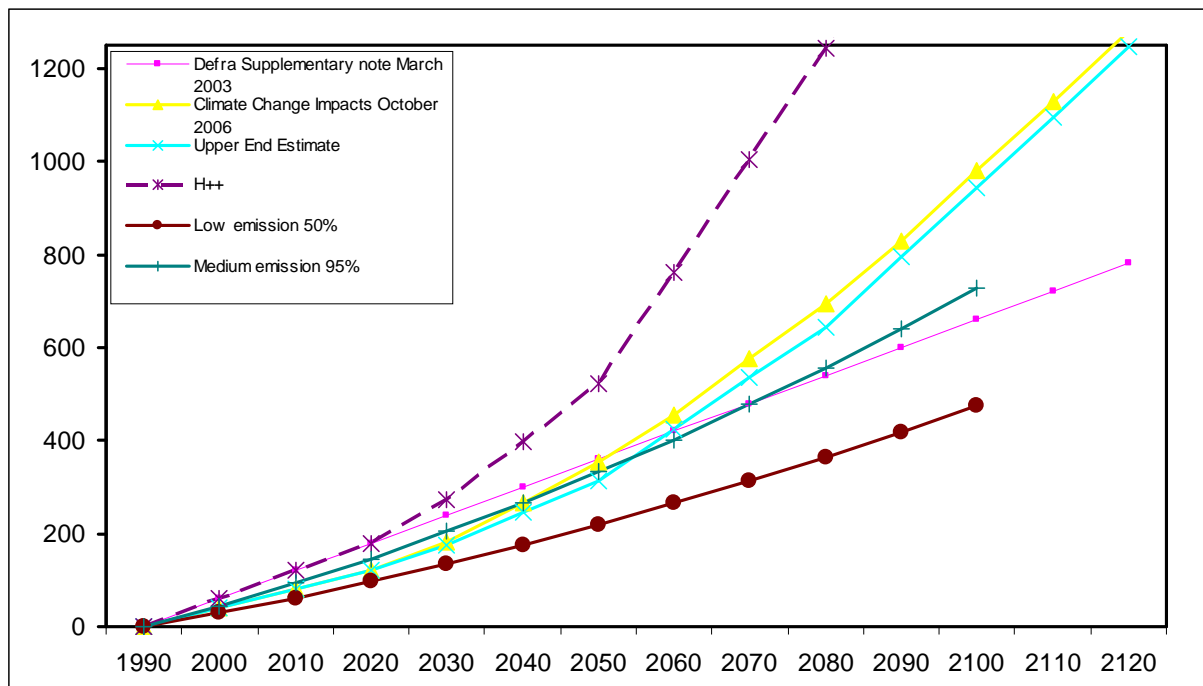
**Figure 2.6 DEFRA 2003, 2006 and EA 2011 sea level rise predictions**

predictions are compared below (Table 2.9 and Figure 2.6). For the period of the BMP (2017 – 2022) the rate of SLR predicted over 5 years is within 7mm of the previous DEFRA (Department of Environment, Food and Rural Affairs) 2006 allowances.

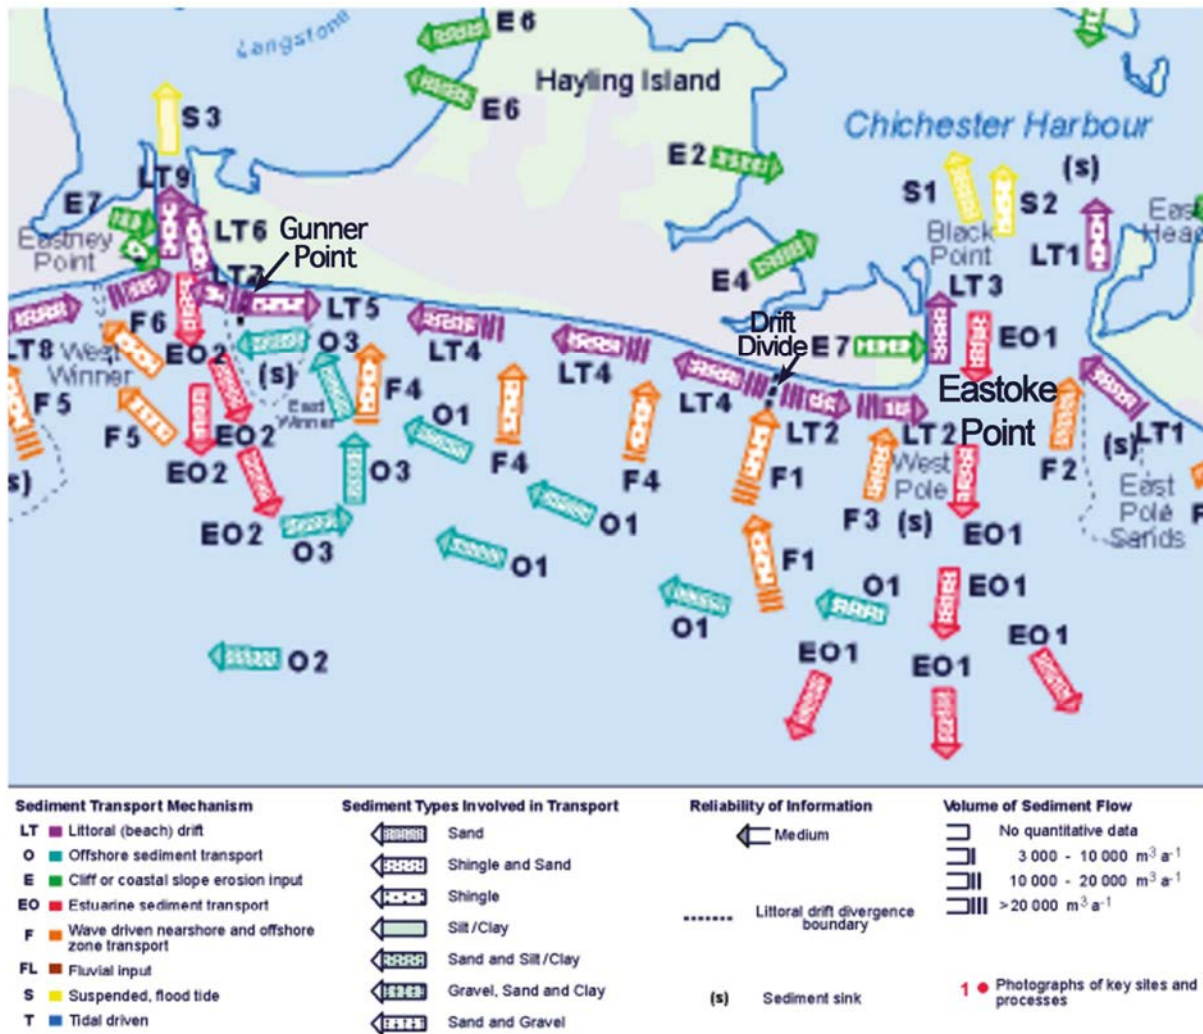
Figure 2.9 Sediment Transport Pathways (adapted from Ref 2.21)

The Hayling open coast has a drift divide located at the centre of the nourished frontage, close to Creek Road car park, where the natural supply of material onshore (F1, Figure 2.9) is not sufficient to maintain the beach to the required levels. Beach sediment is transported both east and west off the nourished frontage at the drift divide by wave action.

A number of studies have investigated the geomorphology and sediment transport around the Hayling coastline, and the adjacent Chichester Harbour tidal inlet, covering both pre- and post-nourishment periods. The SCOPAC Sediment Transport Study (Ref 2.21) provides a review of the available research up to 2004. Further detailed studies have been carried out by the Eastern Solent Coastal Partnership to improve the understanding of sediment transport from the nourished Eastoke frontage and around the wider frontage. The main sediment transport pathways around the BMP frontage are shown below (Figure 2.9).

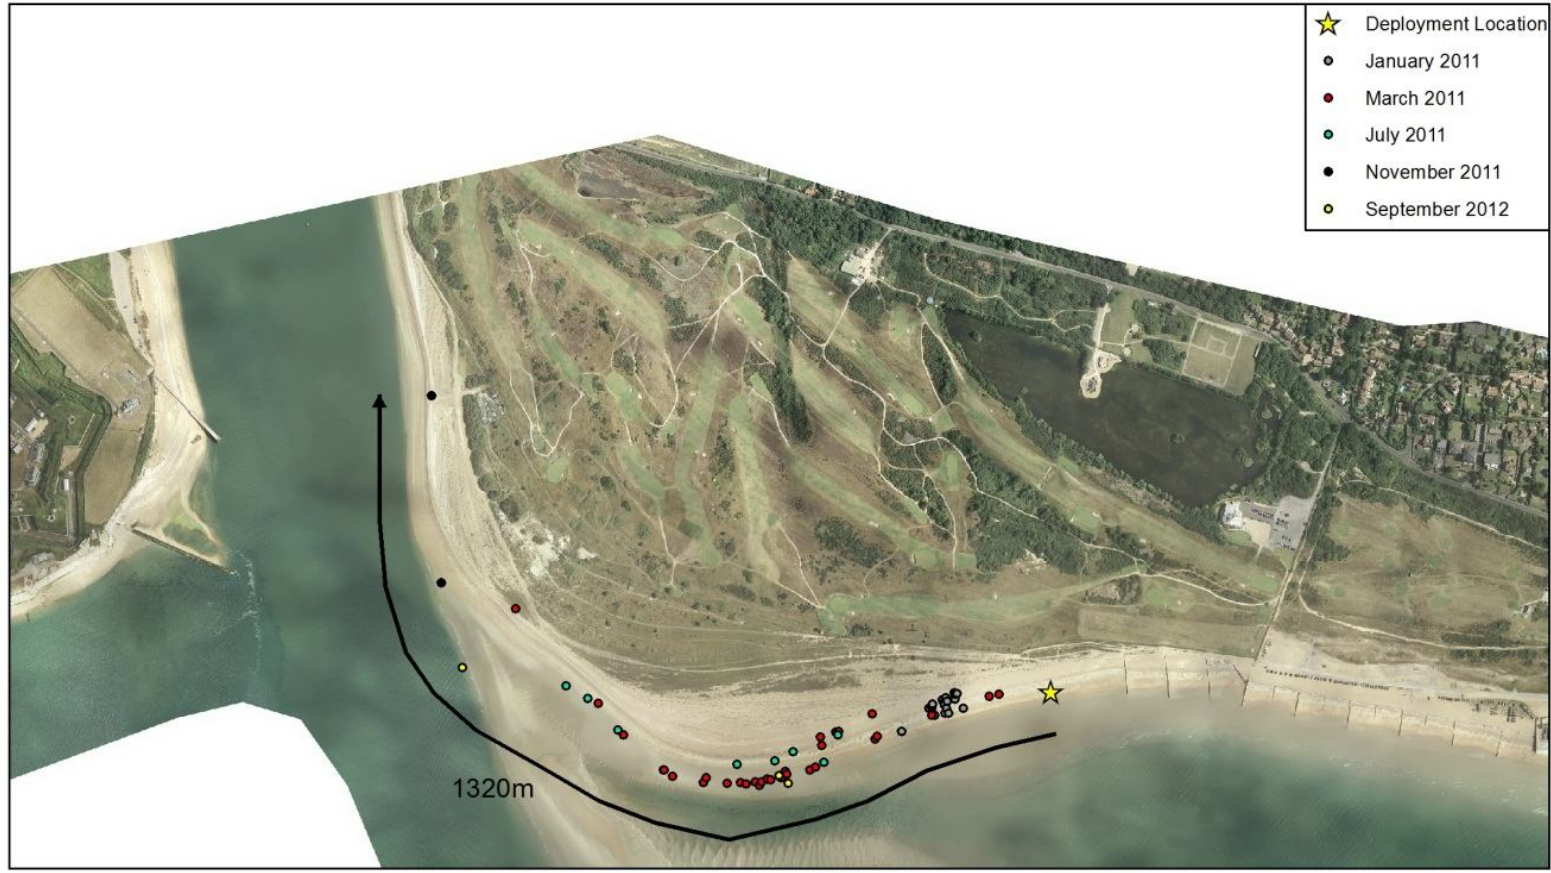
Figure 15. Pebble Movement: Gunner Point deployment 2

Figure 2.11 Results of the Tracer Study (Ref 2.35) for Gunner Point deployment (pebbles deployed in January 2011)

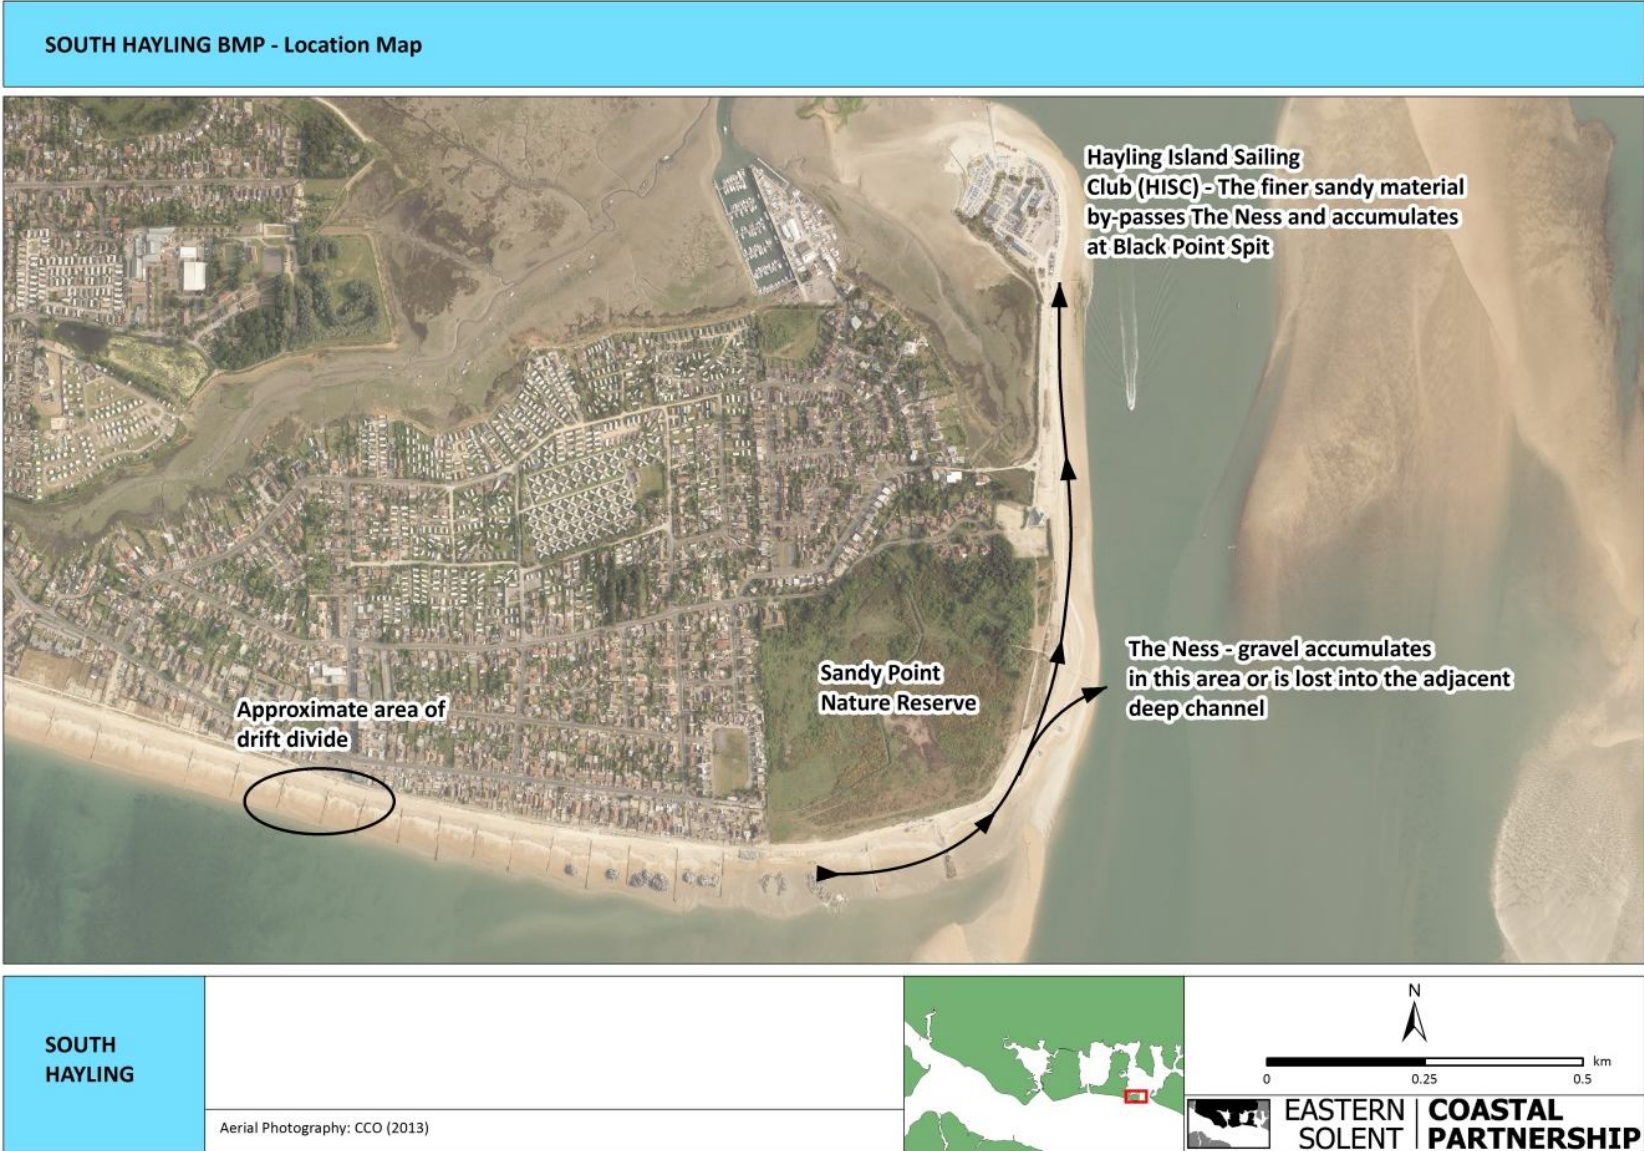
Figure 2.12 The sediment drift around Sandy Point and Black Point Spit

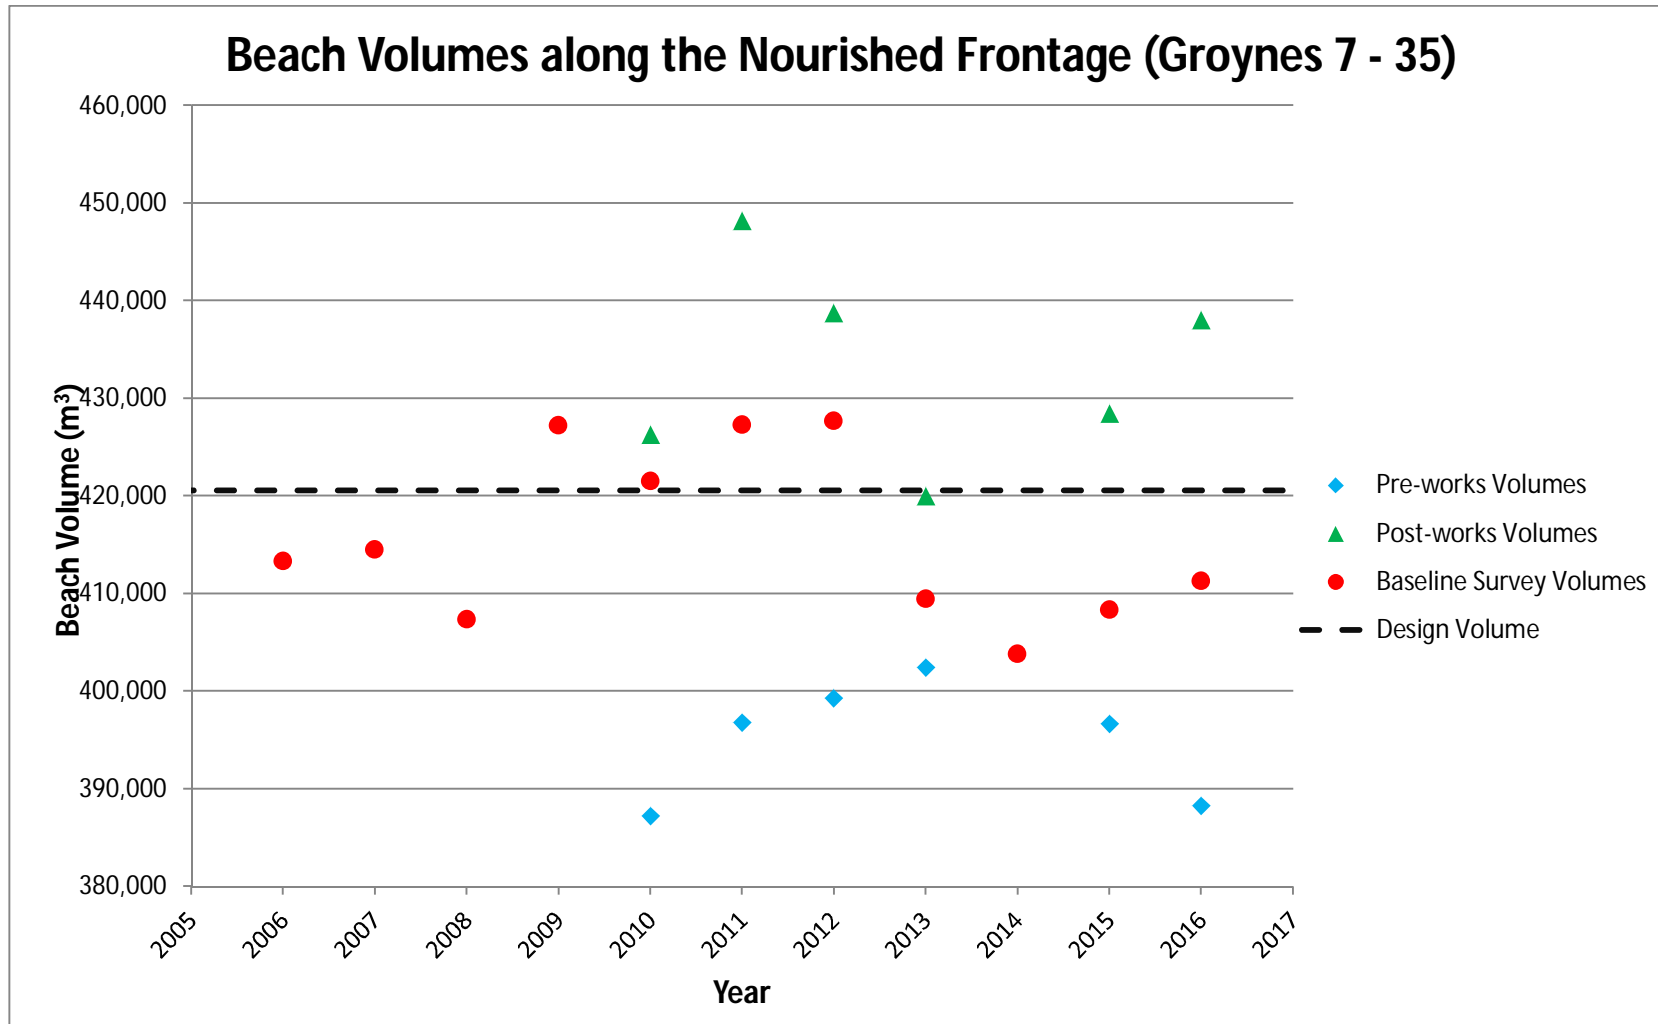
**Figure 2.16 Eastoke beach design volume graph. Pre-works volume and post-works volume are beach volumes extracted from topographic surveys before and after Beach Management Activities. Baseline survey volumes are beach volumes extracted from summer topographic surveys. All surveys are clipped to a common area between 2006 and 2016; volumes are above MLWS and the design volume is based on a 1 in 200 year SoP.**

Two separate beach surveys, 'in' (pre-recycling) and 'out' (post-recycling), are typically undertaken for every beach recycling operation. This will be used to establish the volume of material required along the nourished frontage before each operation and to build up a long-term picture of losses along the frontage after the works are completed. Where possible, these surveys should reach Mean Low Water Springs to allow comparison with other surveys and to update the design profile graph (Figure 2.16).

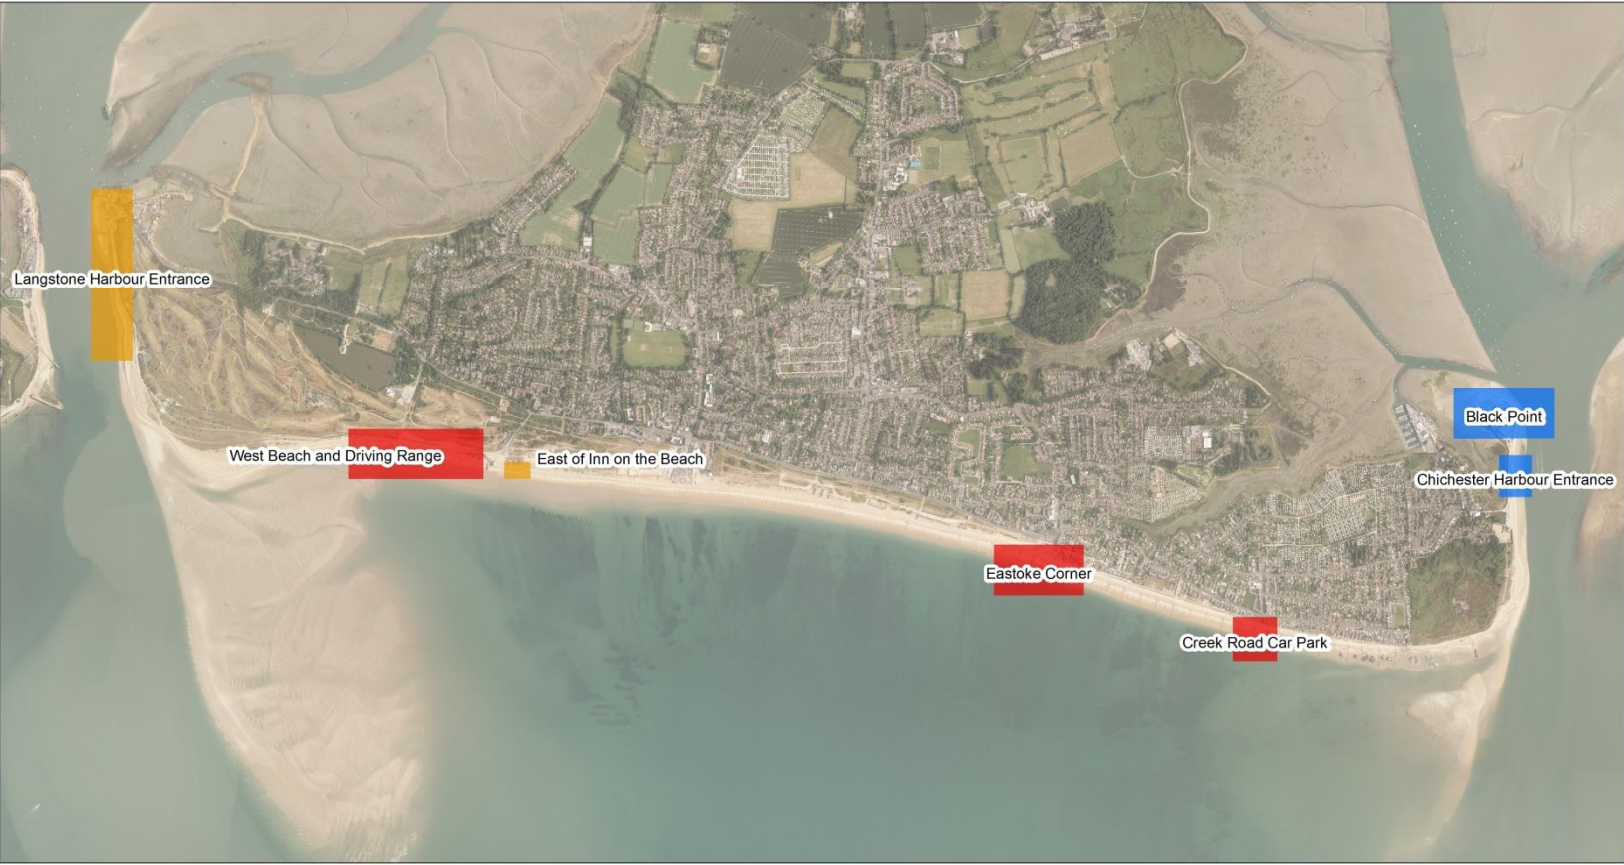
- Erosion Hotspot
- Erosion Watchspot
- Other issues

**Figure 2.20 Erosion hotspots, erosion watch spots and other issues**

Figure 2.20 shows the location of all the erosion hot spots (current issues), watch spots (potential issues) and other issues around the South Hayling frontage. These are discussed in more detail below.

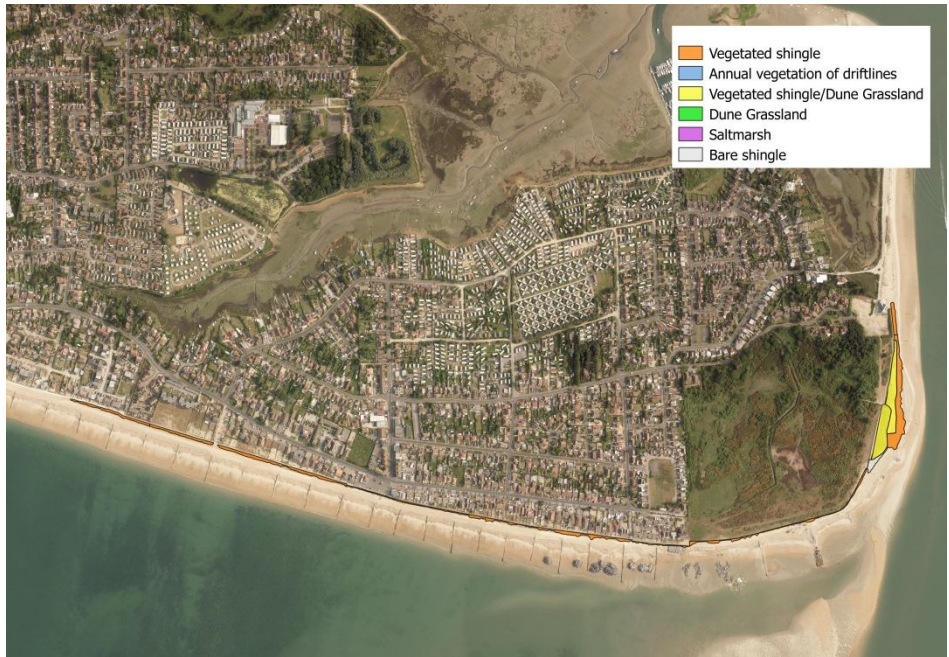
**Figure 2.21 Habitats on the Hayling Frontage – Eastoke, Sandy Point and Black Point Spit**

To provide a baseline, a vegetated shingle survey was undertaken in 2016 to establish the extent of the habitat types; *Perennial Vegetation of Stony Banks* and *Annual Vegetation of Drift Lines*. This survey covered the entire frontage and recorded distinct compartments with species level information. Figures 2.21-2.24 show the current extent of habitats based upon the 2016 survey. Figure 4.1 and Figure 4.2 indicate the areas for ongoing surveys and monitoring and the ecological restrictions that will be applied within each area to mitigate against harm to the various ecological sensitivities.

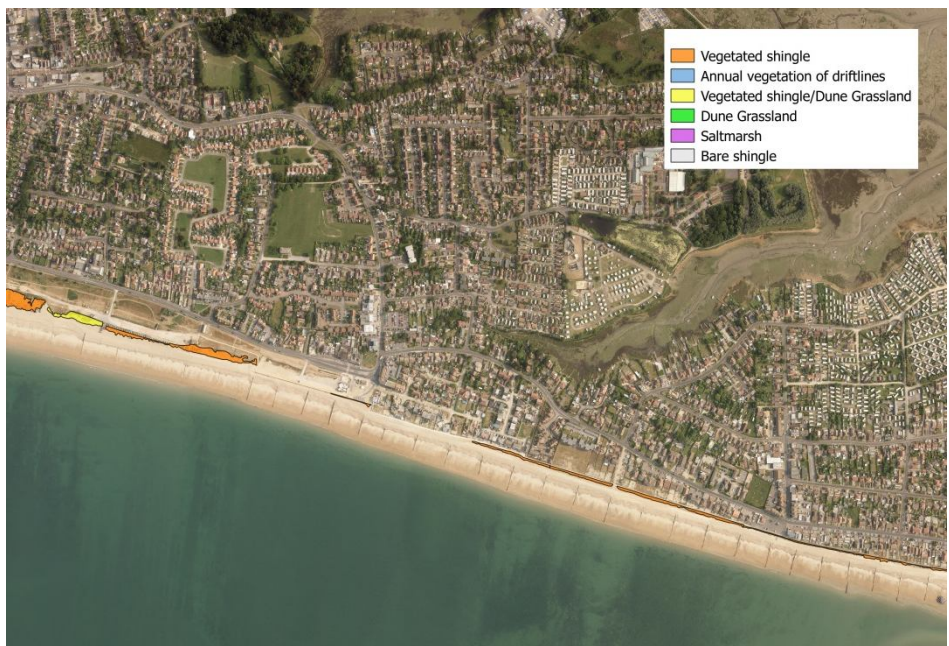
**Figure 2.22 Habitats on Hayling Frontage- Eastoke Corner**

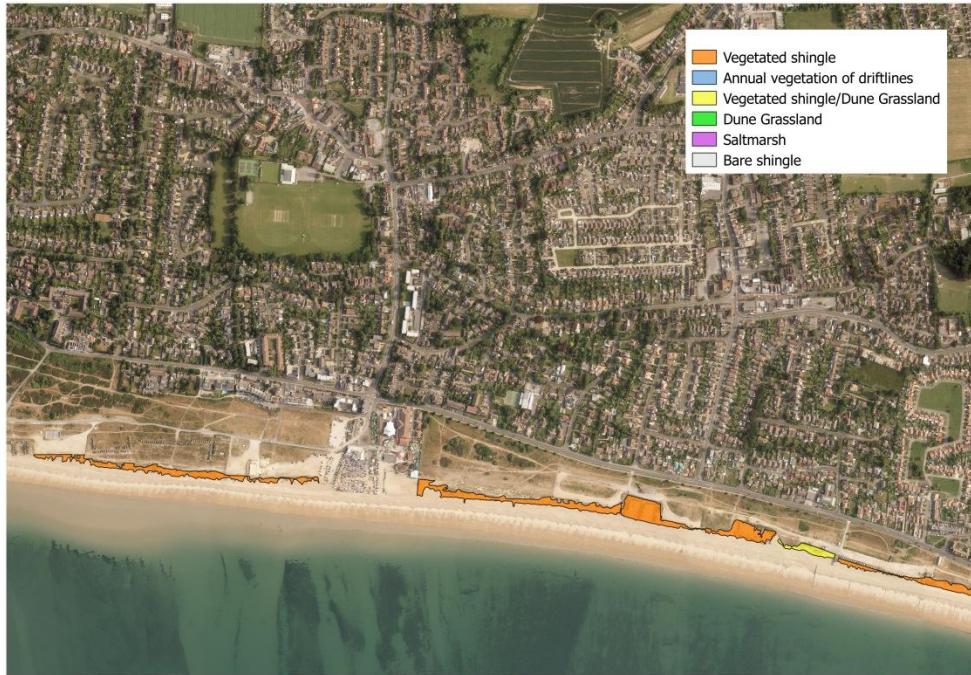
**Fig 2.23 Habitats on Hayling Frontage- Beachlands**

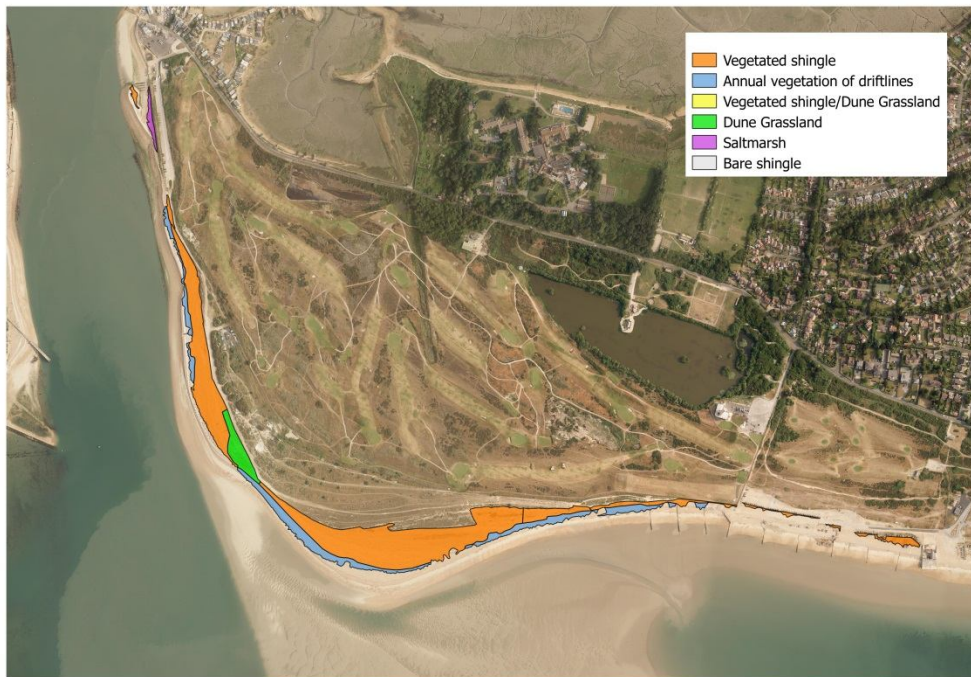
**Figure 2.24 Habitats on the Hayling frontage – Gunner Point, West Beach and Langstone Harbour entrance**

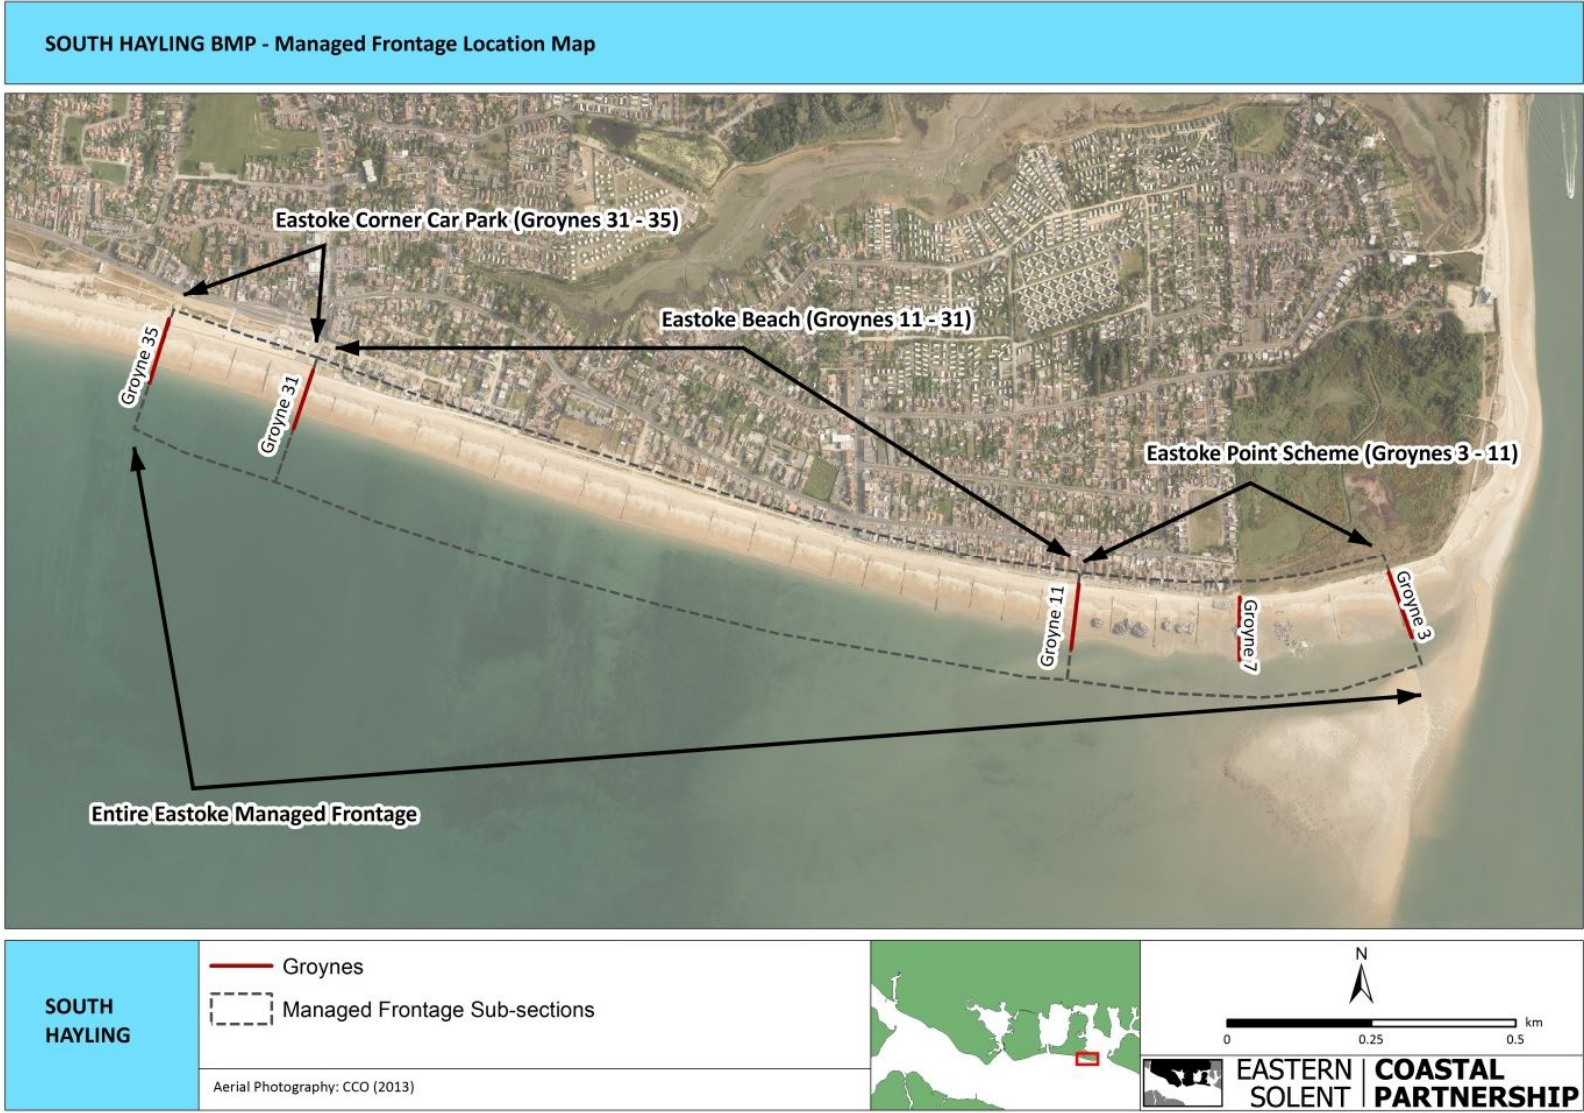
**Figure 3.3 Eastoke Managed Frontage**

In summary, the managed frontage is now broken down into three sections depicted in Figure 3.3:

- Eastoke Point Scheme (Groynes 3 – 11)
- Eastoke Beach (Groynes 11 – 31)
- Eastoke Corner Car Park (Groynes 31 – 35)

nourished frontage. A summary of the individual design profiles is tabled in Appendix D. The +5.6mOD design profile is recommended between Groyne 11 to Groyne 35 given the properties and infrastructure at risk (Figure 3.3). East of groyne 11, the design profile is lower at a crest height of +4.6mOD where it intersects with the rock 1m below the crest and a slope of 1 in 12 (Ref 3.9 – Figure 3.3 and Figure 3.9). Rather than add an additional requirement for material east of Groyne 7 for the Eastoke Point scheme, this current BMP will work on the assumption material is being transported east, thereby feeding Eastoke Point before being transported to The Ness and West Pole Sands in Chichester Harbour where it can be recycled back into the system. **However, there is a recommendation that the beach levels at Eastoke Point continue to be monitored and if necessary, will require additional material to be brought in.**

A theoretical design volume of 652,831m<sup>3</sup> has been calculated for the managed frontage (Groyne 3 – Groyne 35) which includes the 5.6m design profile height between groyne 11 – 35 and a 4.6m design profile height between groyne 11 - 3 (Figure 3.3). The design beach surface was generated from the design profiles along the nourished frontage. The volume of

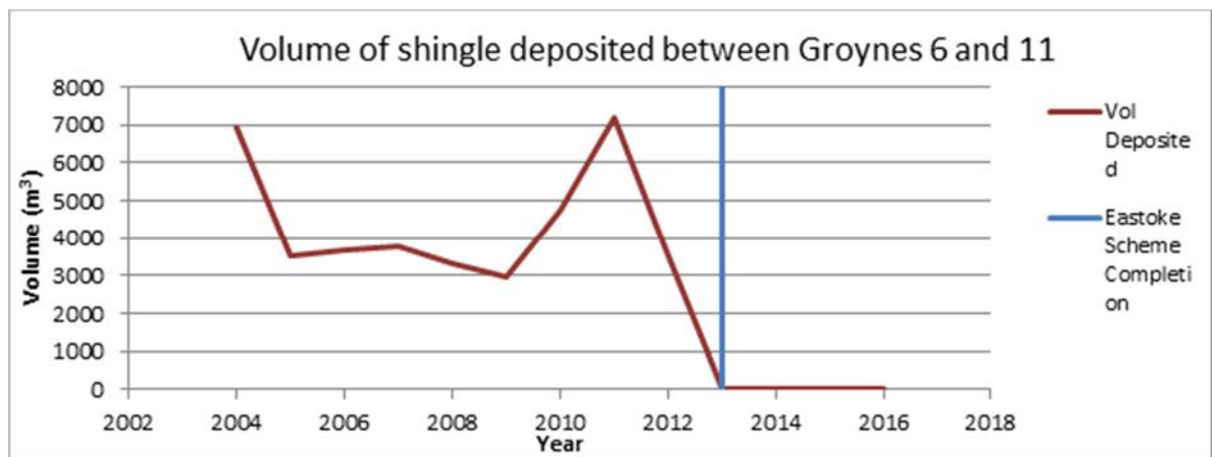
**Figure 3.5 Volume of shingle deposited between groynes 6 and 11 between 2004 and 2016**

Prior to the Eastoke Point scheme, an average annual volume of 4397m<sup>3</sup> was deposited in groyne bays 11 – 6 between 2004 – 2012 (Figure 3.5). Since construction and import of 25,000m<sup>3</sup> of material in 2013, only a nominal amount of 31m<sup>3</sup> has been deposited between groyne bays 6 – 11 (Figure 3.5) as the scheme has been performing well.

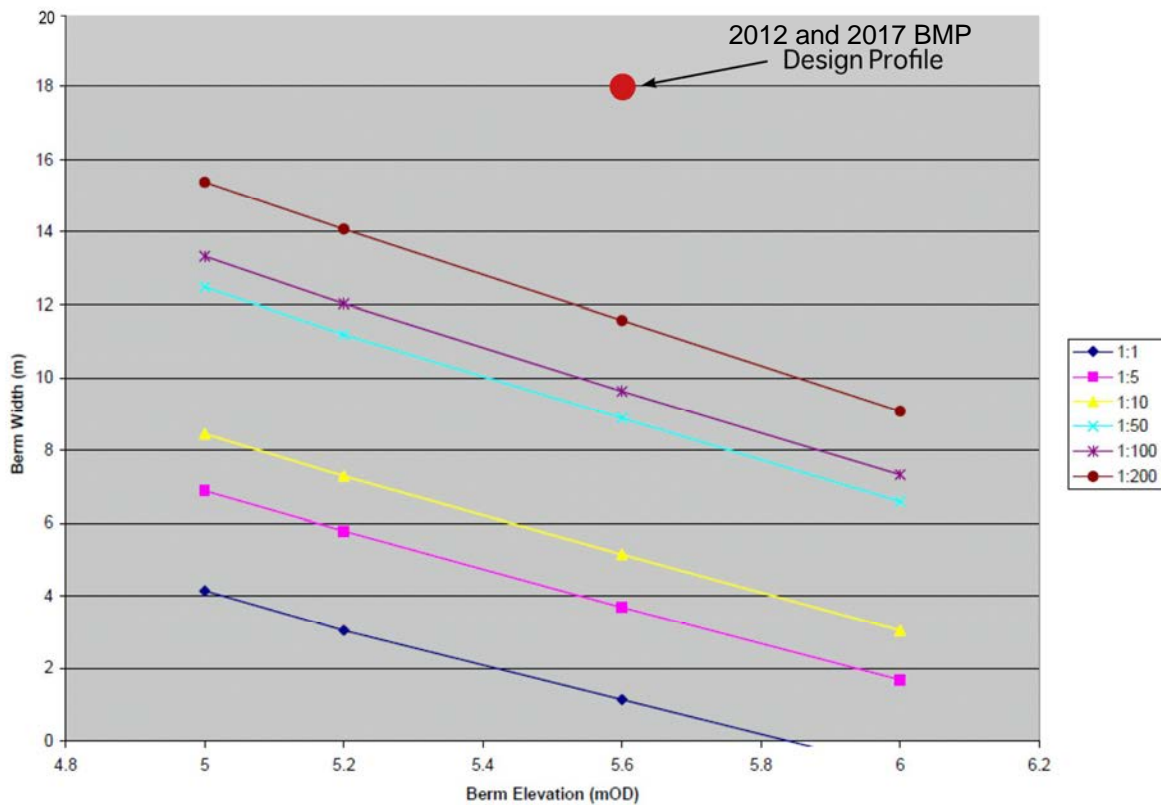
**Figure 3.6 Beach Design Profile Parameters (adapted from Ref 3.5) for varying overtopping standards of protection. Current design profile added to graph.**

- Three or more consecutive groyne bays depleted below a 1 in 10 year SoP (see Figure 3.6). ACTION: The area shall be monitored daily by suitable officer to assess whether the area is deteriorating or naturally regenerating. If the area is regenerating then daily monitoring shall continue until the standard of protection is in excess of the 1 in 10 year standard.
- The nourished frontage volume falls within 10,000 m<sup>3</sup> of the design volume (Section 3.3). ACTION: Volume of the nourished frontage to be monitored to establish if low levels are a result of a single anomalous survey, e.g. event drawing material down below toe of surveys, or a longer term erosional trend.

- The nourished beach volume continues to fall below 10,000 m<sup>3</sup> of the design volume before the end of the BMP period. ACTION: Emergency works triggered, along with the appropriate ongoing monitoring (Section 4).
- Individual bay drops below 1 in 1 year SoP (Figure 3.6). ACTION: Emergency works triggered, along with the appropriate ongoing monitoring (Section 4).
- 50% of frontage falls below 1 in 100 year SoP (Figure 3.6). ACTION: Emergency works triggered, along with the appropriate ongoing monitoring (Section 4).

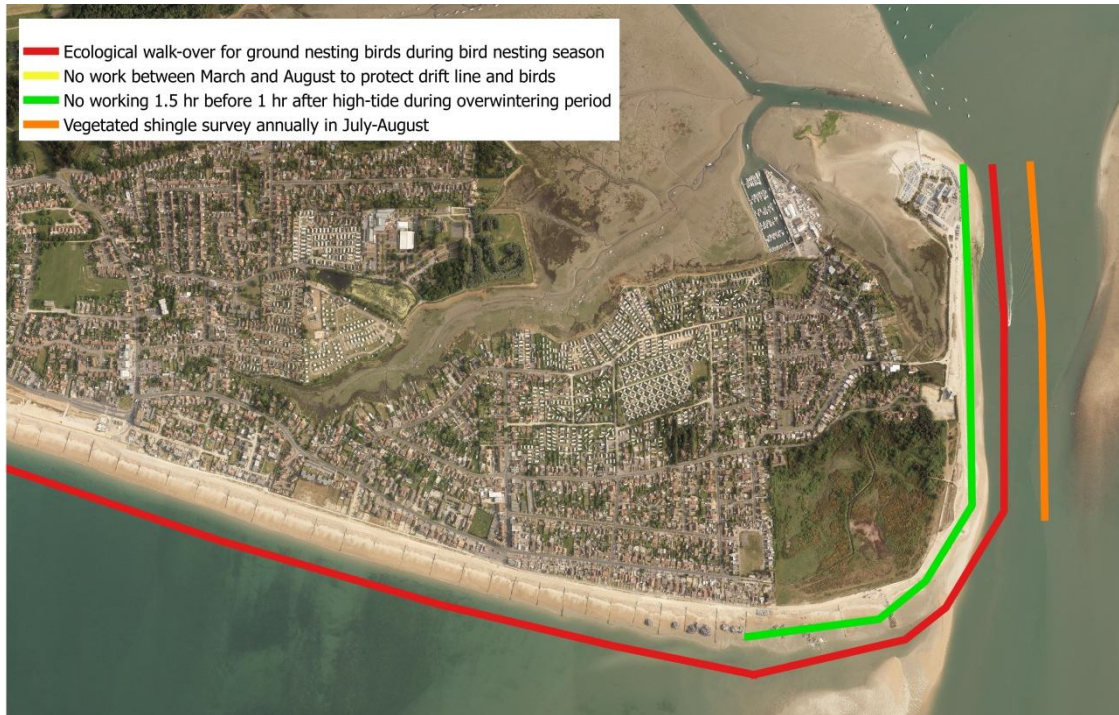
**Figure 4.1 Restrictions and surveys along the Hayling Frontage (East)**
